Report

on field survey after May 22, 2012 Pernik earthquake

June 6, 2012

Coseismic geological effects

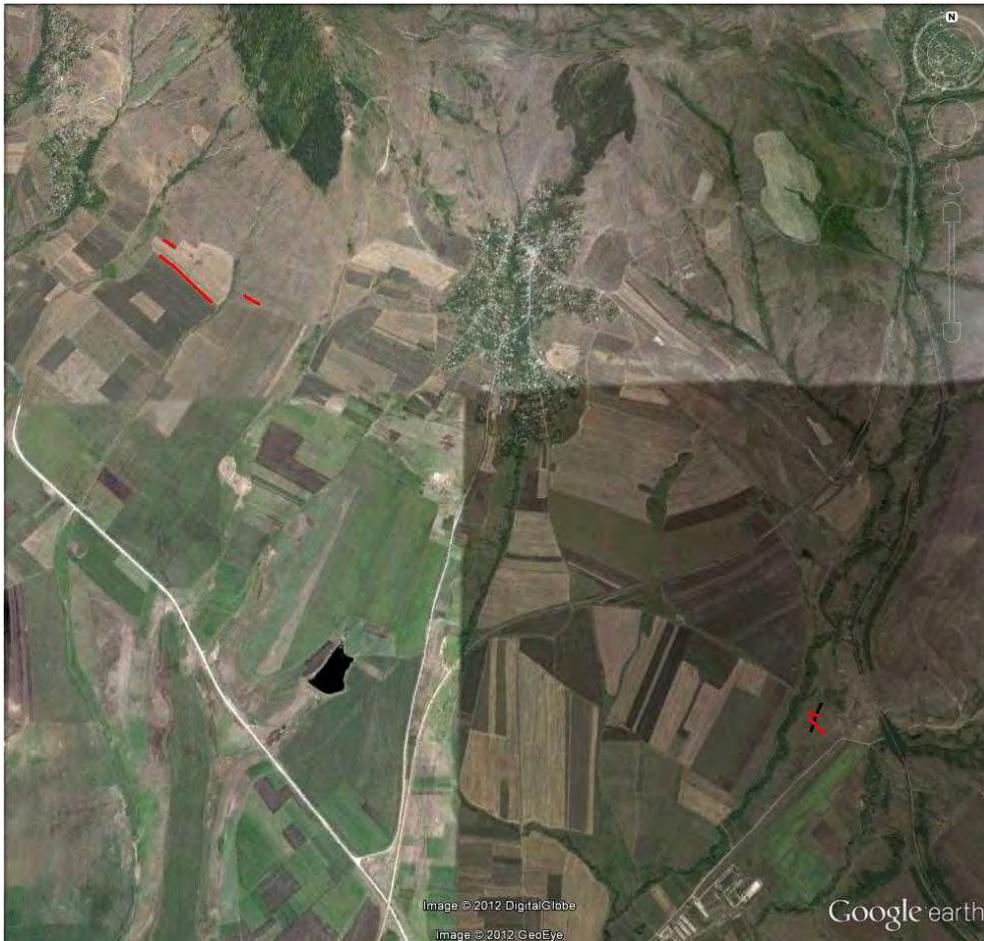
Ground cracks were observed in two localities – SE from Viskyar village and N from Meshtitsa village. The map of observed features is shown on figure 1.3. Localities in KML file are available at <http://www.geology.bas.bg/seismo/Coseismic%20geological%20effects%20Pernik%20Mw%205.6%20earthquake.kmz>.

Figure 3. Map of observed coseismic geological effects. Red lines show position of ground cracks. Black line: position of the resistivity profile.

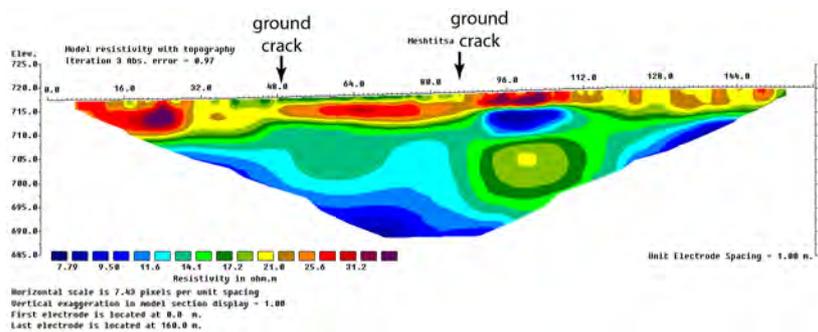
The other area where ground cracks are observed is located in the Ralevska river floodplain, northward Meshtitsa village. Crack morphology is similar but they are wider (up to 8 cm) and vertical displacement is not observed. We did a resistivity profile to verify relationship between cracks and fault (figure 1.4). We interpret the vertical zone between meter 80 and meter 90 from the profile as a medium that hosts a syn-depositional fault. That zone separates parts of different stratification pattern. The uppermost higher resistivity layer (more than 20 Ω .m) corresponds to Holocene fluvial deposits which base is positioned at different elevations across the fault. The cracks in the Ralevska floodplain should be related to very limited fault slip, which has not reached the ground surface. Ground cracks most probably represent tensional fissures diverged from the main fault and an antithetic fault.

Figure 4. Resistivity profile on the Ralevska floodplain. Profile orientation SSW-NNE. SSW at the left-hand side.

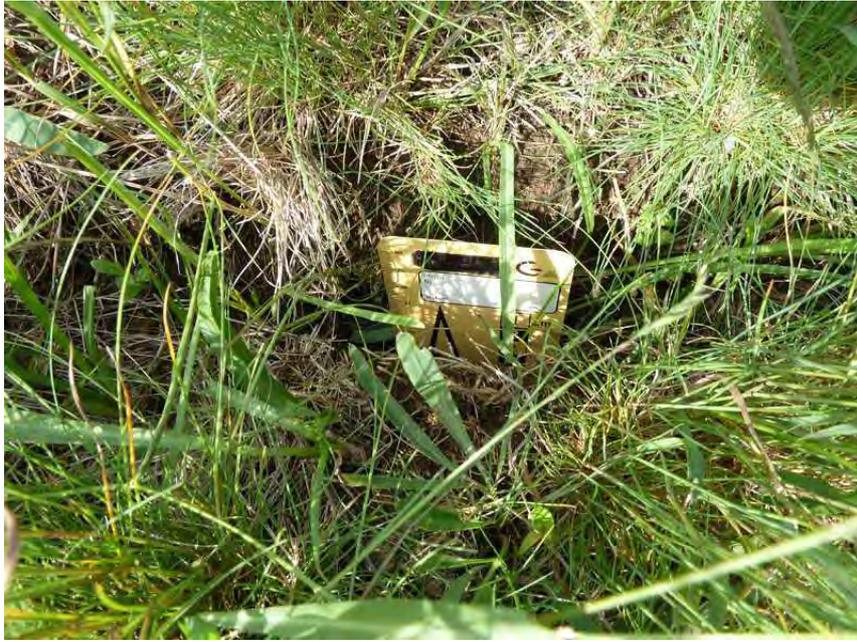
Photo 118. Ground crack in the Ralevska floodplain. Scale is 8 cm high. 42.682746°/ 23.016906°

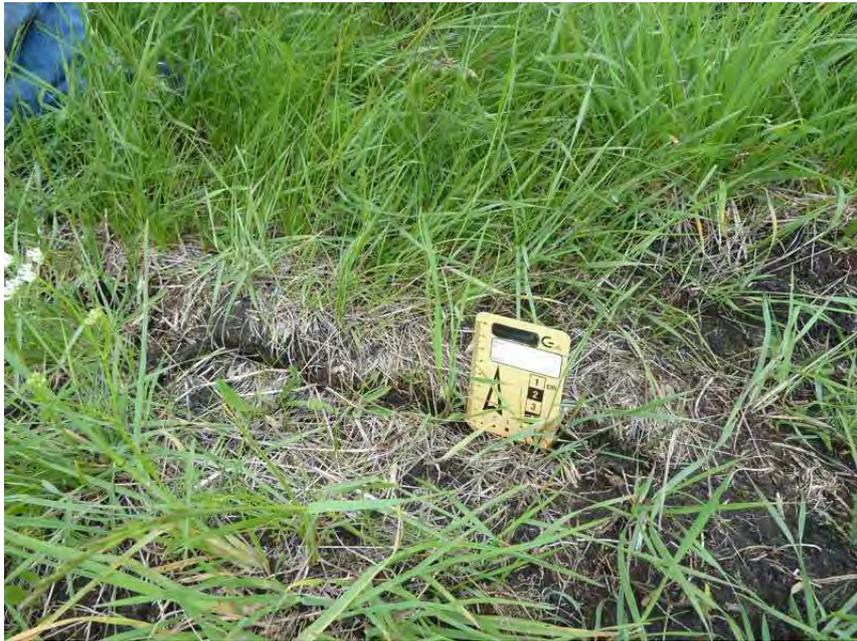
Photo 72. Ground crack with vertical displacement. 42.704152°/ 22.976076°

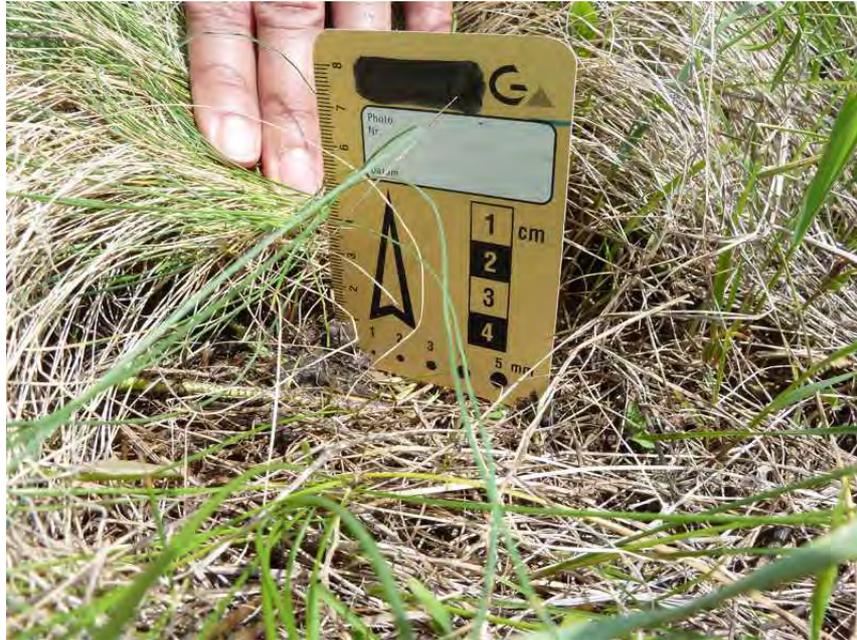
South-east of the Viskyar village the ground cracks are organized in three lines. All the cracks are in wet topsoil. Crack width is between 0,5 and 6 cm, depth is less than 12 cm, and length between 0,3 and 3,0 m. Shorter cracks tend to be straight, and longer cracks form slight bends. Small amount of cracks displaces the ground surface. Cracks with vertical displacement are less opened (0,5-1,5 cm). Maximum observed vertical displacement is 5 cm. All cracks are orientated

Photo 75. Maximum observed vertical displacement 5 cm. 42.703895°/ 22.976501°

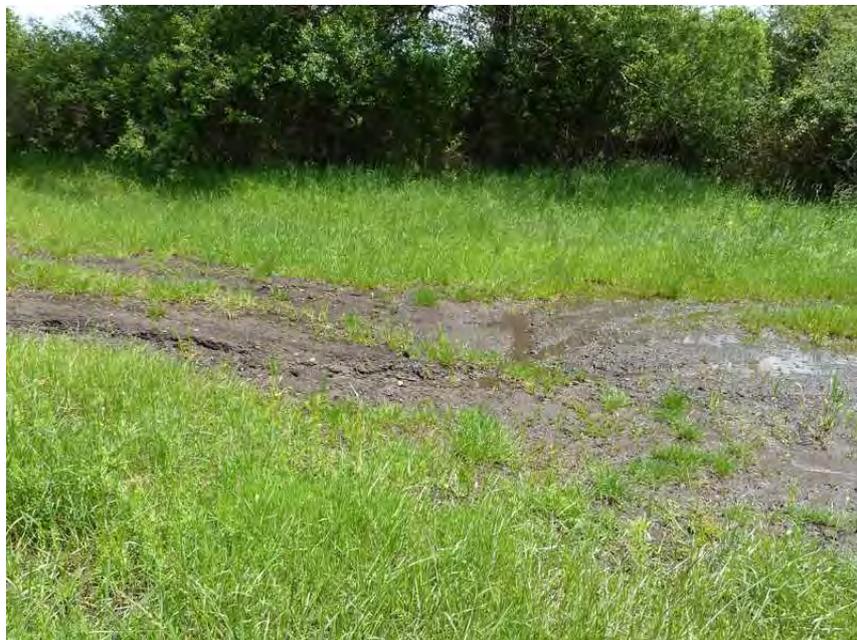
Photo 78. Small active alluvial fan along the line where cracks with displacement were observed.

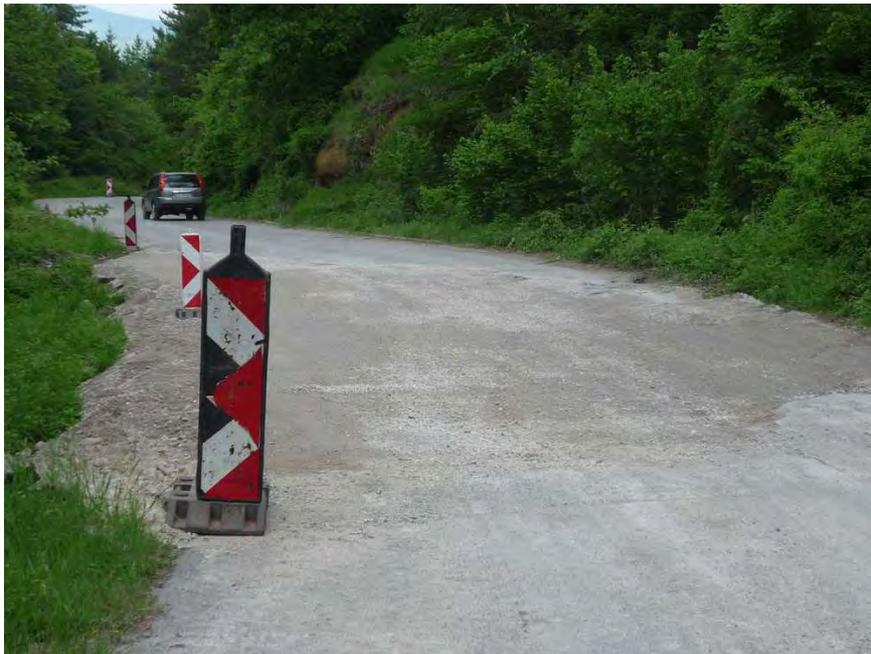
Landslide movements at road section Rudartsi-Kladnitsa triggered on May 27. A 20 meter stretch of roadway is damaged, the maximum subsidence is about 0.5 m (figure 2.1). There is a dangerous area above it, where deformations just have started. There are also 6 additional parts of road with older deformations developed in road embankment materials (figure 2.2).

Figure 2.1. Landslide damaged section of road Rudartsi-Kladnitsa (GPS point 664).

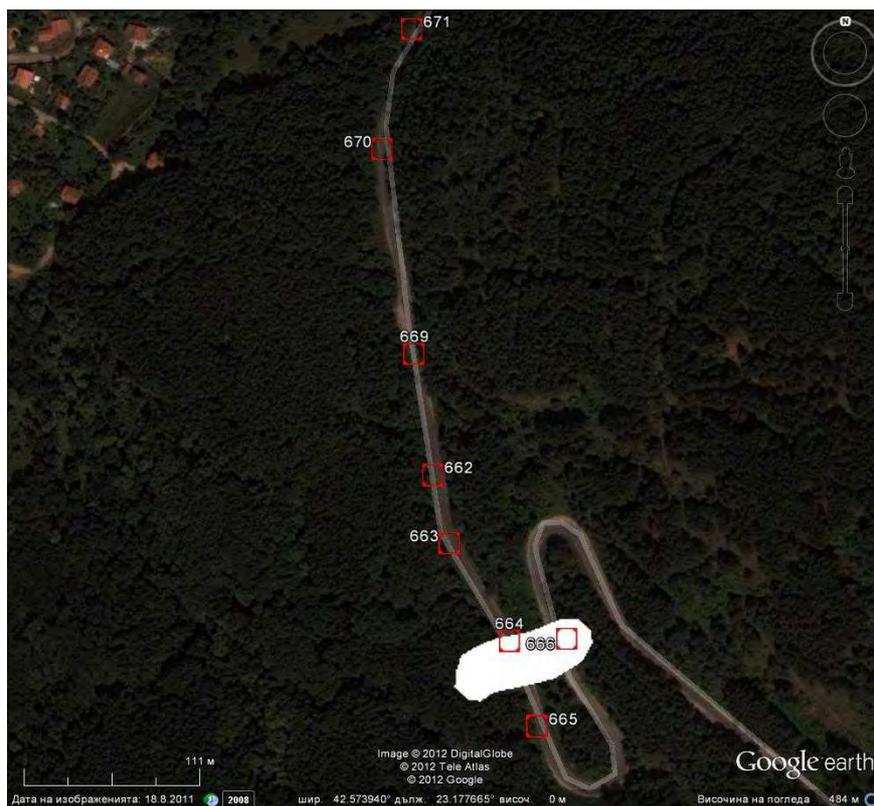
Figure 2.2. Location of landslide along the road Rudartsi-Kladnitsa and possible unstable sites

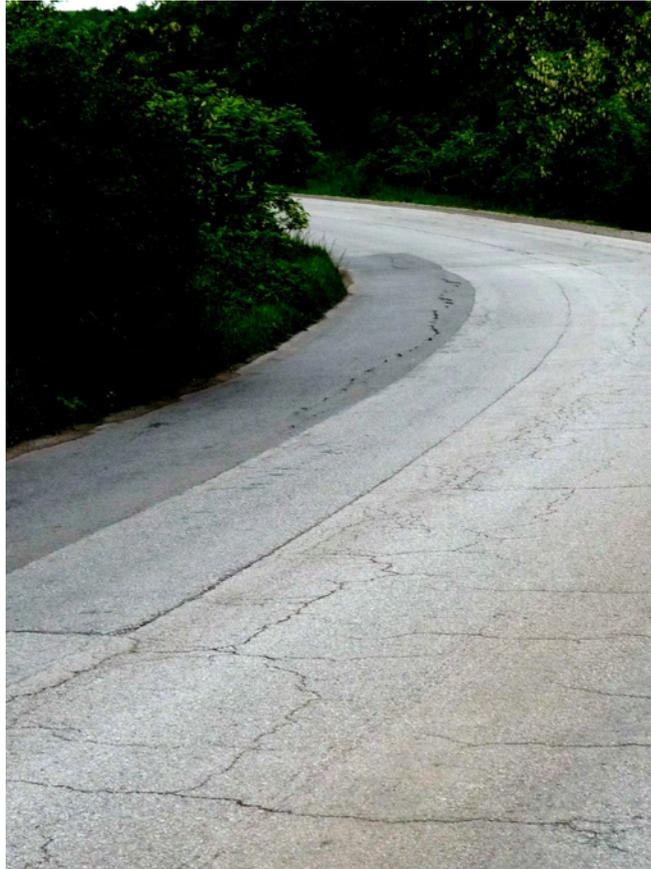
Other deformations have been also identified during the inspection on the road Pernik-Meshtitsa at 0.7-1.0 km before the Meshtitsa village (figures 2.3 and 2.4). The road passes through an old dormant landslide. The newest reactivations have started at left and right landslide flanks

Figure 2.3. Fresh cracks at road Pernik-Meshtitsa (picture at GPS point 693)

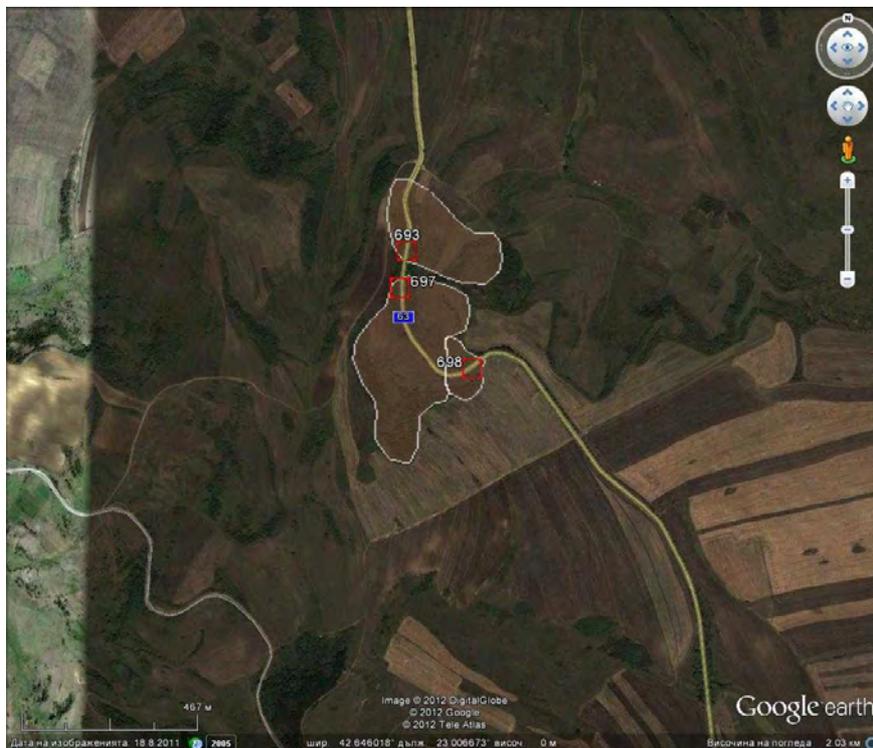
Figure 2.4. Landslides at road Pernik-Meshtitsa. Actication was detected in the two side landslides

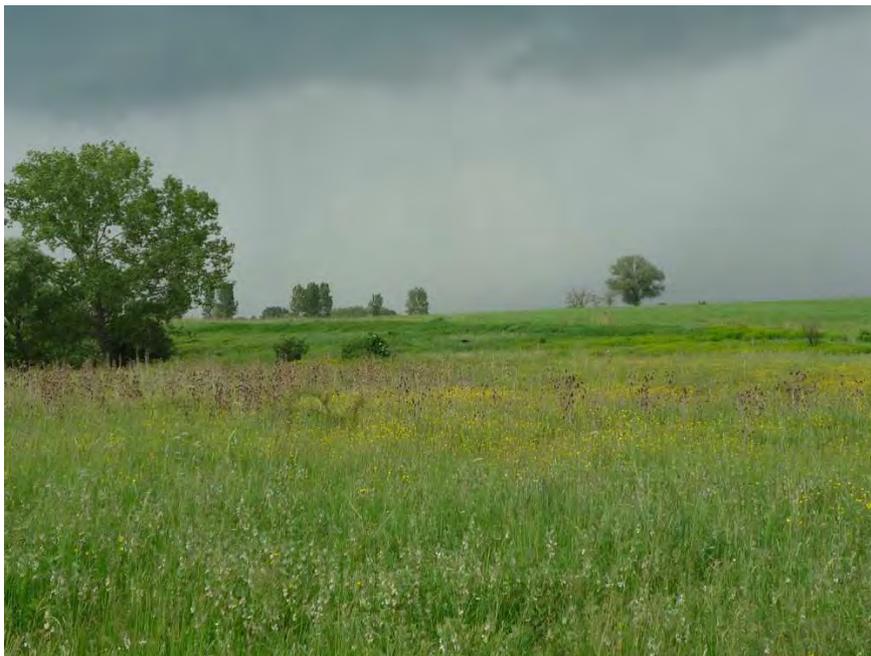
On the west side of the road to the village of Rasnik, we established a landslide with sizes: ~110 meters wide and max. 60 m long (figures 2.5 and 2.6). It is developed into extremely gentle slope inclination – just 3°. The landslide is of earthflow type, almost his entire body falls in marshy terrain. The body of the landslide is situated on the fault line scarp.

Figure 2.5. Small landslide scarp near Rasnik Village

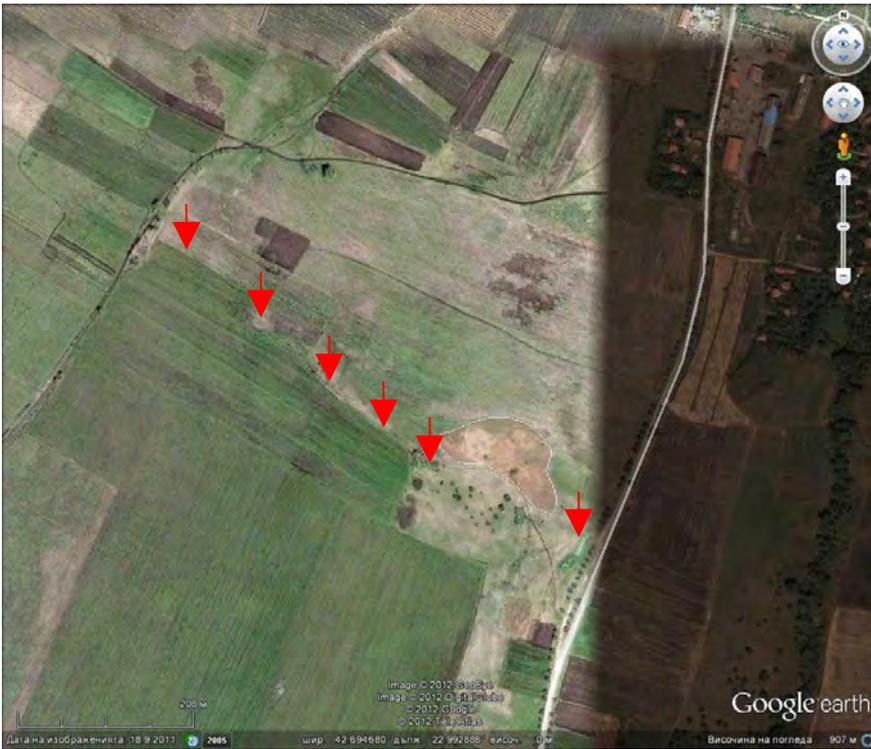
Figure 2.6. Satellite image of the gentle landslide and the visible fault trace (red arrows)
