M7.2 Kumamoto Earthquake

14 and 15 april 2016

A compilation of data and results with focus
on surface rupture

By Stéphane Baize (IRSN) for the INQUA Project
SURFACE

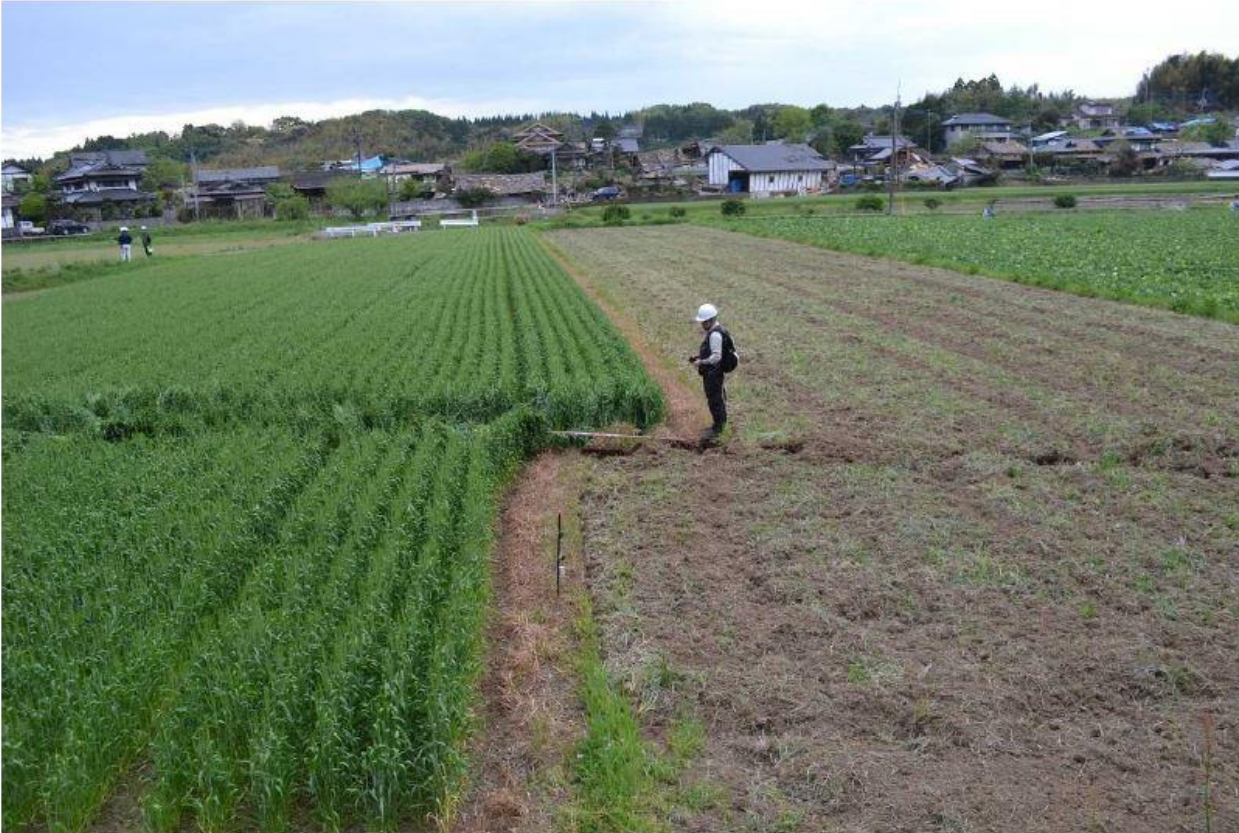
地点3 (堂園)
右横ずれ 約2m

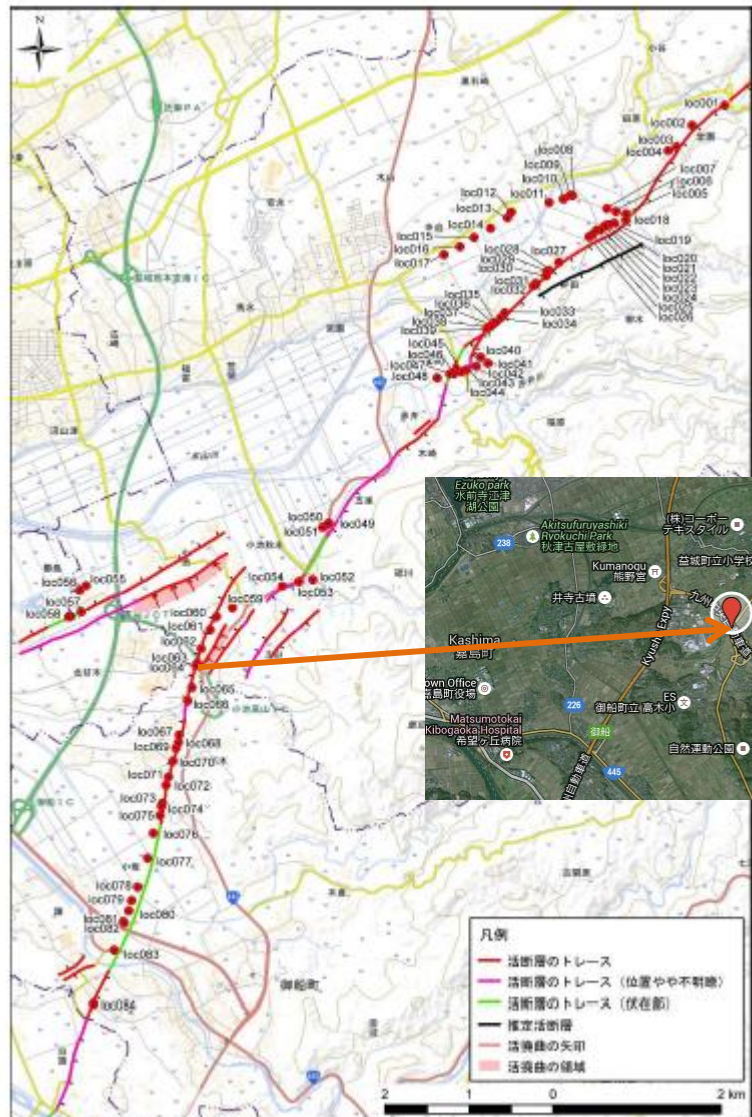
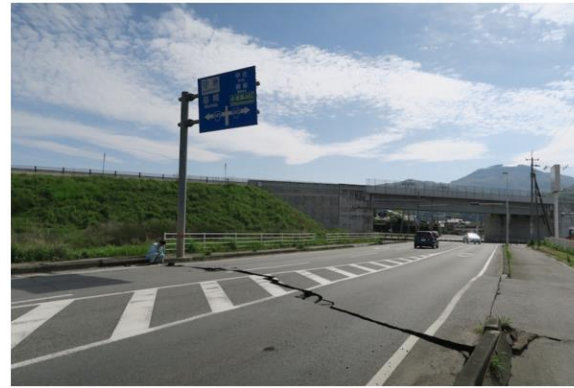
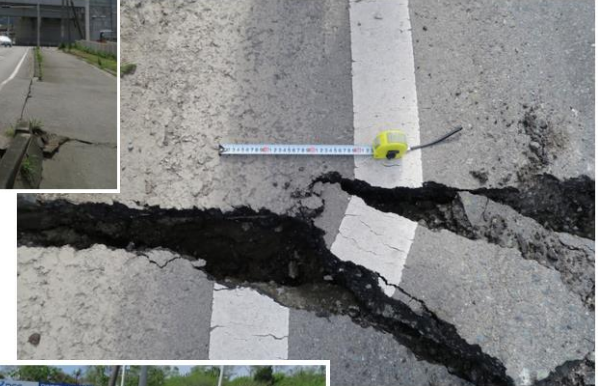
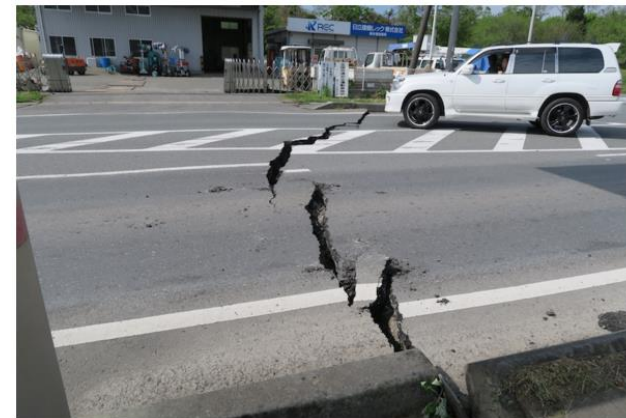
“Right lateral dislocations cross the road way. The gap was approximately 30cm. The dislocation may be a part of surface faulting. This is because no landslides are expected in the area, the crack azimuth agrees with the fault strike, and its location is almost on the fault surface. **According to the neighbor, the dislocation slightly appeared after the 1st event, and it grows to the current size after the 2nd event.**”

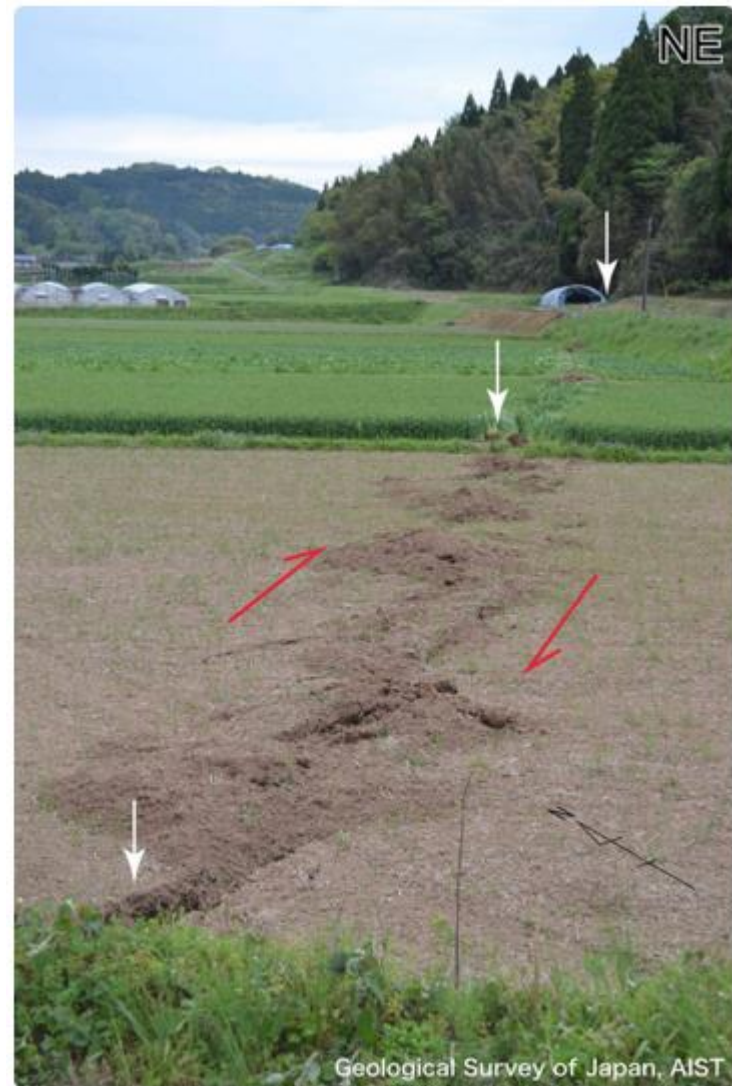
Mall track caused by the right-lateral displacement and displacement seen in the fields of Birds Nest village. Picture taken toward the northeast direction. Fault passes through the right of the blue vinyl house, leading to the mountains. White arrows fault position, the red arrows indicate the displacement sense. (2016 April 16 shooting)

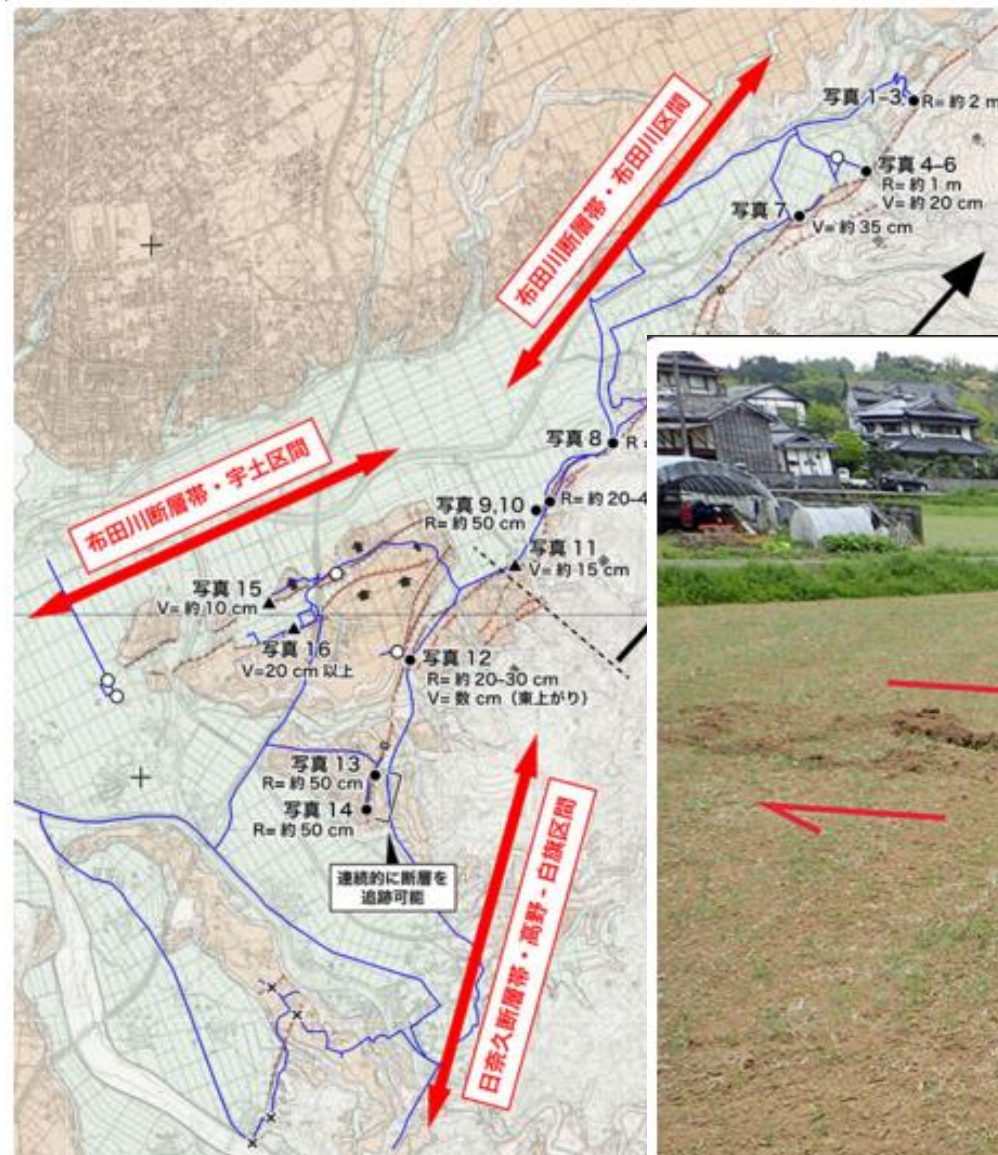
Right-lateral displacement seen in the fields of Birds Nest village. Picture taken toward the northwest direction. Right-lateral displacement amount of time relative to the footpath is about 200 cm. (2016 April 16 shooting)

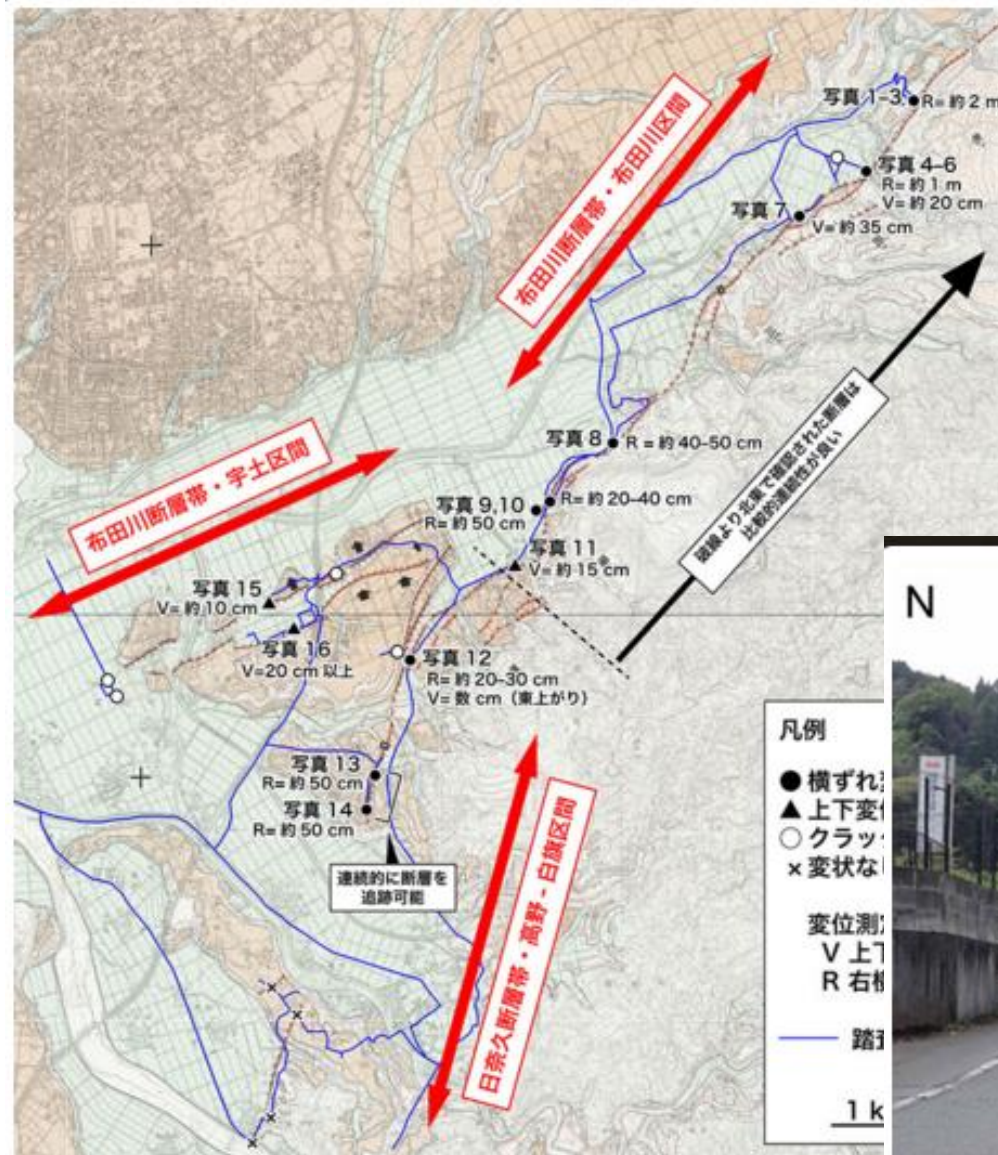
Shortening deformation seen in the pavement of the photo 3 Kamijin settlements. Picture taken toward the southeast direction. Vertical displacement weight of about 40 cm. Fault continues to N70E direction. (2016 April 16 shooting)

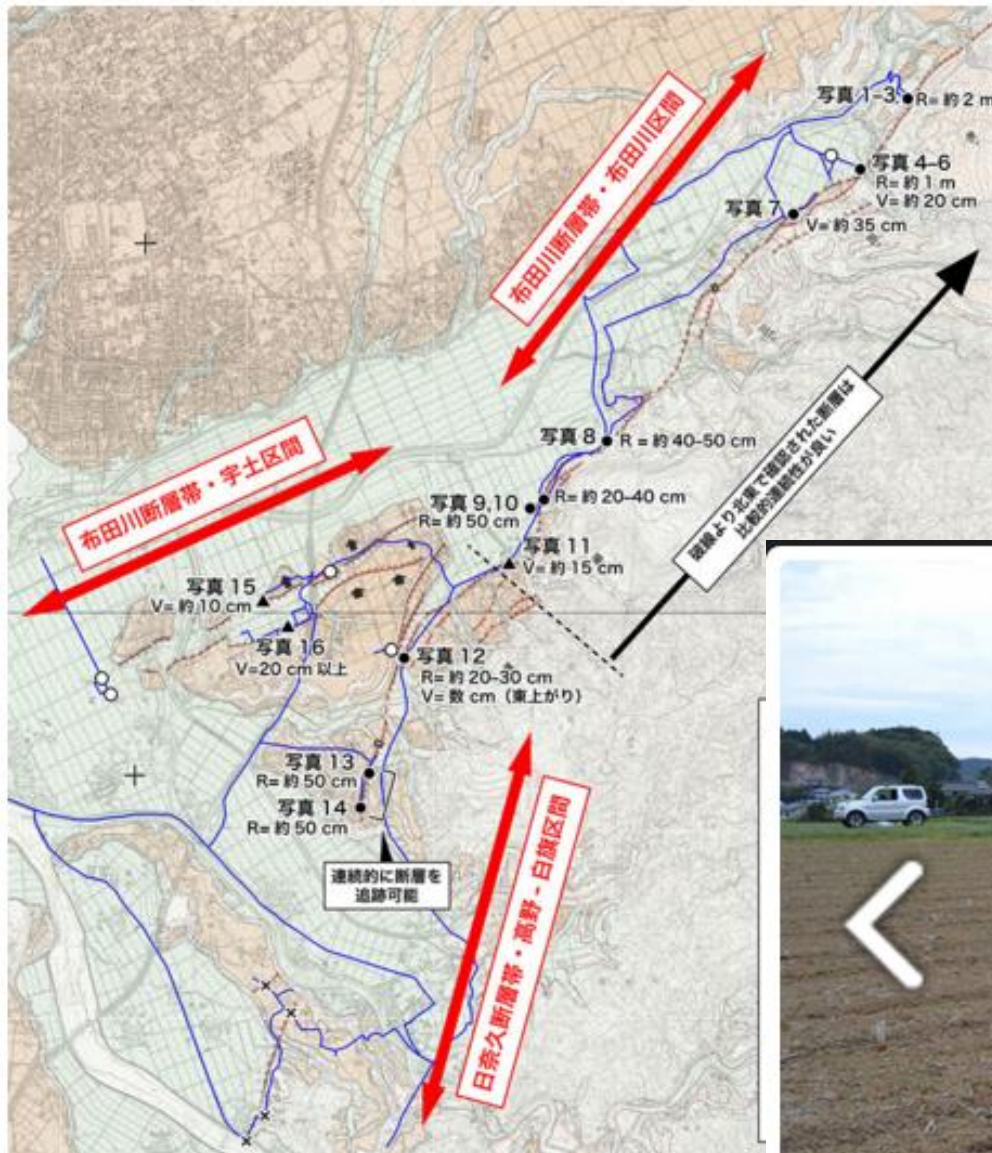
Right-lateral displacement and mall track seen in photo 4 Shimojin village west. Picture taken toward the northeast direction. Right-lateral displacement weight of about 100 cm, vertical displacement weight of about 20 cm. (2016 April 16 shooting)

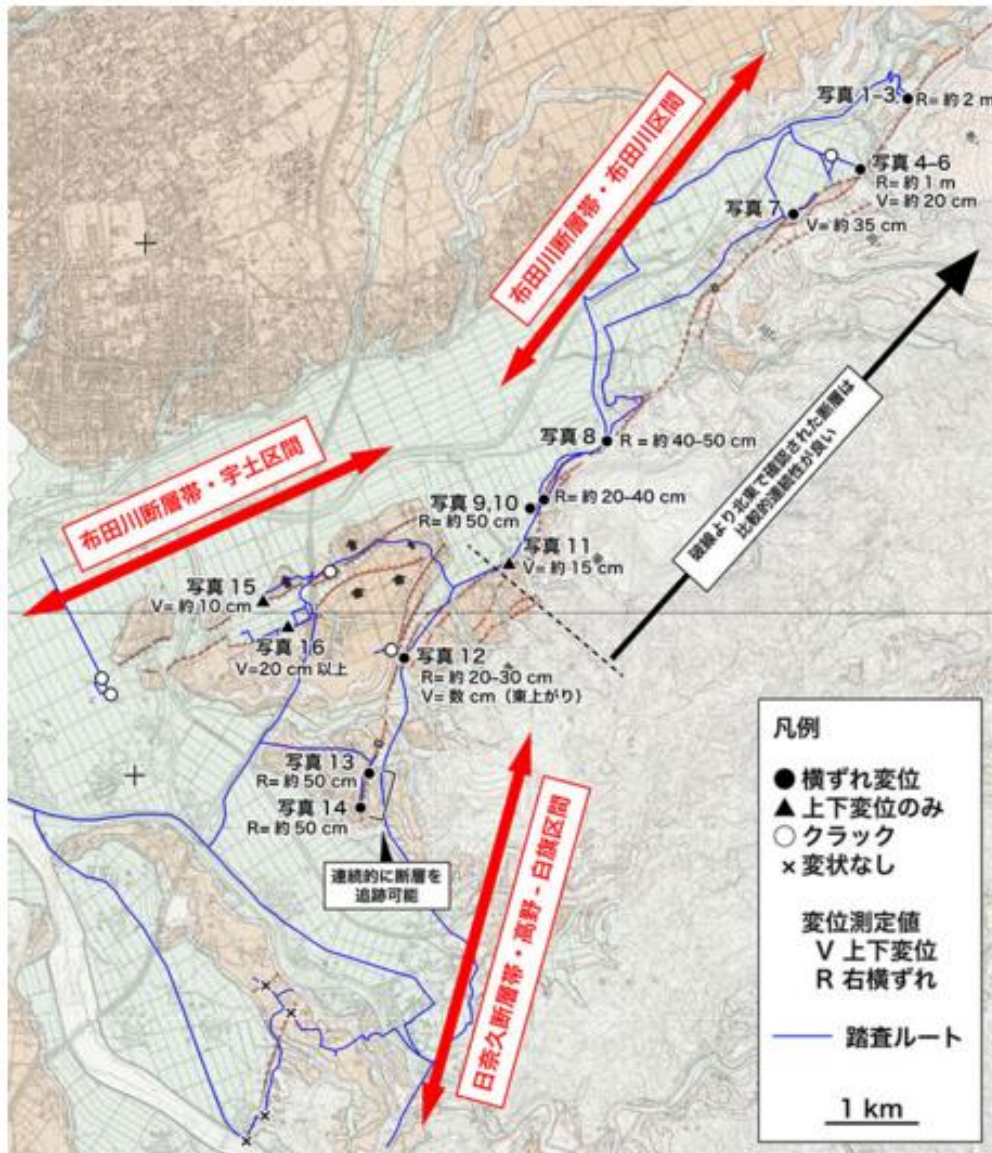
6- Flexure deformation of the paddy field with a left-lateral strike-slip component of N70W strike seen in Shimojin village west. Picture taken toward the west-northwest direction. Vertical displacement weight of about 15 ~ 20 cm, left-lateral strike-slip displacement amount is about 20 cm. (2016 April 16 shooting)

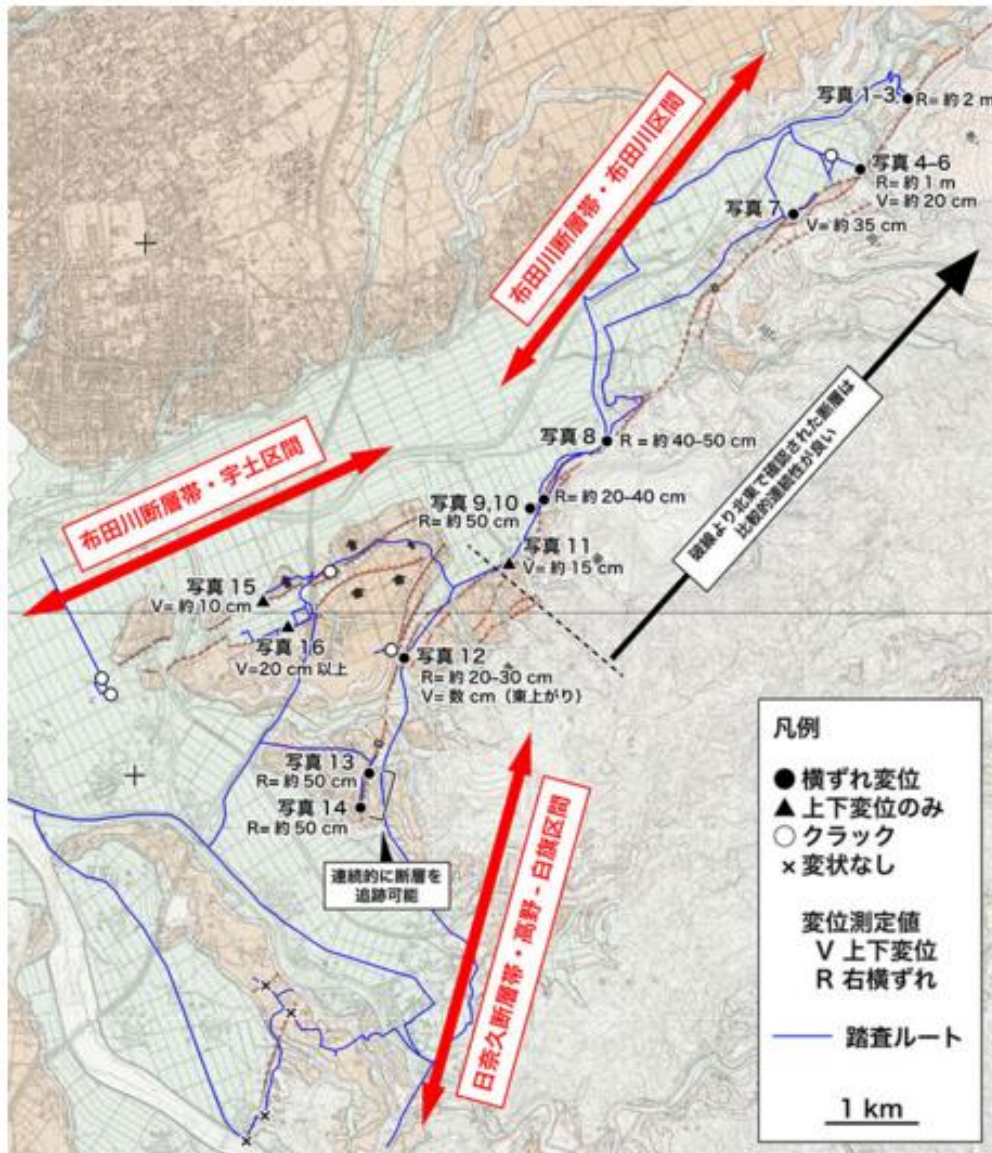
7- Right-lateral displacement seen in photo 7 Mitake village southwest of paddy. Picture taken toward the northeast direction. Fault passes through the road from the distortion part of the guardrail, through the right of the back of the house, continuing to photograph 5. (2016 April 16 shooting)

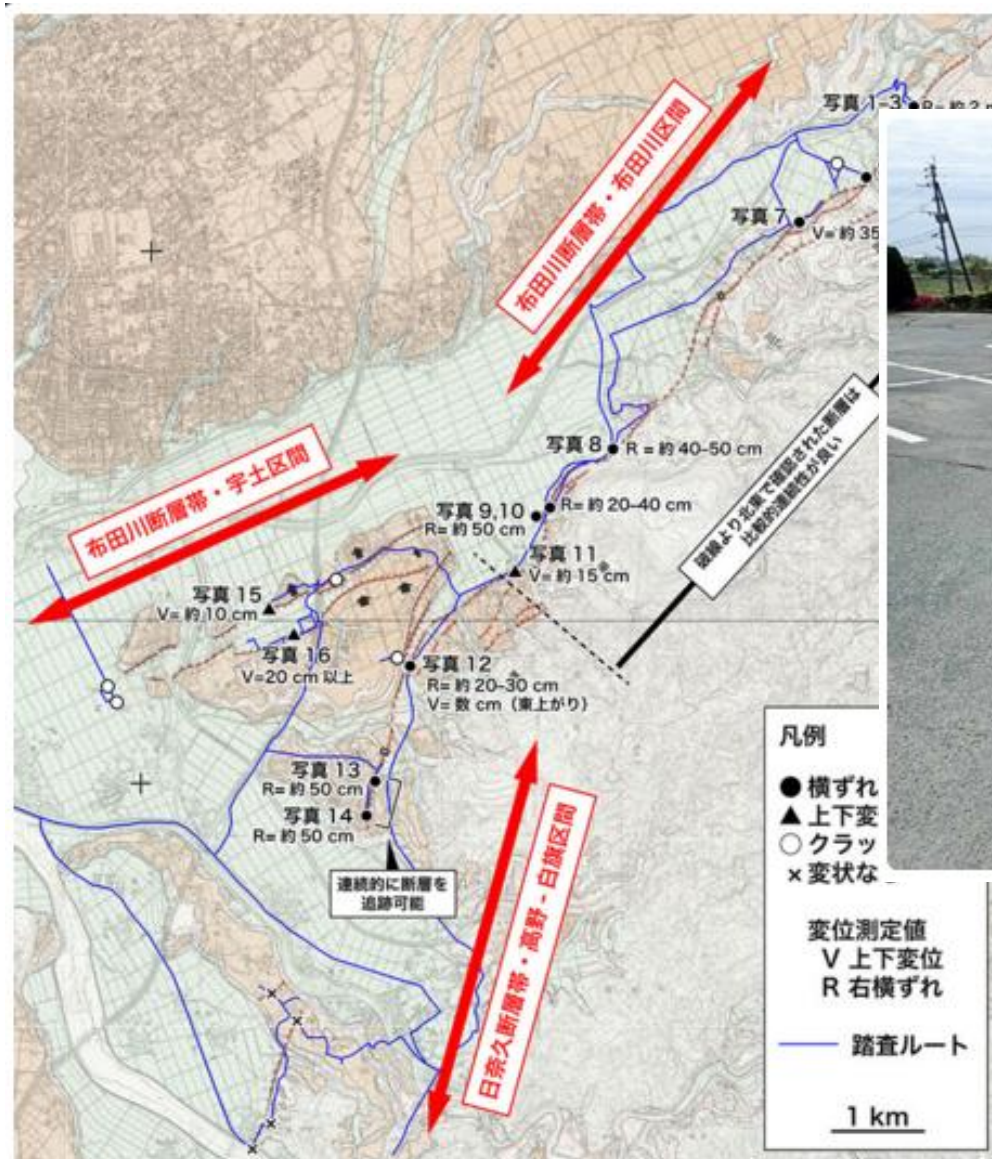
8-Akai village "mashiki townspeople rest of the house," parking lot to see is right-lateral displacement. Picture taken toward the northwest direction. Right-lateral displacement amount is about 40 ~ 50 cm. (2016 April 16 shooting)

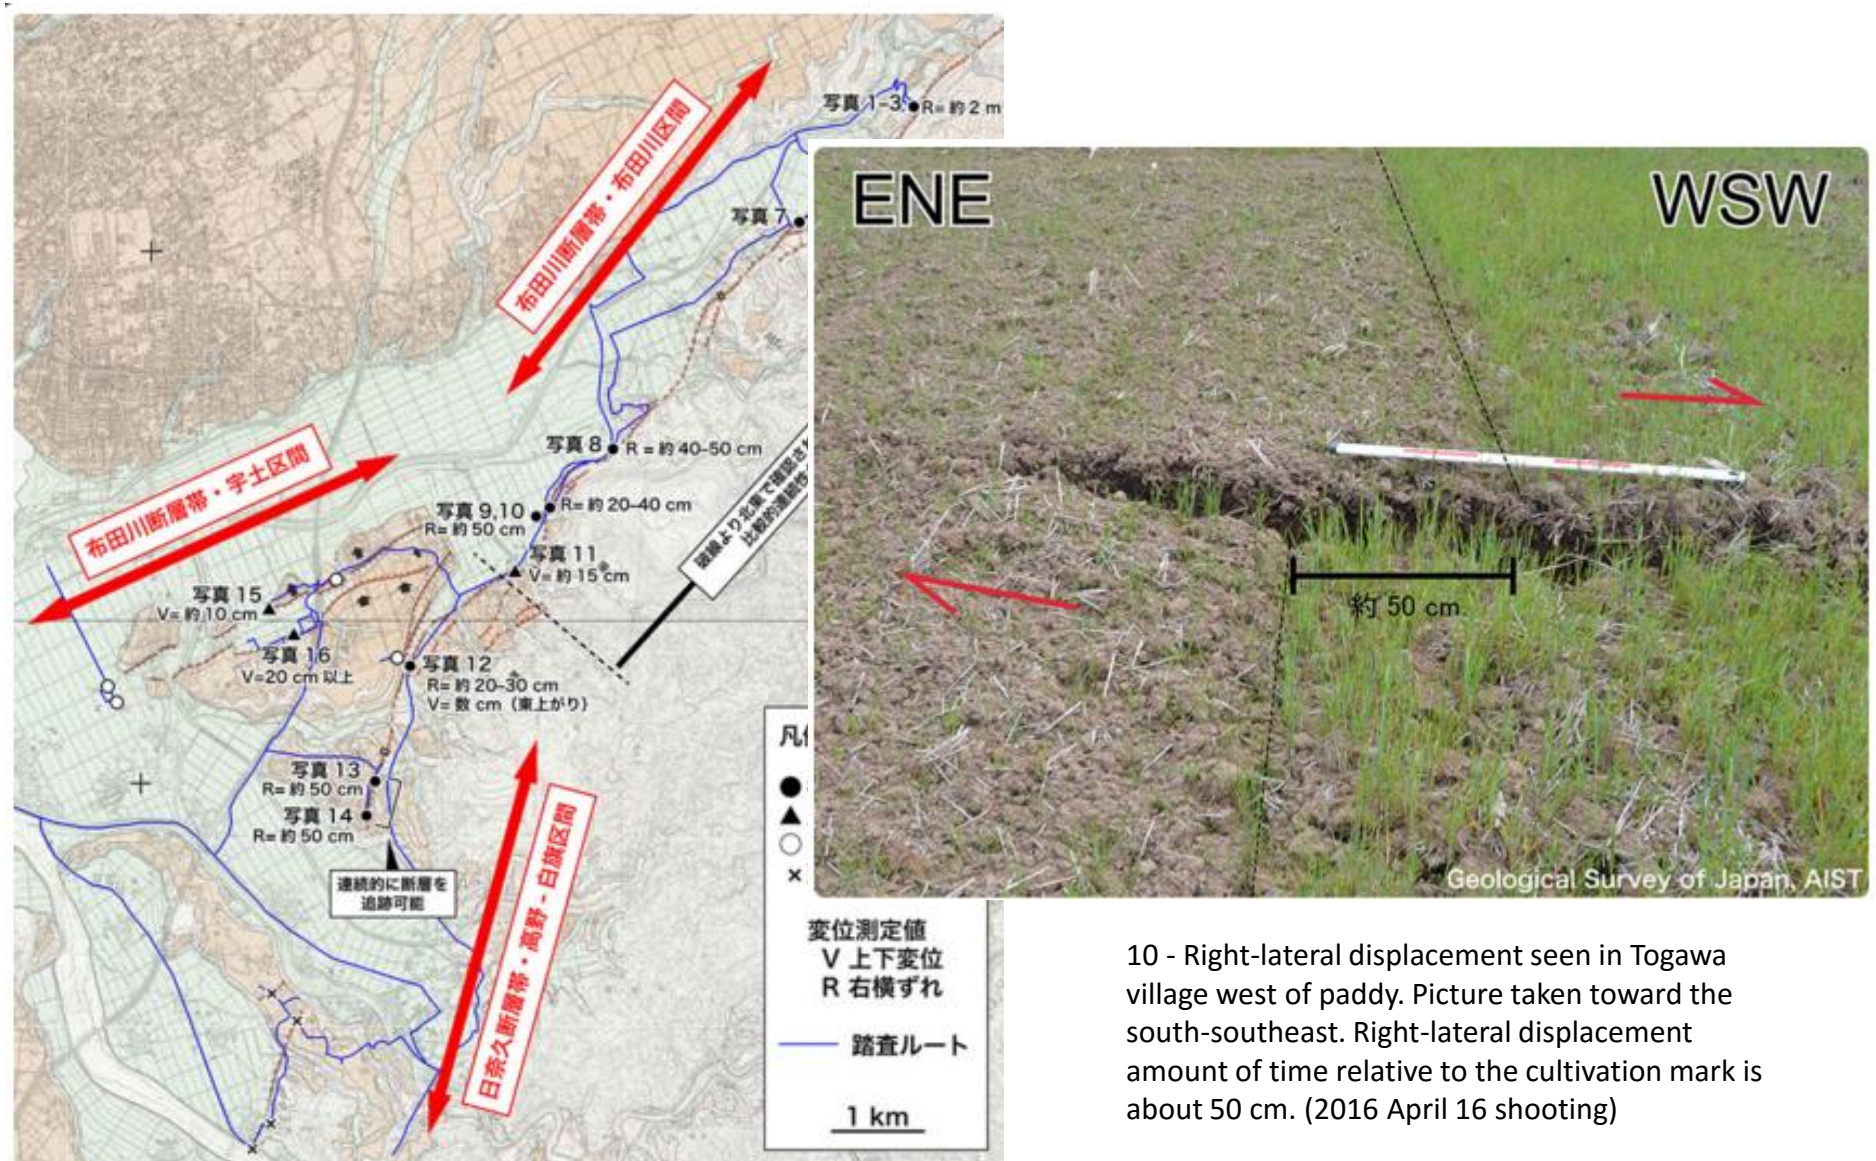
10 - Right-lateral displacement seen in Togawa village west of paddy. Picture taken toward the south-southeast. Right-lateral displacement amount of time relative to the cultivation mark is about 50 cm. (2016 April 16 shooting)

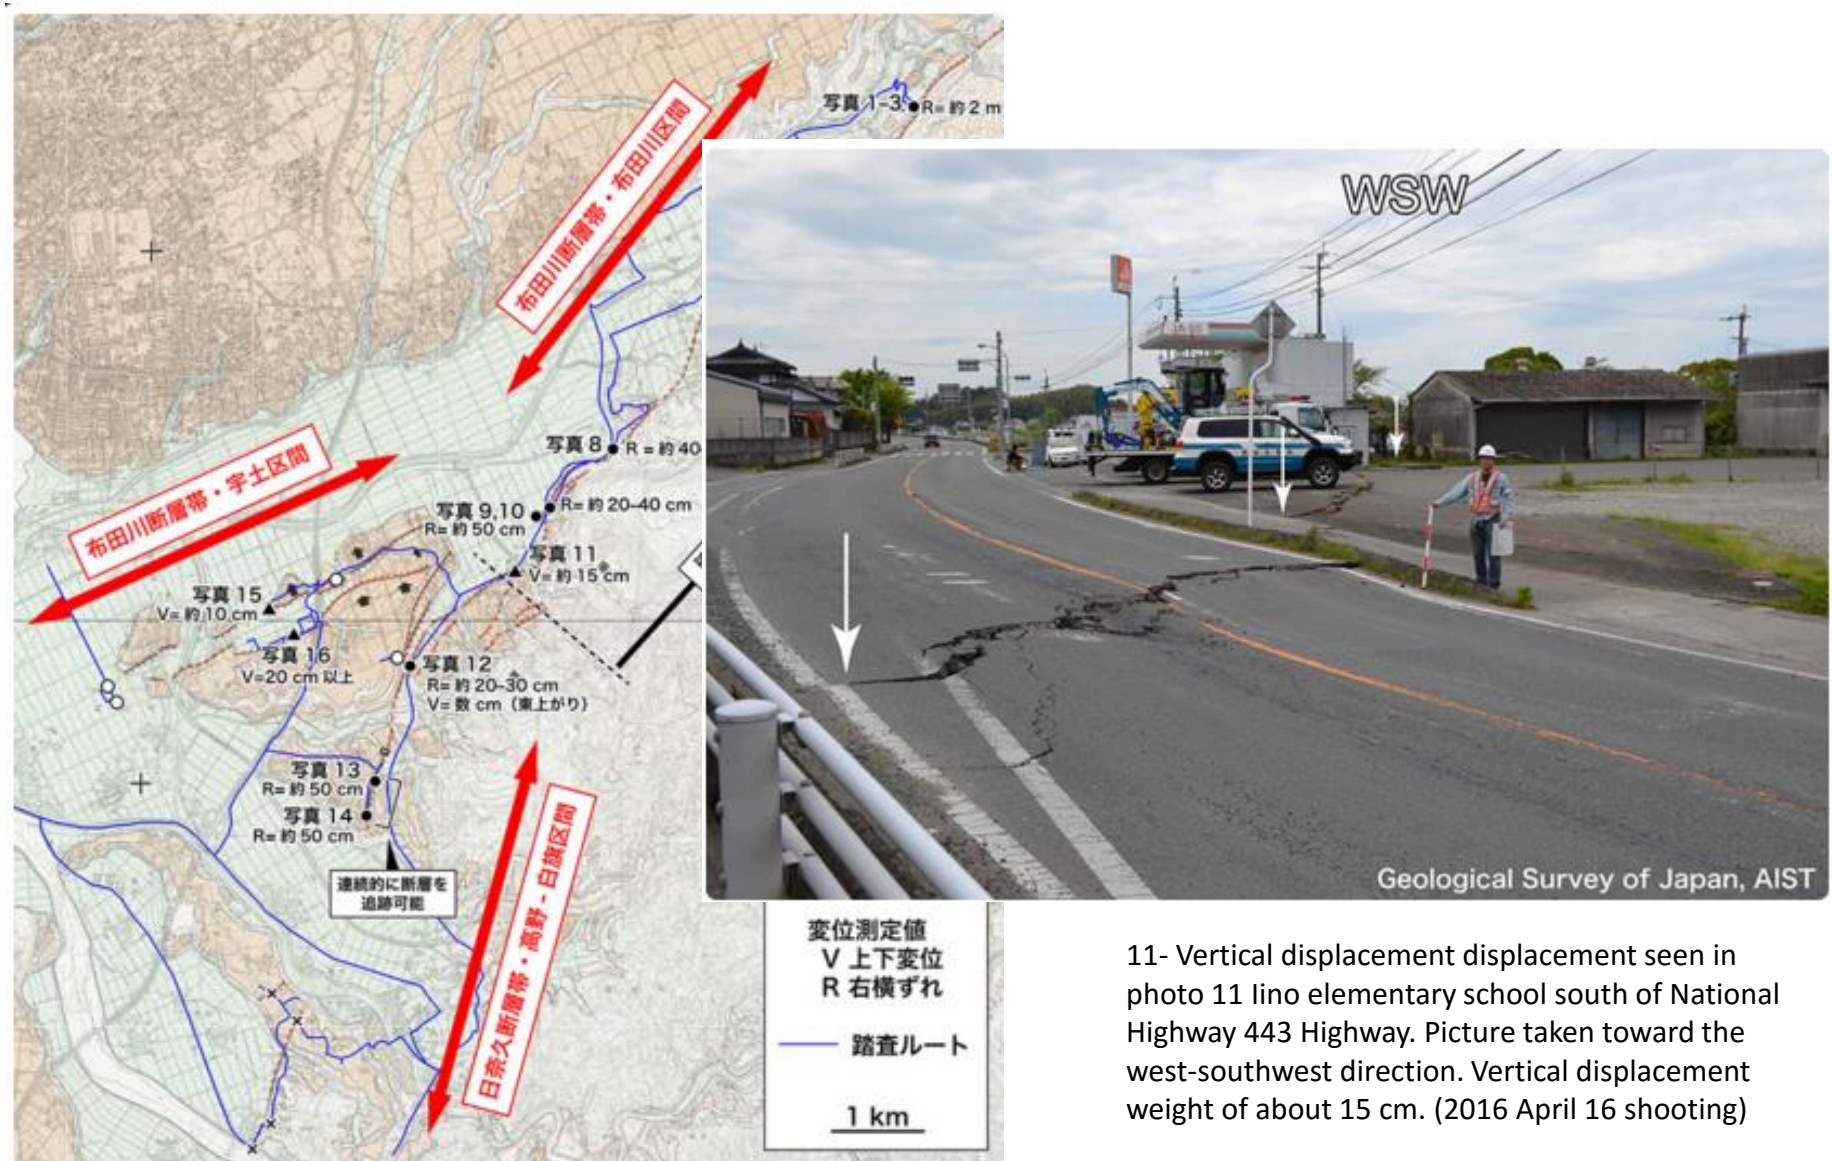
11- Vertical displacement displacement seen in photo 11 lino elementary school south of National Highway 443 Highway. Picture taken toward the west-southwest direction. Vertical displacement weight of about 15 cm. (2016 April 16 shooting)

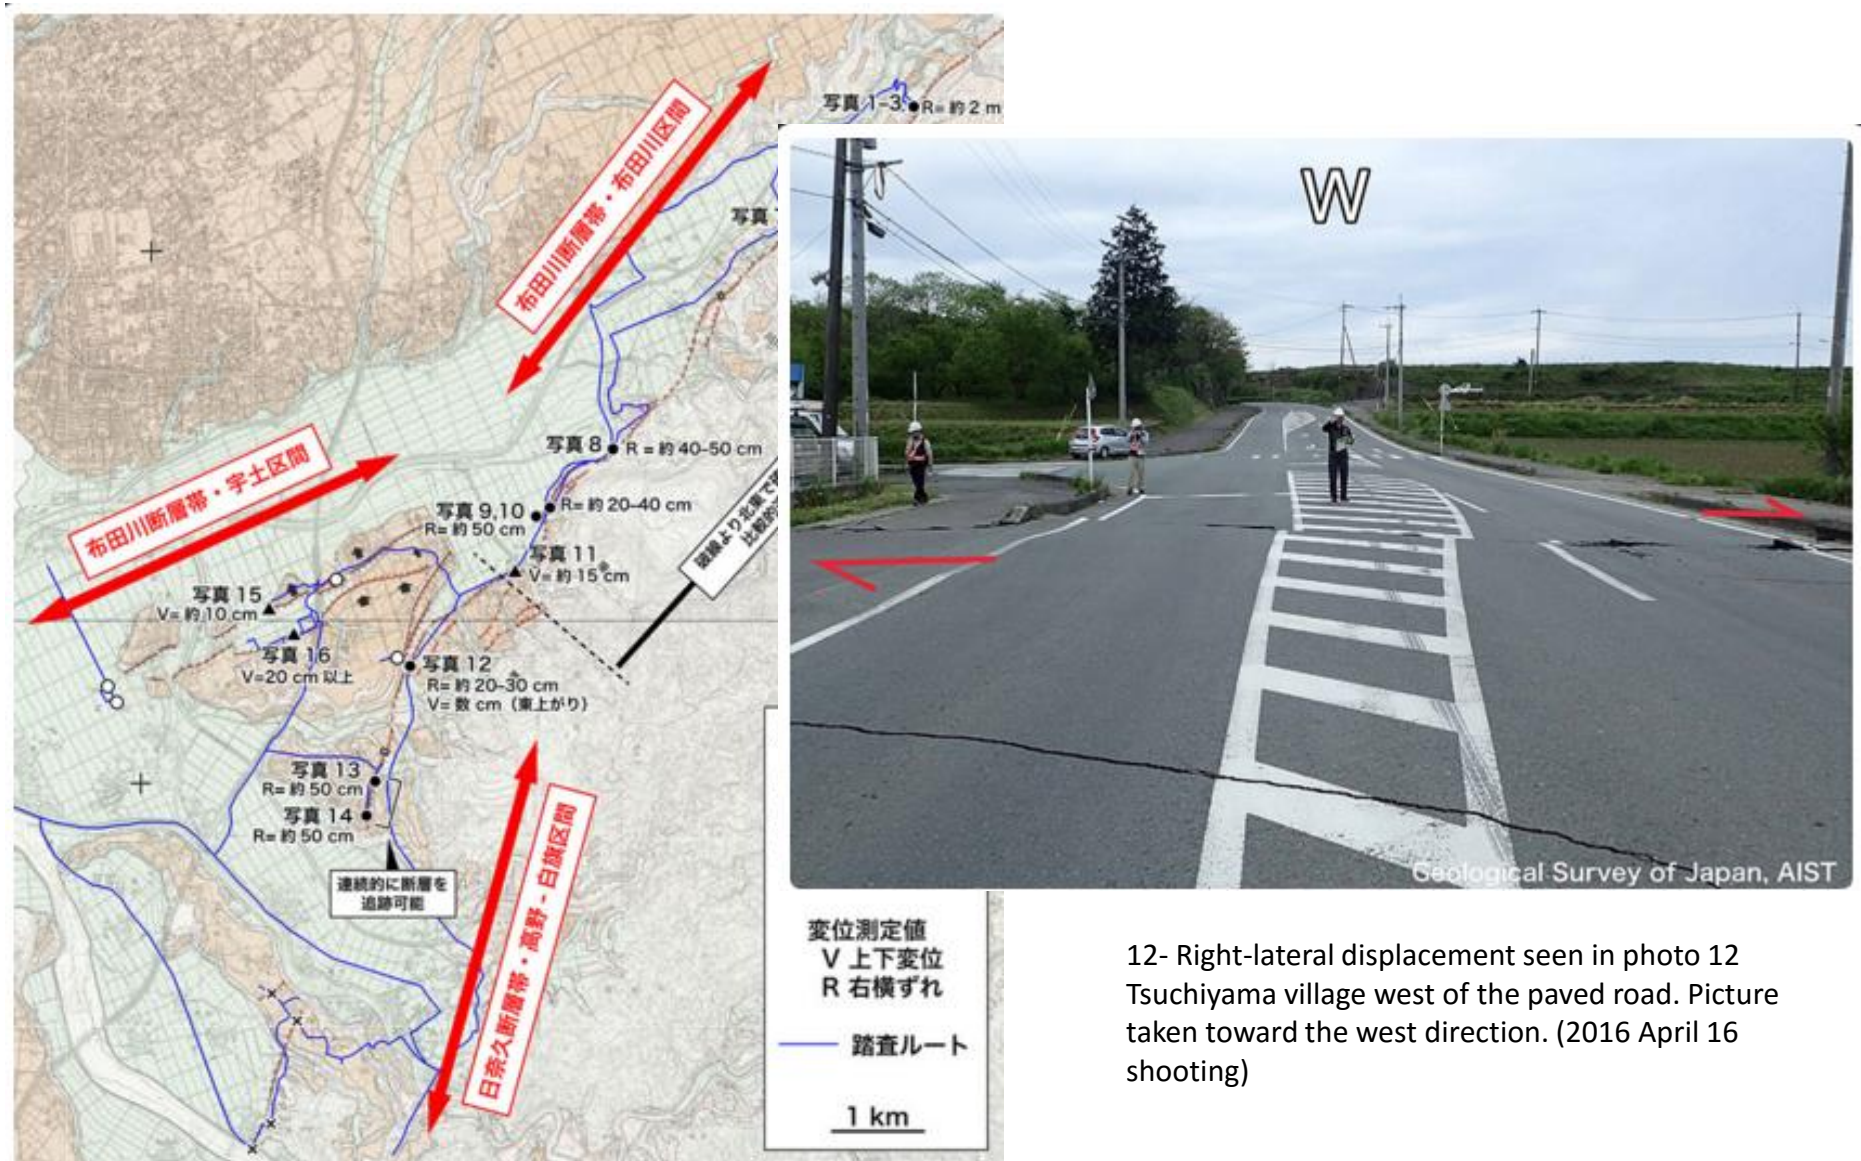
12- Right-lateral displacement seen in photo 12 Tsuchiyama village west of the paved road. Picture taken toward the west direction. (2016 April 16 shooting)

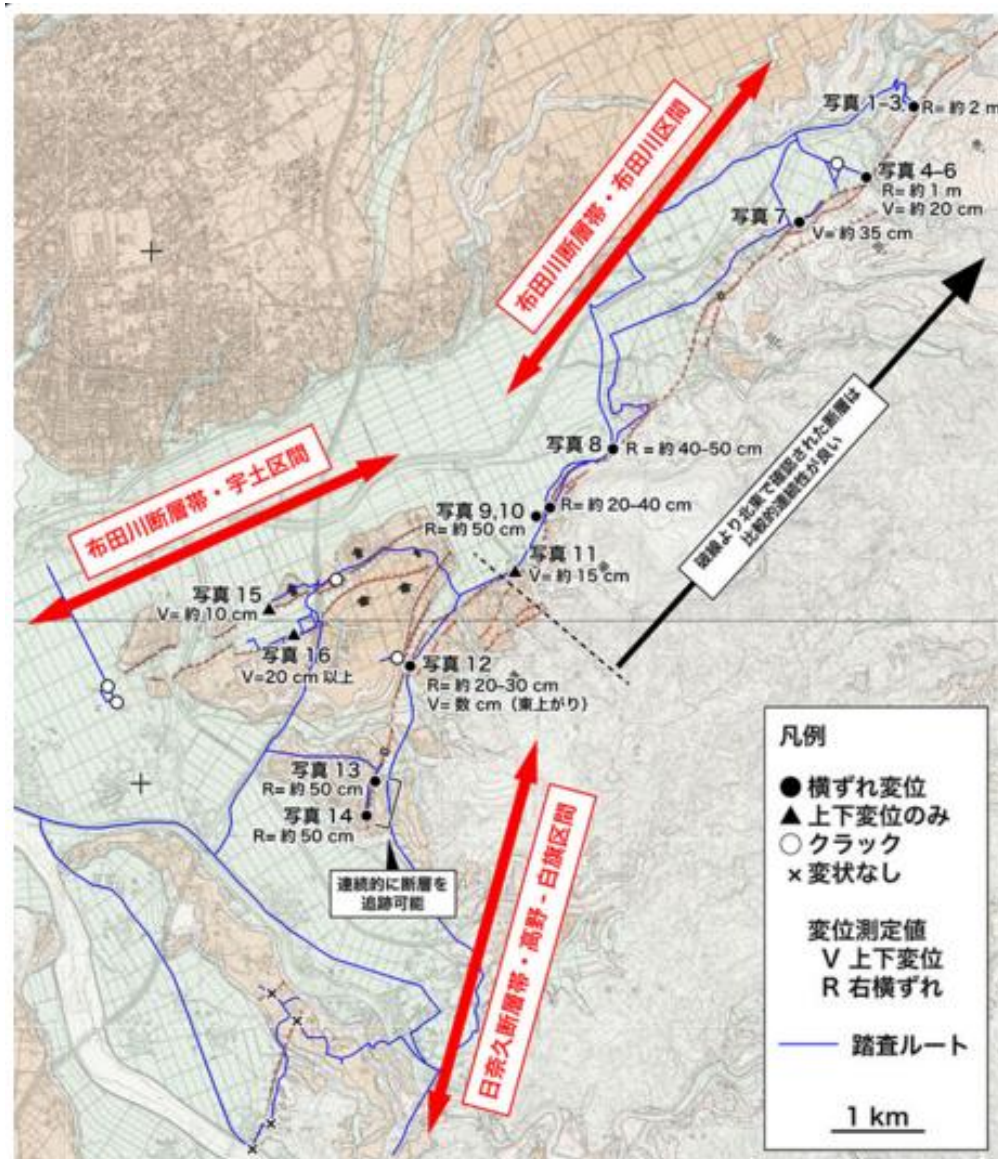
13-Right-lateral displacement seen in the rice paddies of the photo 13 Takagi village. Picture taken toward the south direction. Right-lateral displacement amount is about 50 cm. (2016 April 17 shooting)

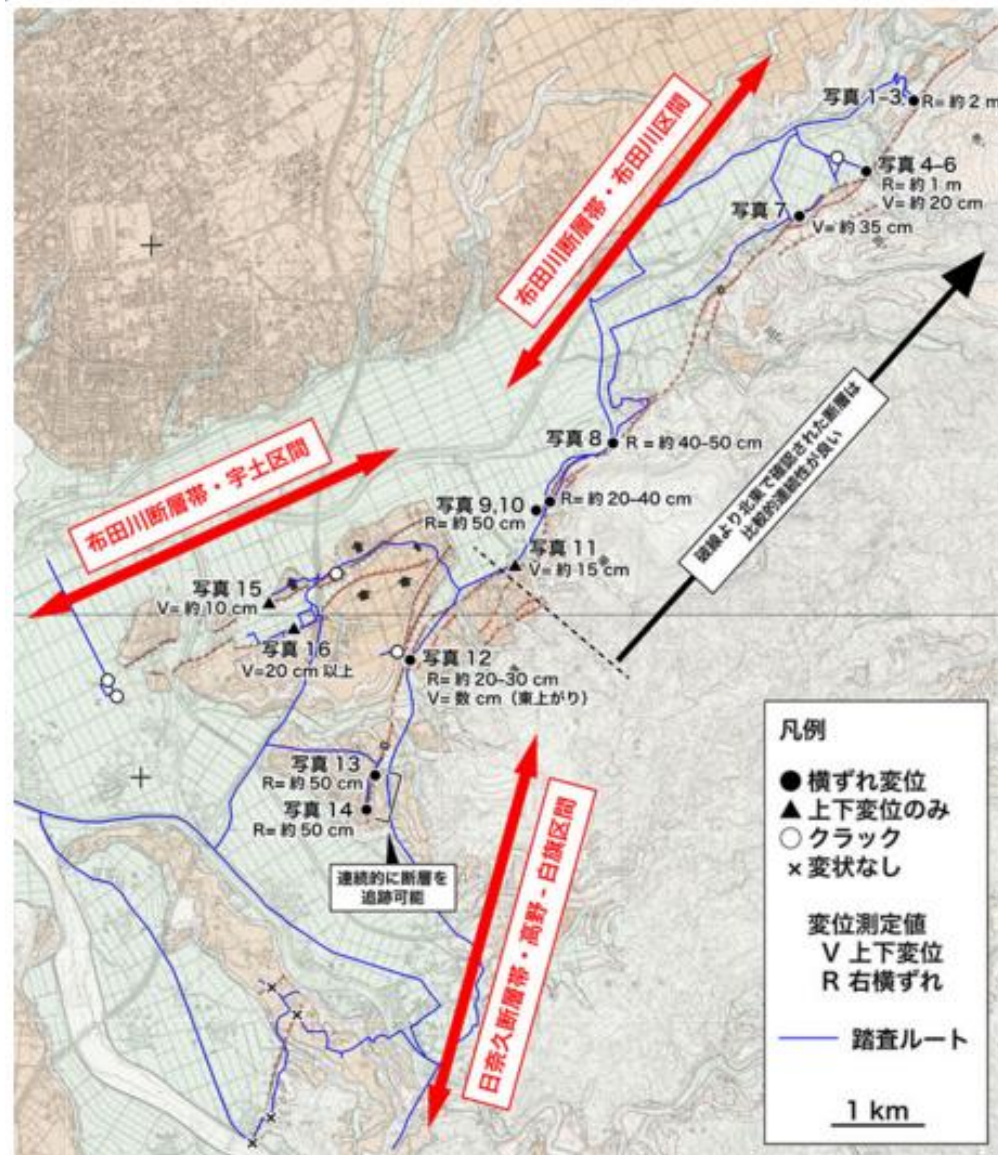
14- Right-lateral displacement seen in the pavement of Kamikoya village. Picture taken toward the east direction. Right-lateral displacement amount of time on the basis of the gutter is about 50 cm. (2016 April 17 shooting)

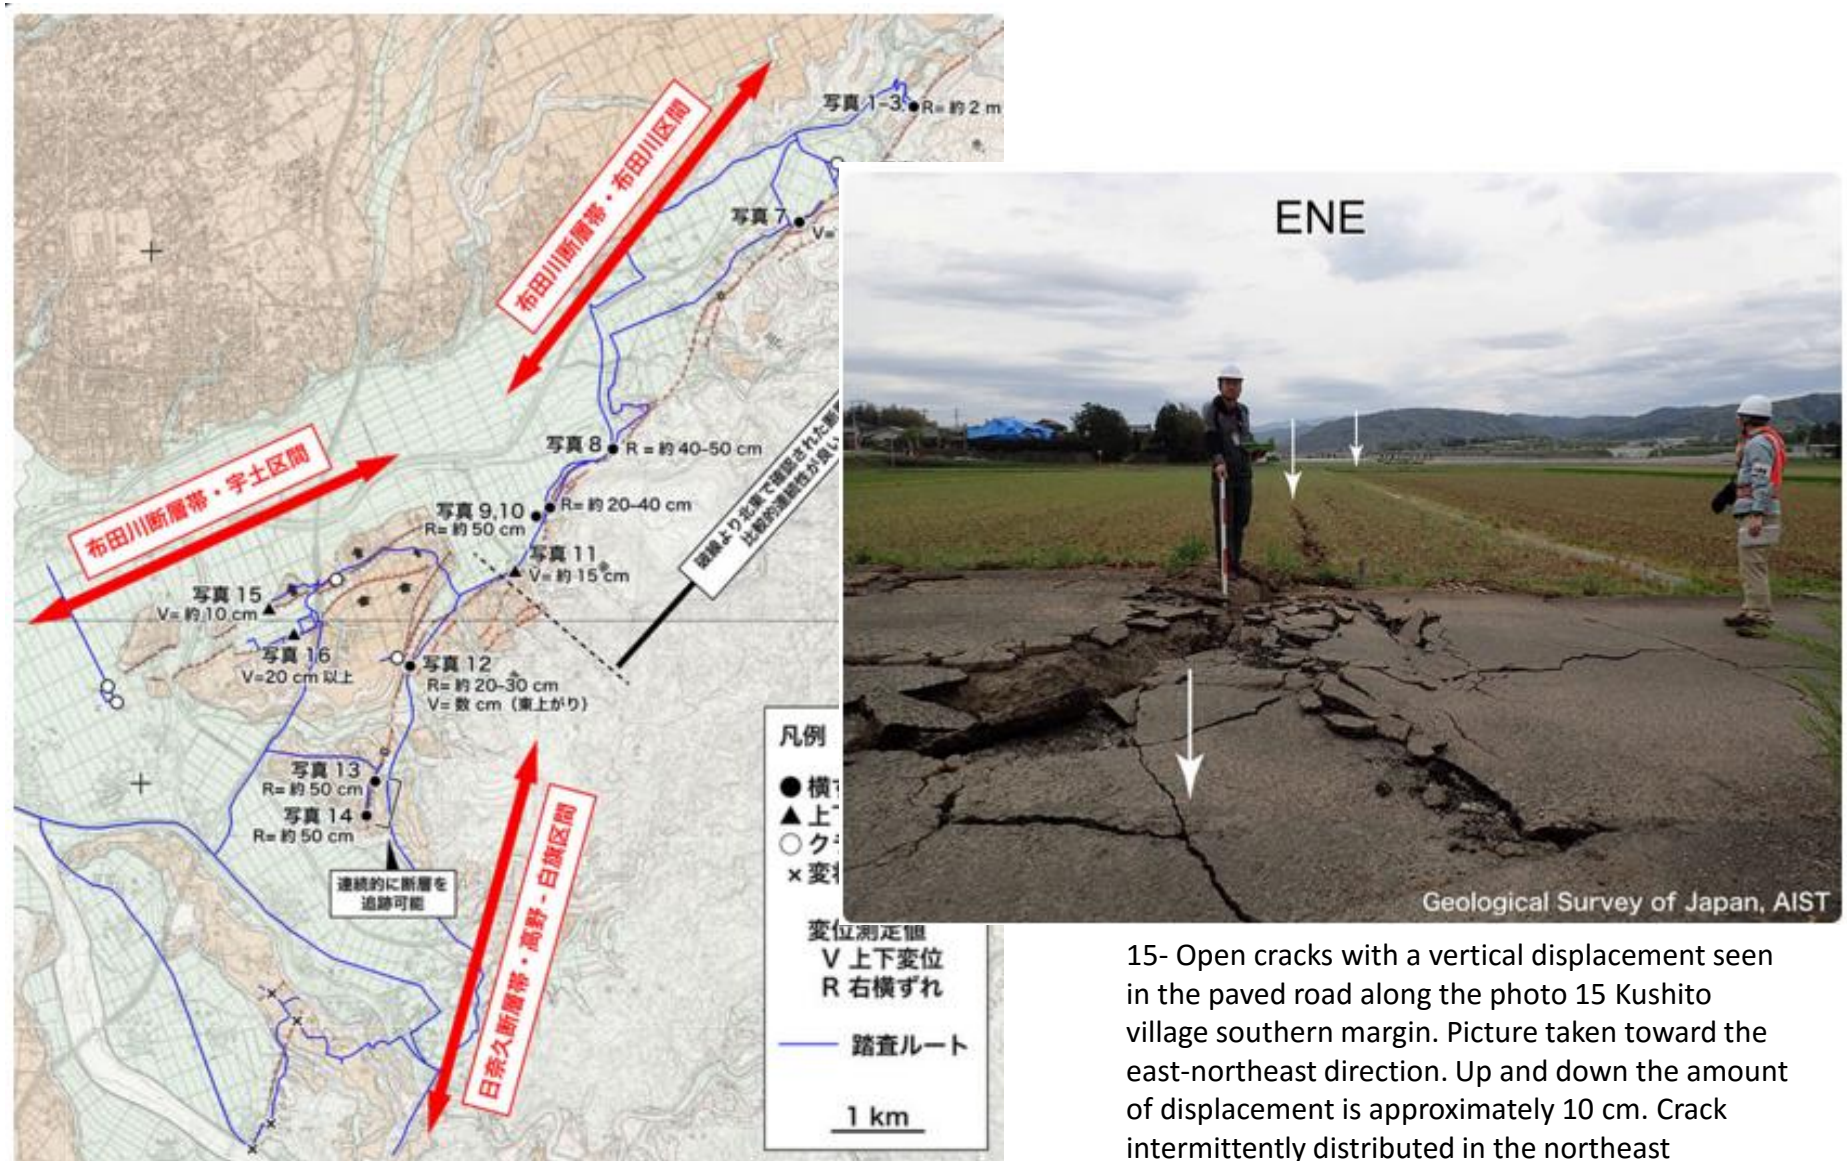
15- Open cracks with a vertical displacement seen in the paved road along the photo 15 Kushito village southern margin. Picture taken toward the east-northeast direction. Up and down the amount of displacement is approximately 10 cm. Crack intermittently distributed in the northeast southwest direction of the field. (2016 April 16 shooting)
