M7.2 Kumamoto Earthquake

14 and 15 april 2016

A compilation of data and results with focus
on surface rupture

By Stéphane Baize (IRSN) for the INQUA Project
SURFACE

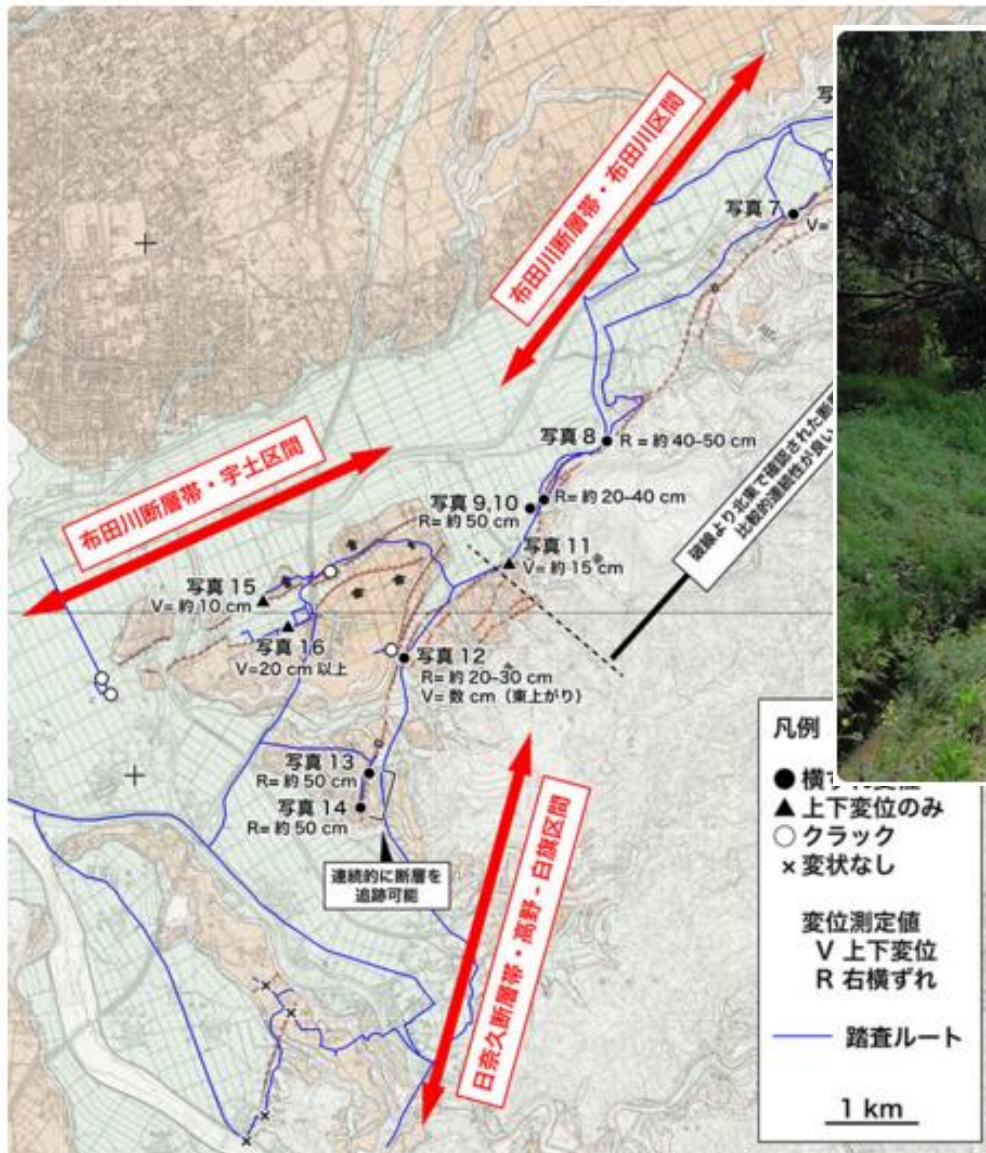
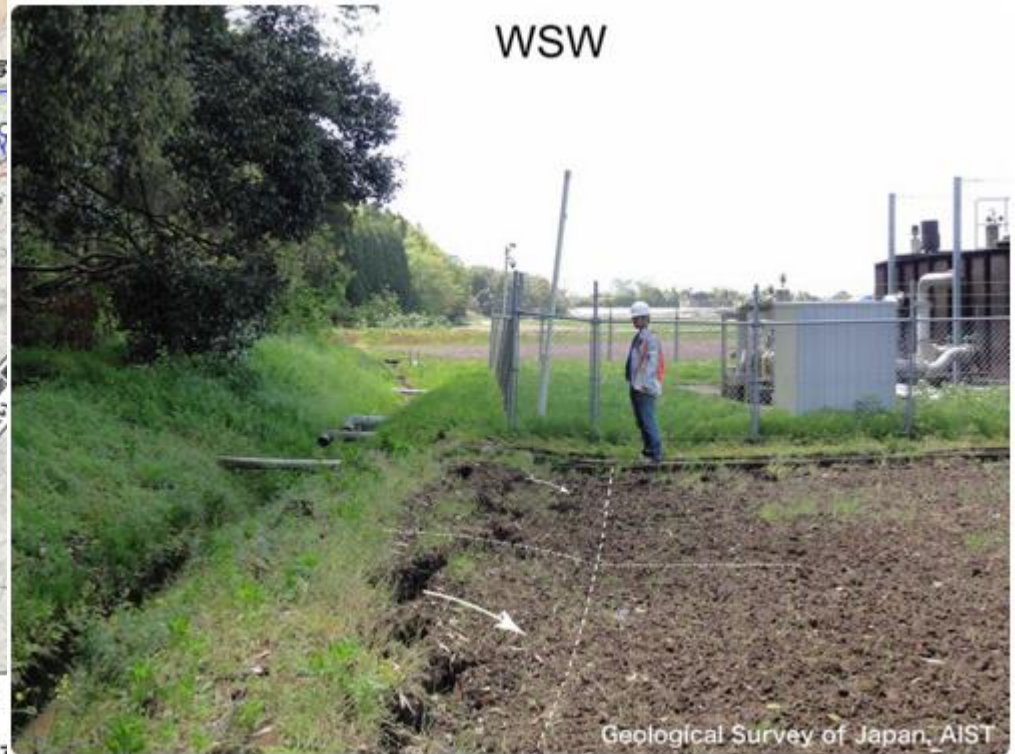
16- Deformation of the fence caused by the south open cracks and the south side of the deflection-up of the rise that occurred at the boundary between the photo 16 Kushito village south of topographical growing and rice paddies. Picture taken toward the west-southwest direction. Up and down the amount of displacement is approximately 20 cm or more. Deflection and opening cracks in the south rise is seen continuously along the terrain boundary. White arrows represent the shape of the deflection. (2016 April 17 shooting)

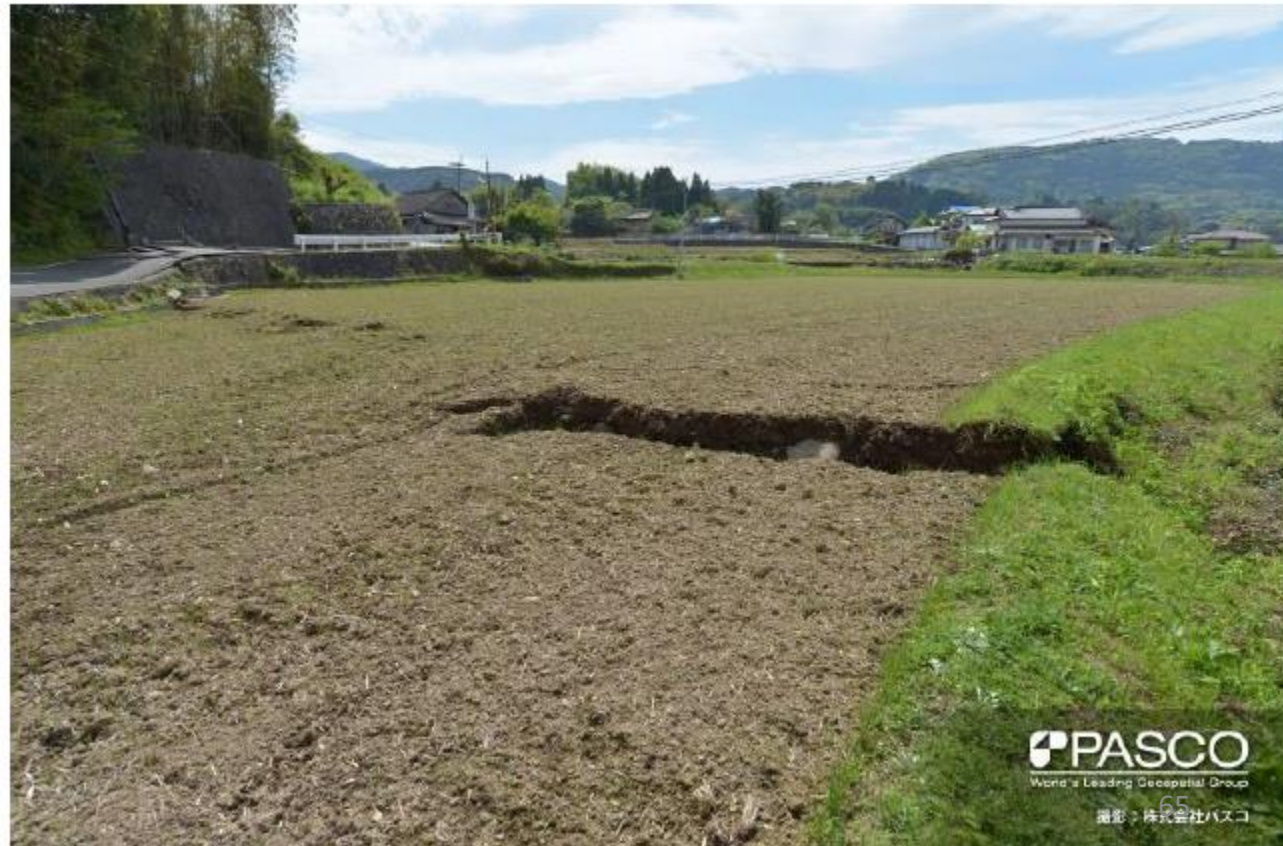
loc040

Left Lateral + Vertical on WNW-ESE

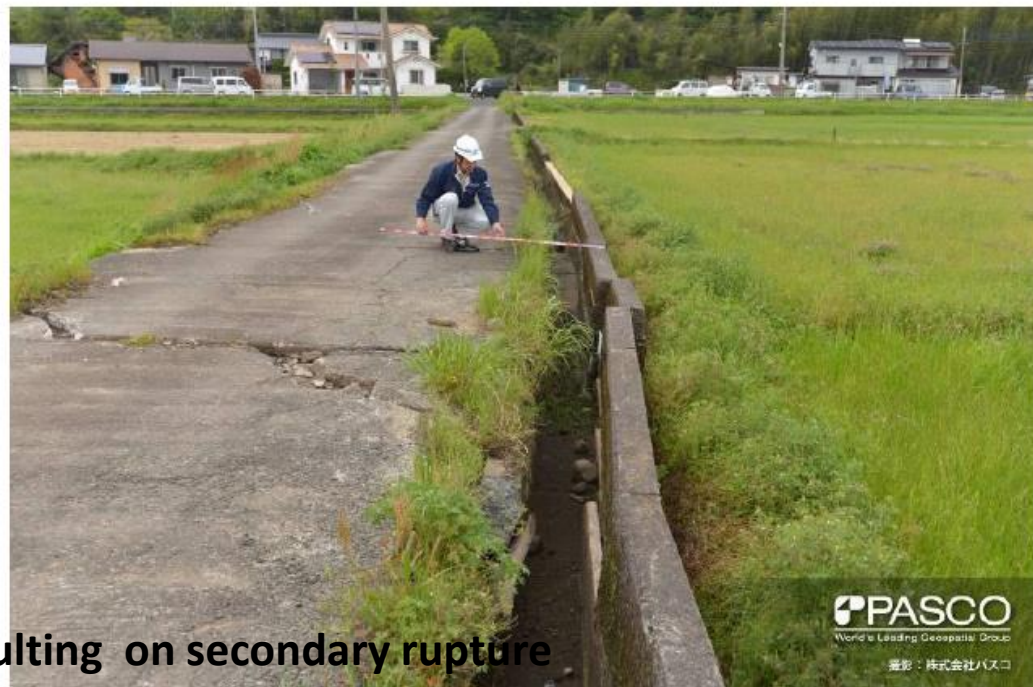
loc016

Right Lateral Faulting on secondary rupture

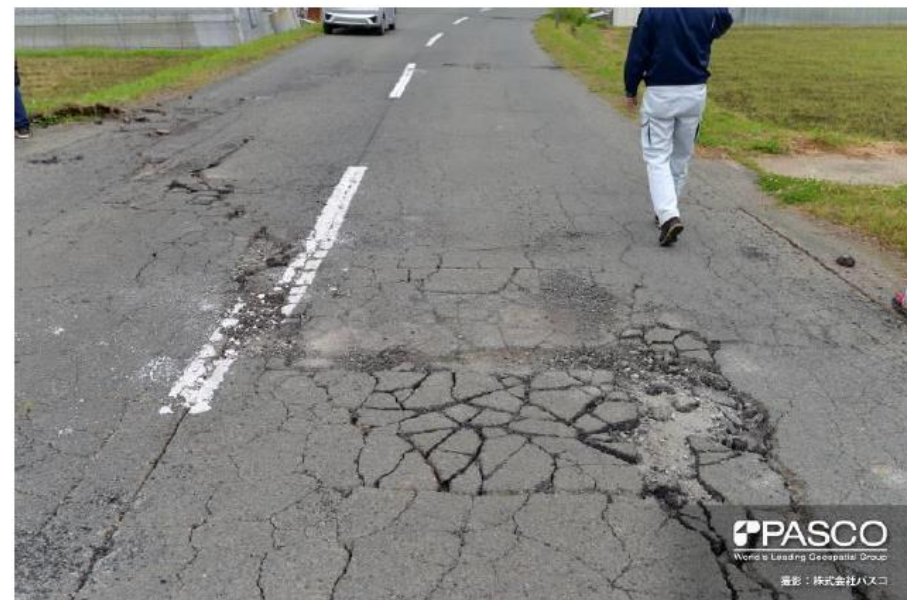
loc008

農道が右横ずれ 0.5~1m
程度認められる
写真左右の水田に地表地
震断層が連続する

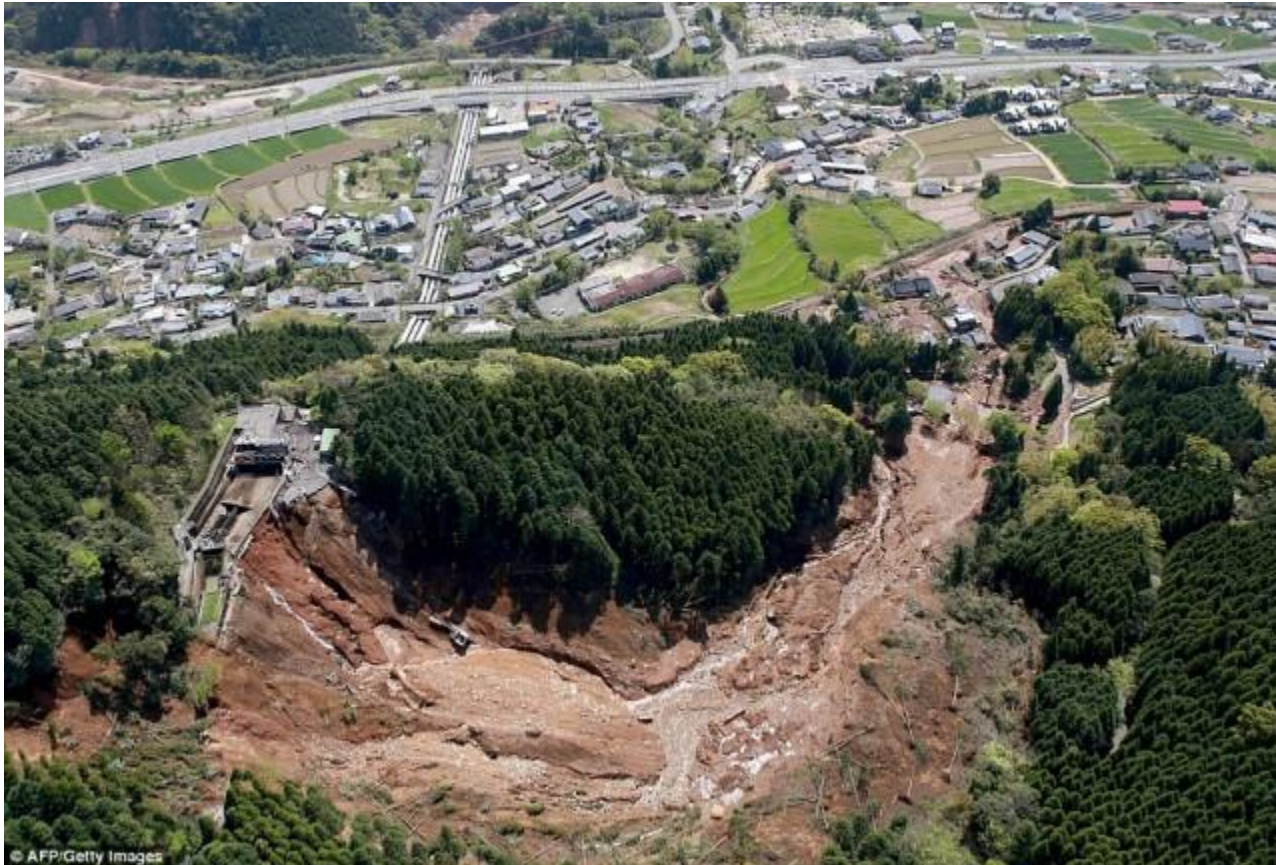
Damage to the Kurokawa Dai-ichi Power Station caused by the Kumamoto earthquake, via AFP

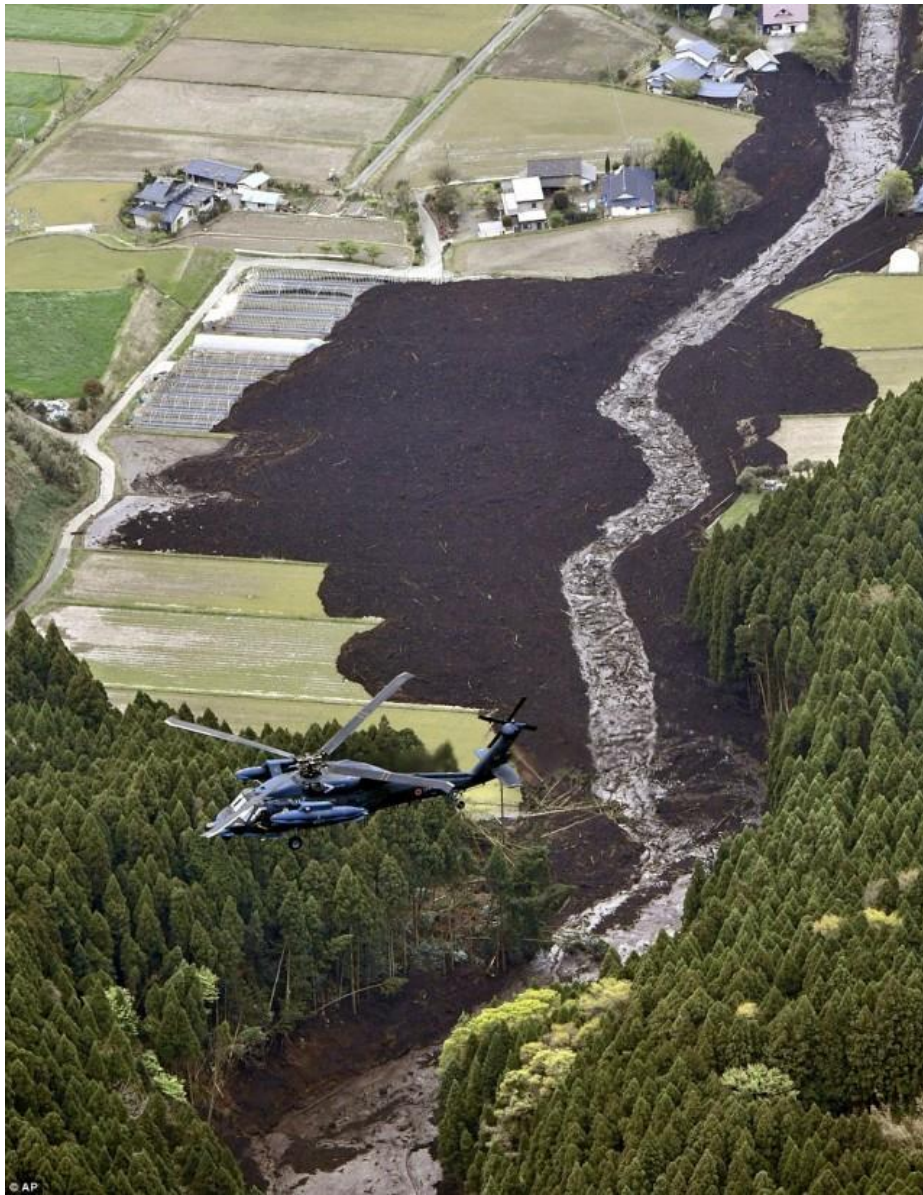
A flowslide triggered by the Kumamoto earthquake, via AP

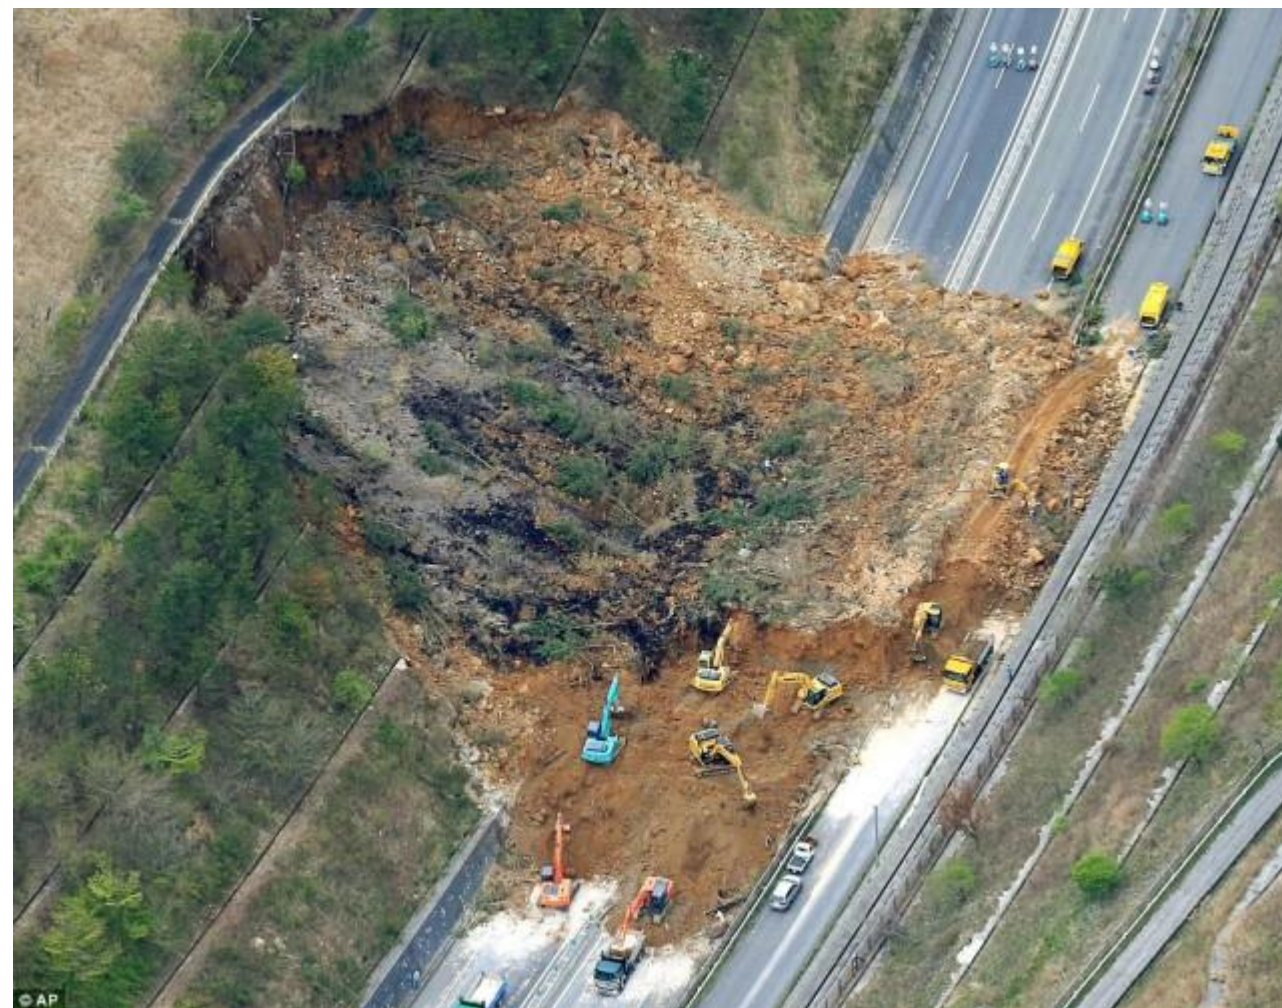
A major cutslope failure on the Oita Expressway, triggered by the Kumamoto Earthquake, via AP
