Date: 20th May, 2011

GEOLOGICAL PRELIMINARY FIELD REPORT OF THE LORCA EARTHQUAKE (5.1 M_w , 11TH MAY 2011)

Translation from the original report in Spanish

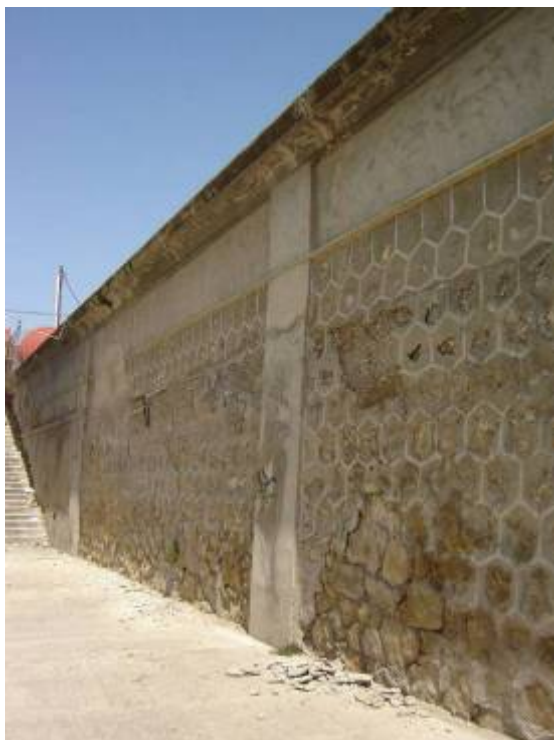
In the village of Lorca we walked along the Guadalentín river banks where the FAM crosses the river. In this are the river course is flanked by two masonry walls more than 6 m high and a concrete channel passing through the city (Fig. 3.1). The orientation of the walls is $N113^\circ$ E in the western section and $N140^\circ$ E in the eastern part. The walk was 600 m long on both margins and no evidences of ground breaking associated with fault displacement were found. The numerous cracks present on the walls do not show movements throughout the wall, and they not have continuity in the bed of the valley. It is noteworthy that the north wall (Fig. 3.2) has more cracks and pill offs than the southern wall that is only affected by several cracks.

Figure 3.1. Masonry wall along Guadalentín river bank passing through Lorca, used as a marker.

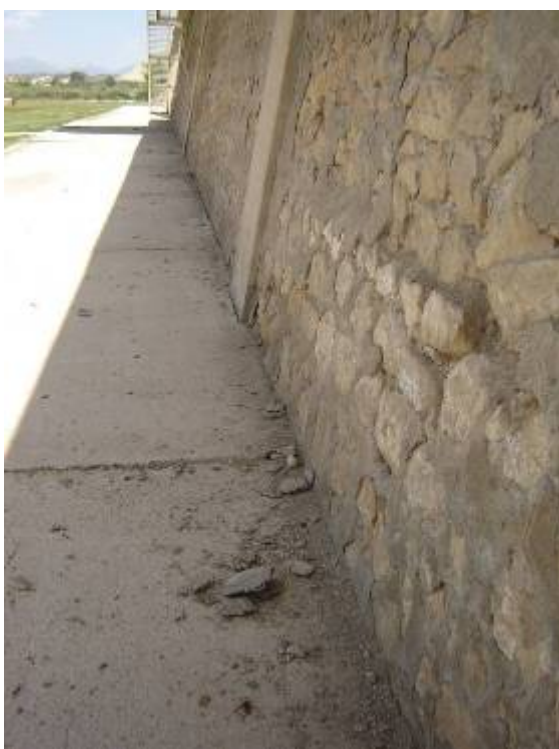
Figure 3.2. Northern Wall of the Guadalentín river valley.

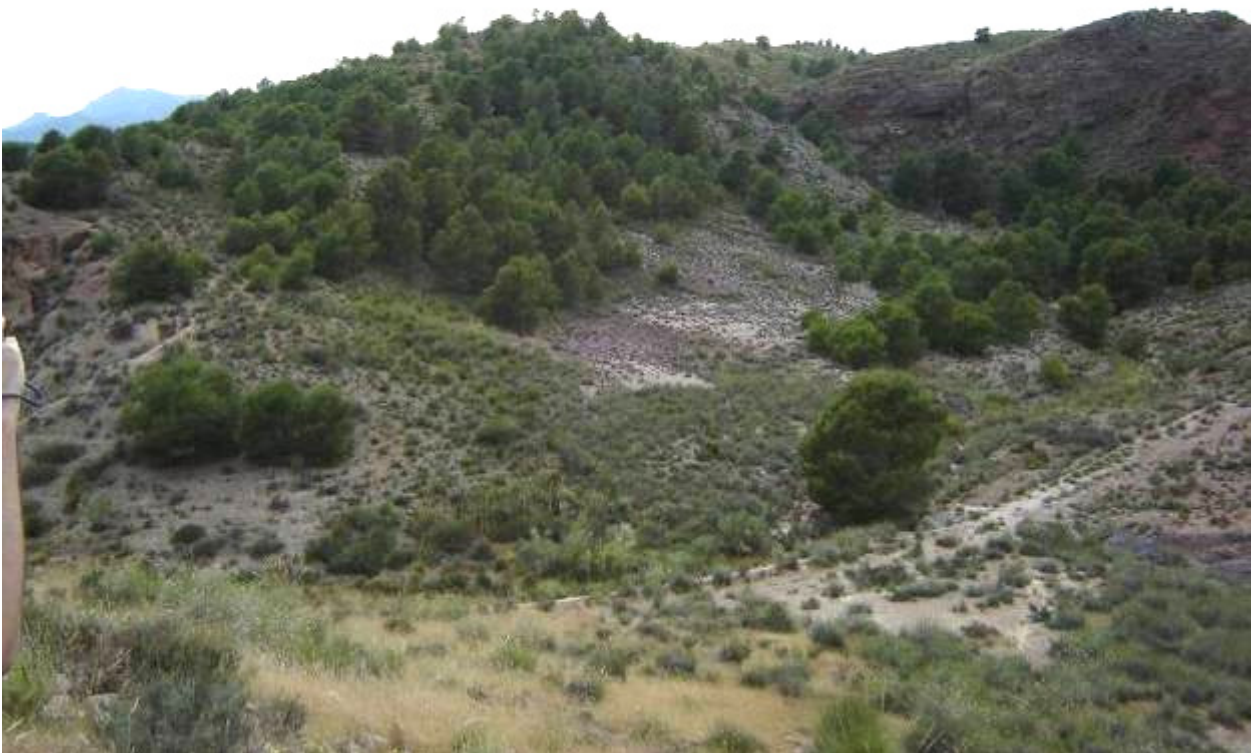
Figure 3.3. Concrete fence basement used as a marker to look for deformation along the fault line of the FAM.

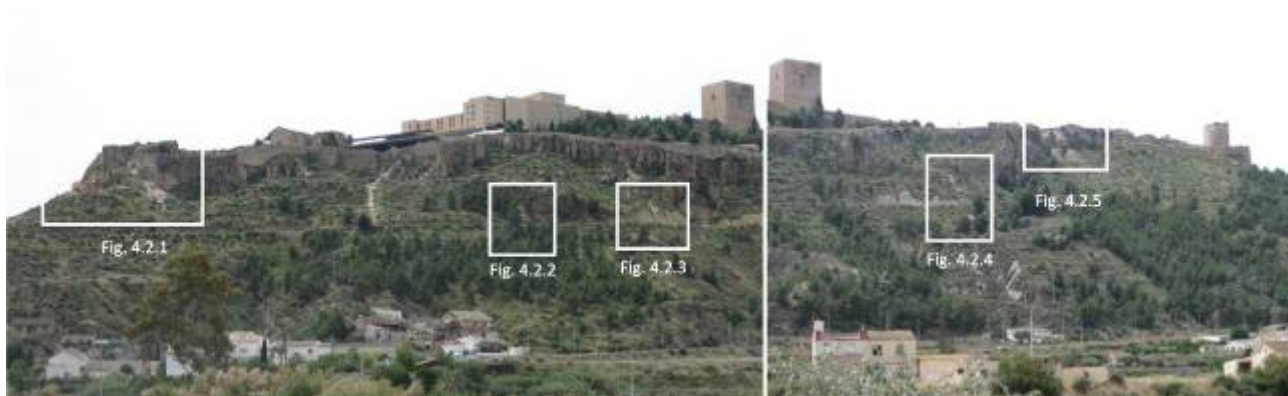
Figure 4.2.0: General view of the north slope of the Lorca's castle cliff. The most remarkable instabilities induced by the 11th May earthquake are identified.

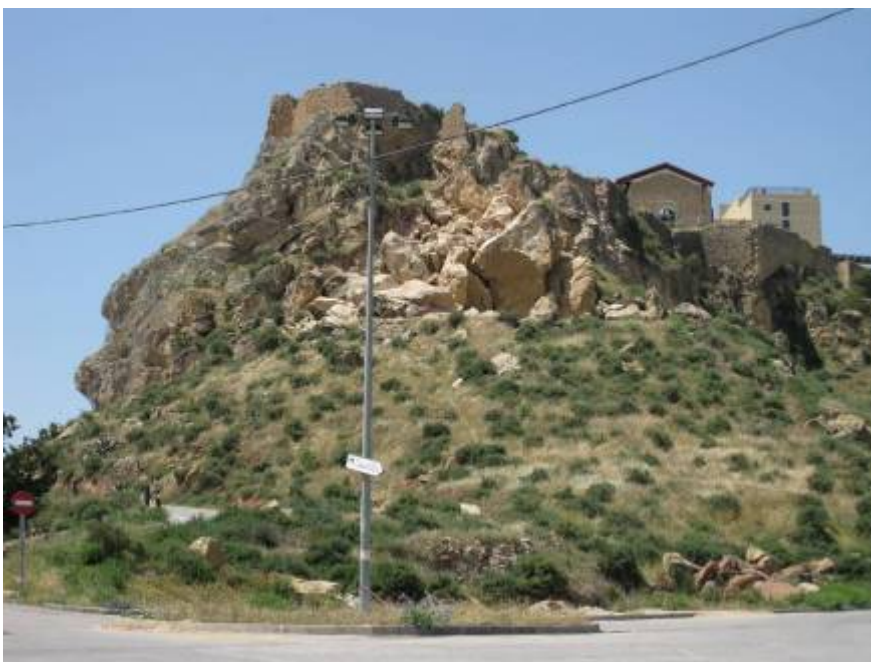
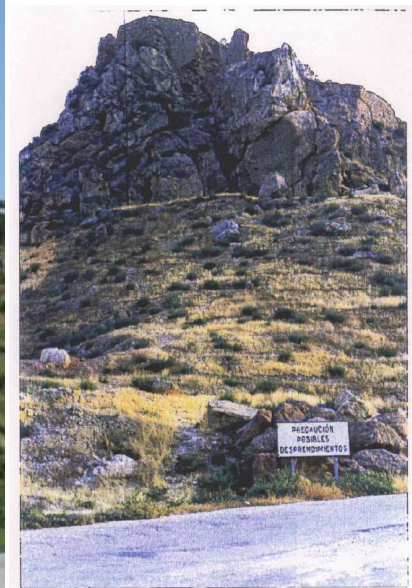
In particular, at the easternmost point of Lorca's Castle cliff, a fallen rock-block has destroyed part of the wall enclosing the patio of a house. Alike, on the road up-the-hill to the castle few rock-falls have badly damaged the pavement. A similar situation has taken place on the road to the Pantano de Puentes, which was temporarily closed to traffic. It is remarkable that on Friday 13th (aprox 24 h after the earthquake) both situations were already solved and driving was possible with relative normality.

Figure 4.2.1a: Partial collapse of the easternmost point of Lorca's castle cliff. A detached rock-block produced damage in a near house (see Fig. 4.2.1c). Picture on right corresponds to the same place few years back (taken from the IGME seismic hazard study of Lorca, 1992).

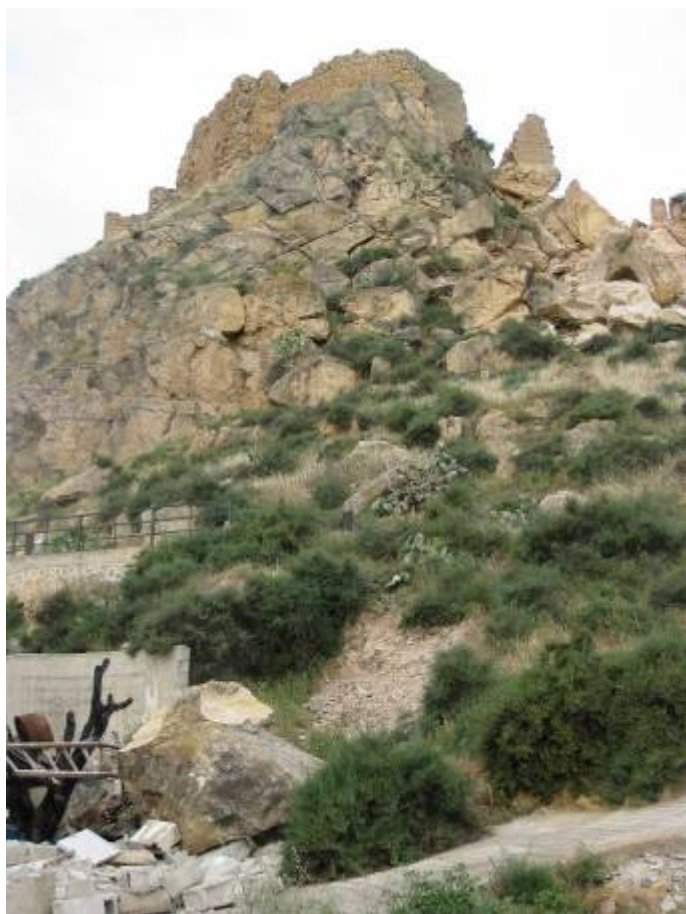
Figure 4.2.1b: View of south lateral of the easternmost point of the castle cliff and of the block that damaged a small wall of a house. The down-the-hill road pavement showed moderate damage at this point. It can be observed on the left the ending of the retaining wire mesh that stabilises the south face of the castle cliff.

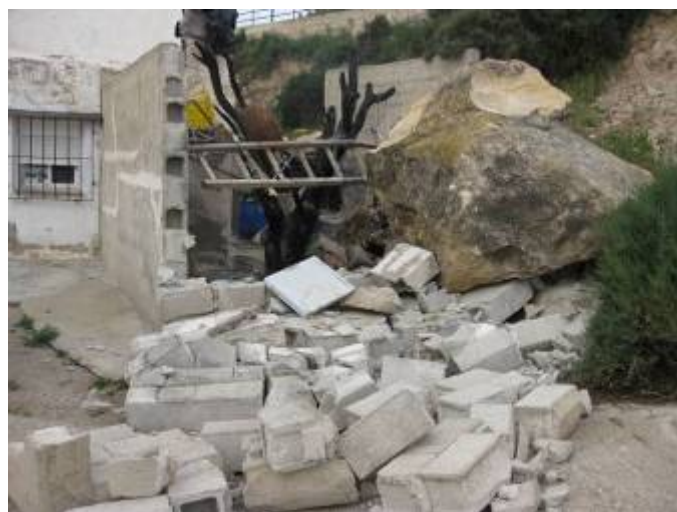
Figure 4.2.1c: Result of the impact on a wall made of concrete blocks enclosing the patio of a house from a rock detached from the easternmost point of the cliff.

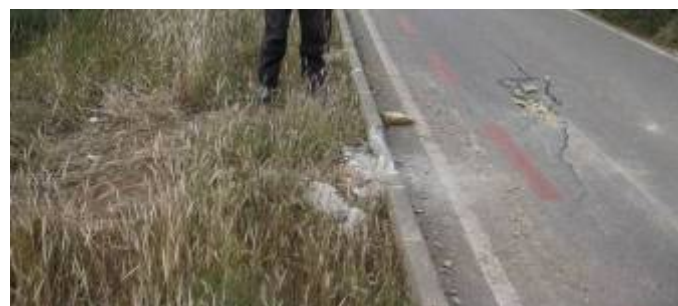
Figura 4.2.1d: Moderate damage on the down-the-hill road caused by the rebound of the block detached from the easternmost point of the cliff (figure 1.b).

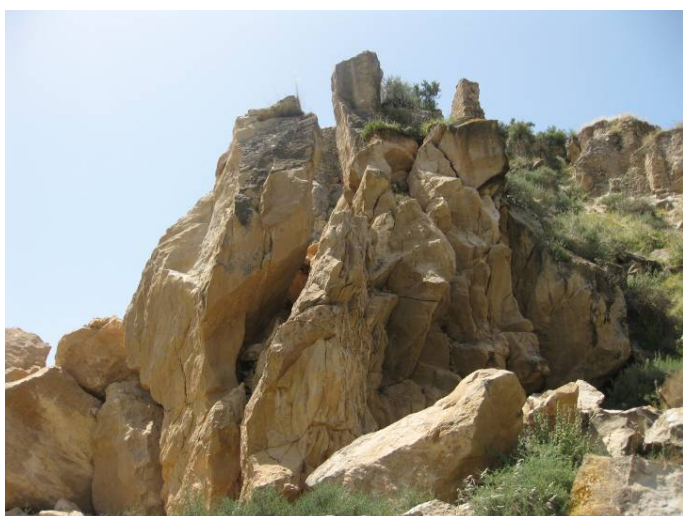
Figure 4.2.1e: Close-up of the collapse of the easternmost point of the castle cliff (looking South) and of the general conditions of the rock mass at this site. On the upper right corner it is observed part of a fallen wall (see figure 1.1f).

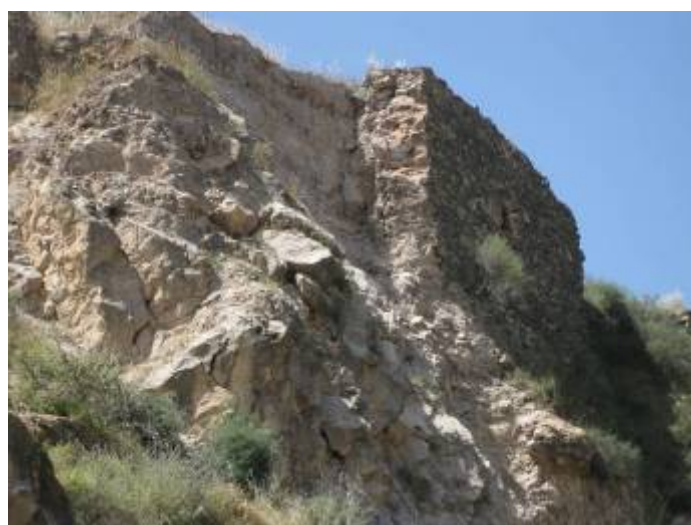
Figure 4.2.1f: Close up of the fall of part of an old retaining wall. It can be observed that the intrados filling remains meta-stable. This type of instability also appears on the south face of Lorca's castle cliff (see figure 2.1).

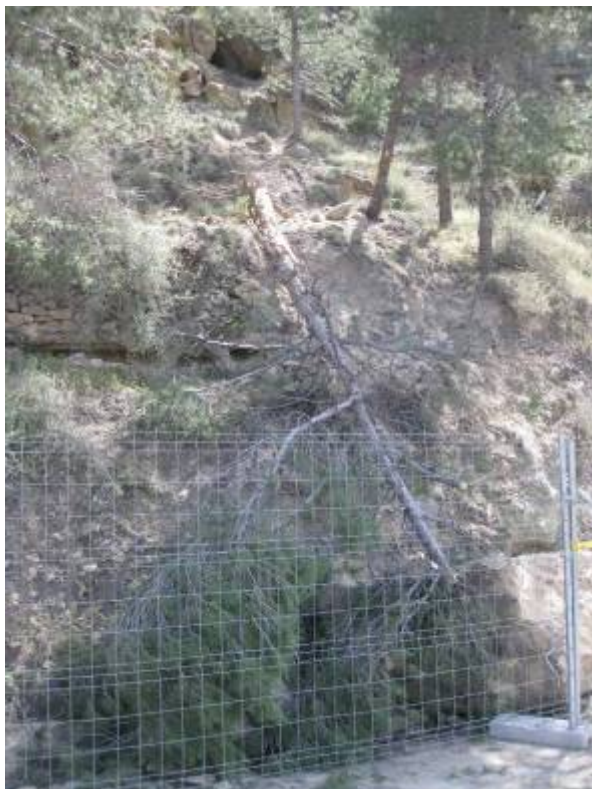
Figure 4.2.2: Small debris dragging a pine tree on the north talus of the up-the-hill road to the castle.

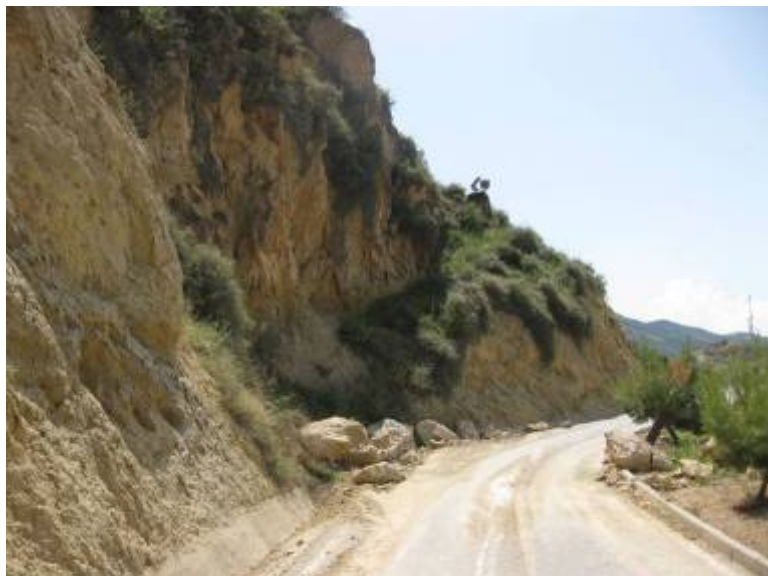
Figure 4.2.3: Rock-falls and debris on the up-the-hill road to the castle.

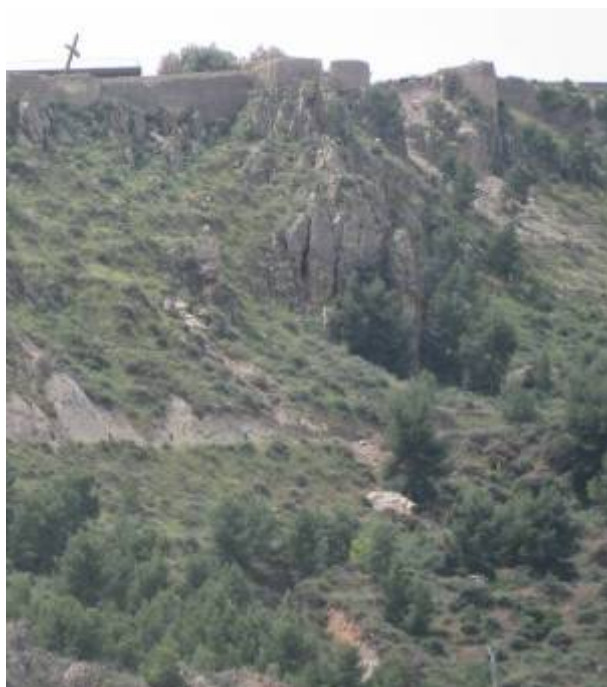
Figure 4.2.4a: Rock-fall of metric size that damaged badly the road (see figure 1.4b).

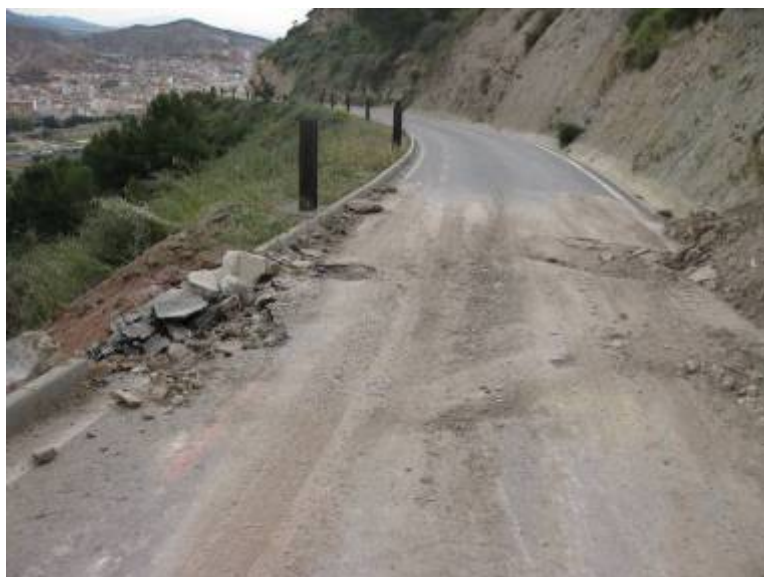
Figure 4.2.4b: Damage on the pavement of the up-the-hill road to the castle due to the fall and rebound of the block shown in figure 1.4a.

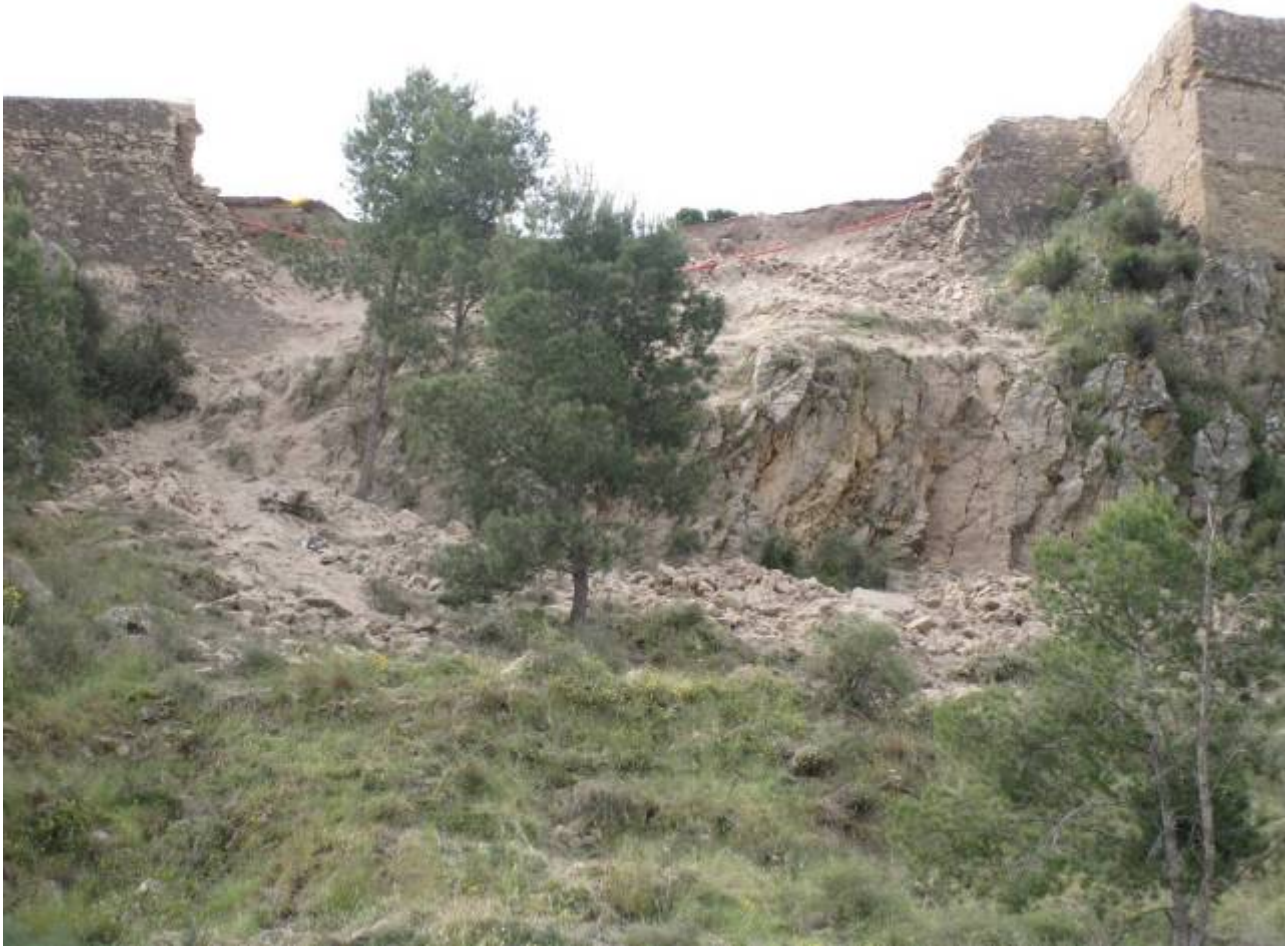
Figure 4.2.5: Collapse of the external wall of Lorca's castle (north face).

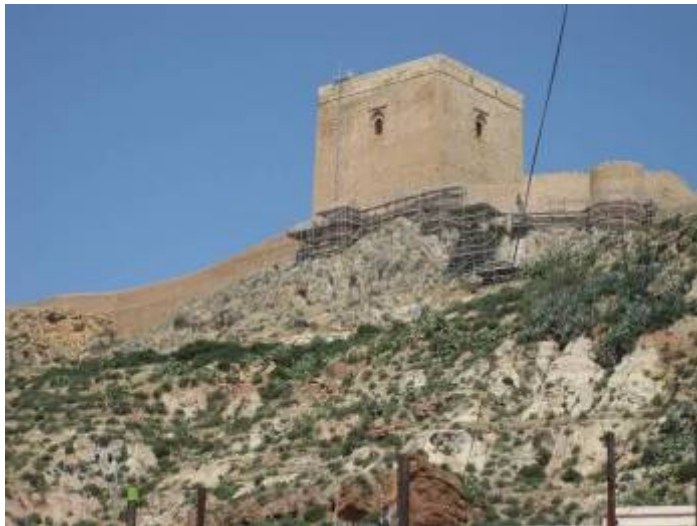
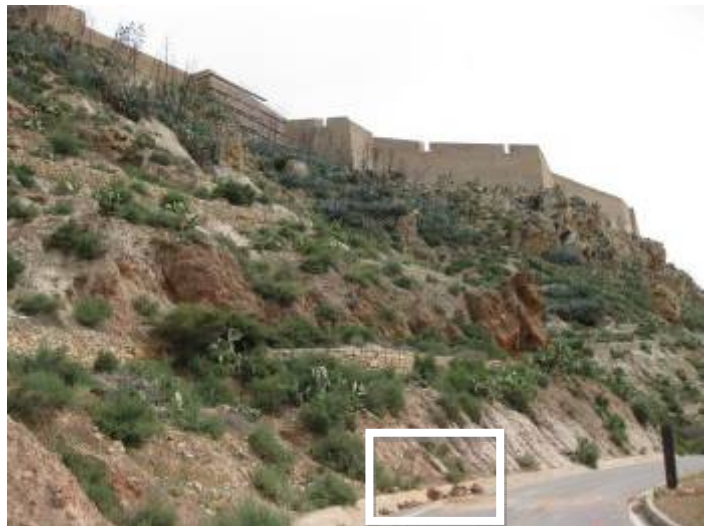
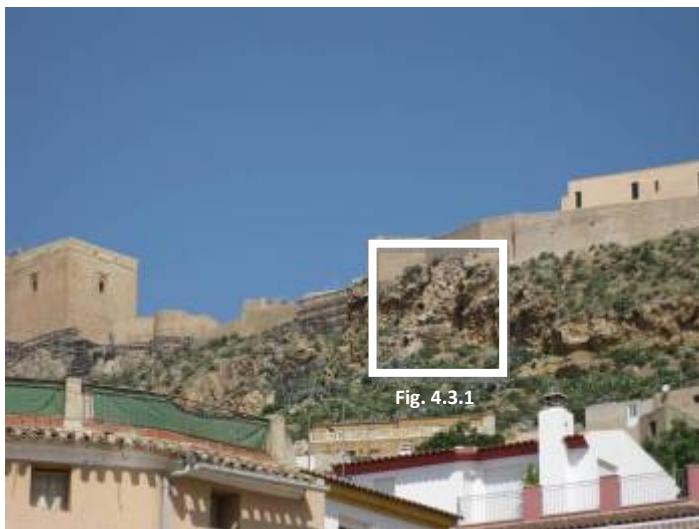
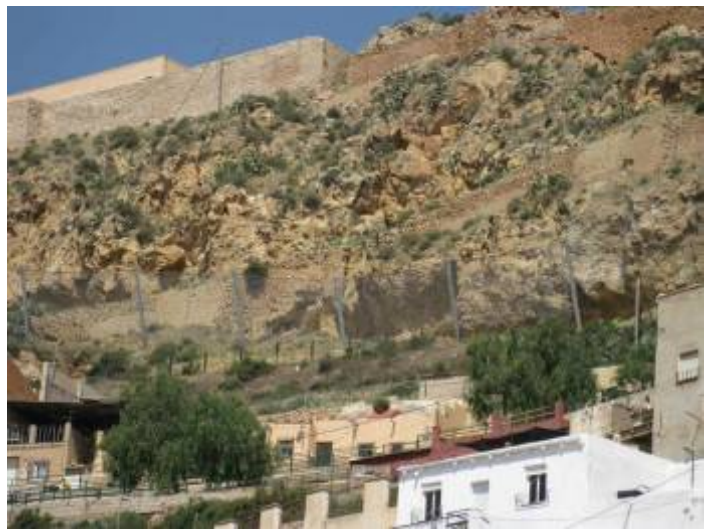
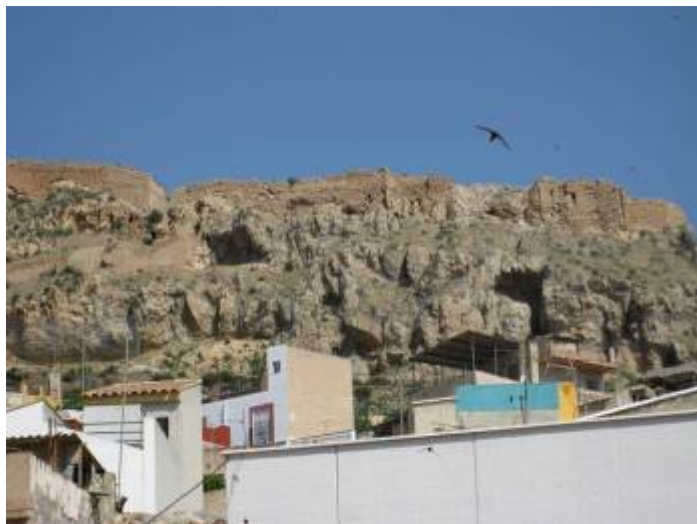
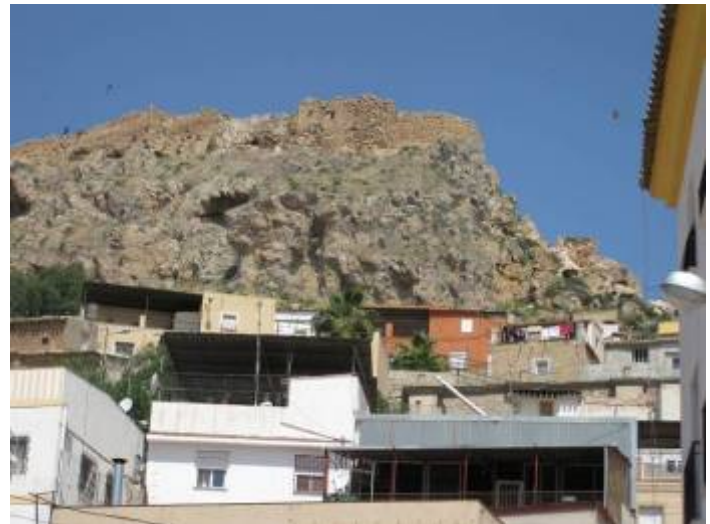
It is highlighted that the stability measures deployed on the southern slope of the castle cliff have performed adequately, avoiding what it would have been an aggravation of the damage produced by the earthquake and may be a larger number of casualties, particularly on the habitations located right under the cliff. A quick visual inspection suggested the perfect state of the measures, although this observation should be confirmed after a systematic and detailed inspection.

Figure 4.3.0: Partial views of the southern slope of Lorca's castle cliff. Photos are arranged from west to east, from left to right. Only two small size instabilities were identified: a small debris fall (photo number 2) and the collapse of the external wall of the castle (photo number 3 and fig. 4.3.1). On the last photo a visual of the easternmost point of the cliff is shown (figure 4.2.1). The stabilization measures of the rock mass performed adequately preventing the occurrence of more damage and personal losses. These consist in a double diameter wire mesh nailed to the rock mass by bolts and a dynamic barrier. These measures were put in place 3 years ago aprox. (pers. com. council).

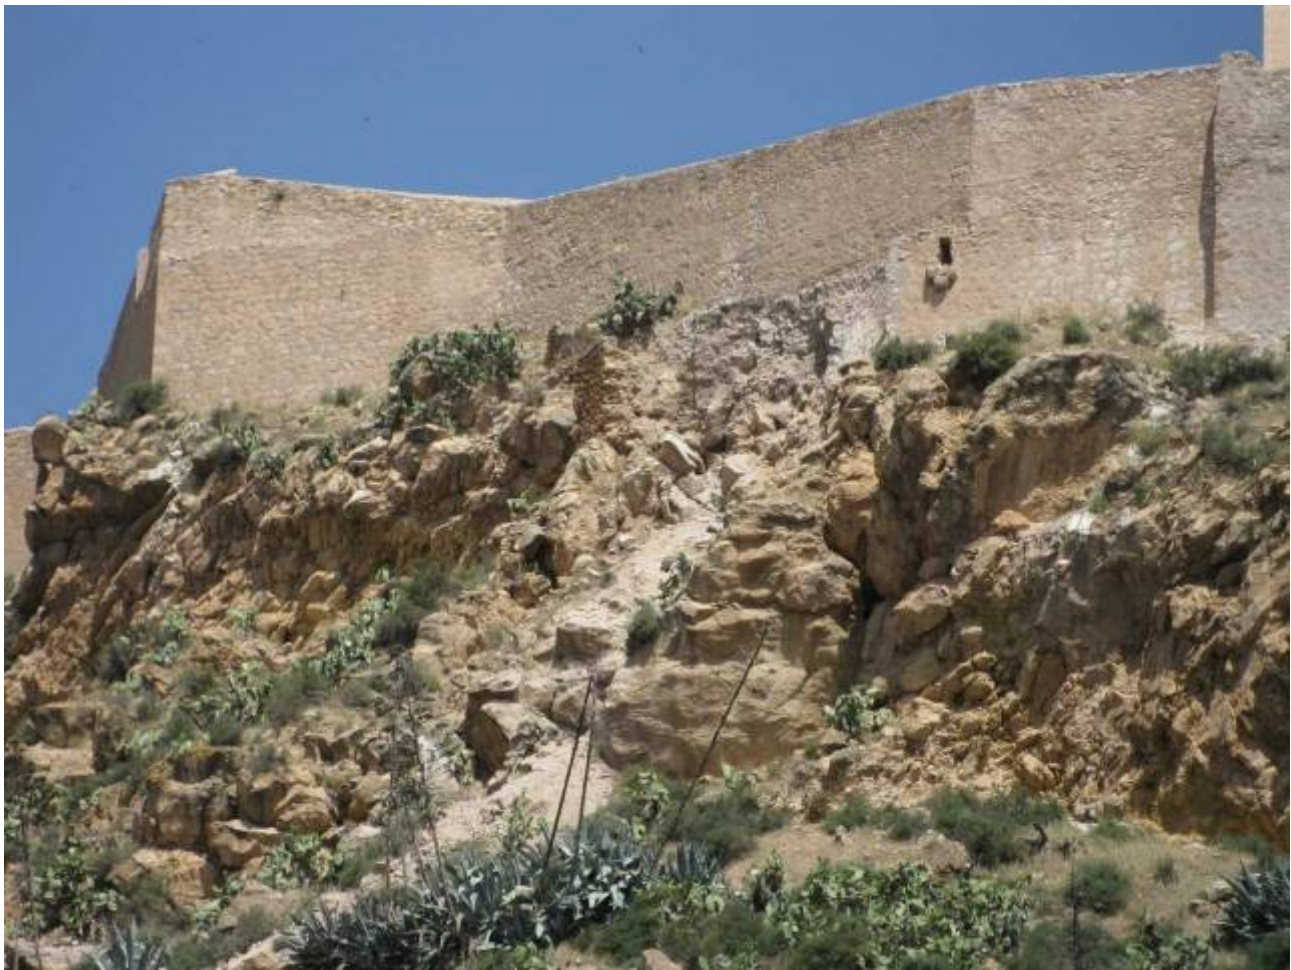
Figura 4.3.1: Collapse of an old retaining wall attached to the external wall of the Lorca's castle on its south face. This instability warned the dwellers of the houses situated right under the cliff, which asked us whether it was safe to return back to their places.

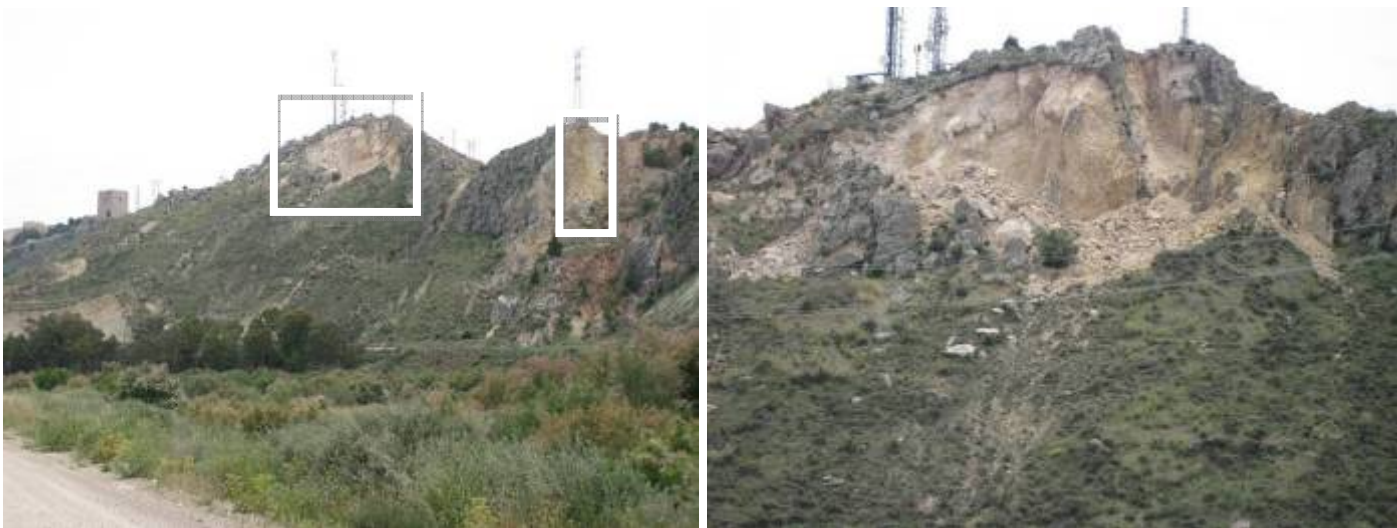
Figure 4.4.1a: Rock-falls and debris on the summit of the north slopes of the Pantano de Puentes road. Their attribution to the earthquake is presumed. The westernmost one (on the right on the first photo) corresponds in part with a previous instability.

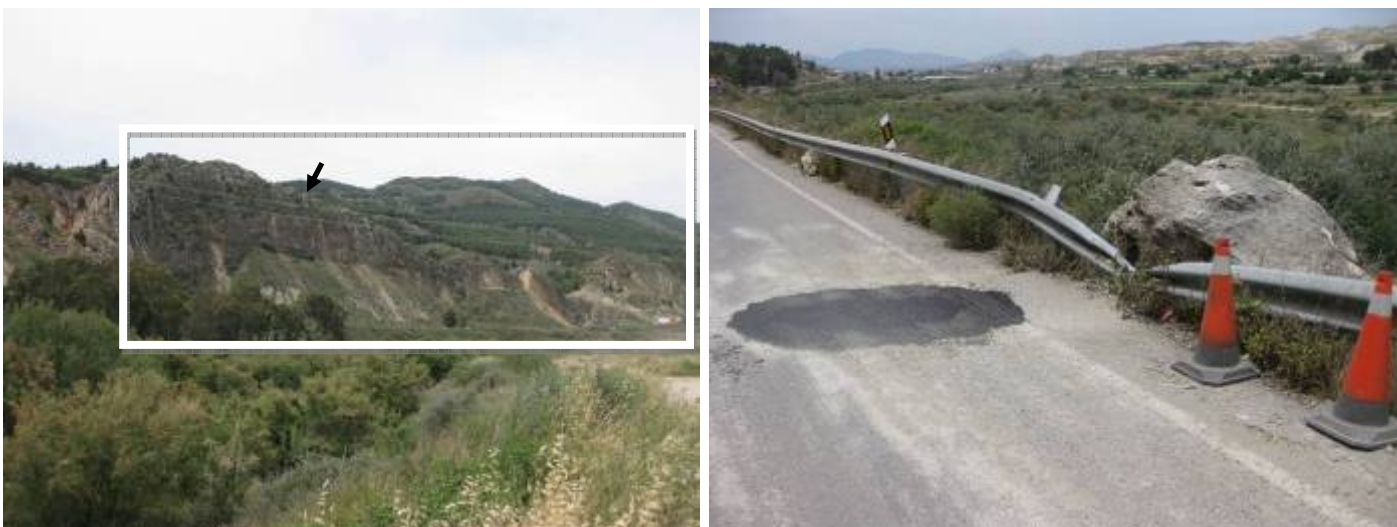
Figure 4.4.1b: Continuation of the Pantano de Puentes road towards the west. Along this road many instabilities were identified, although of a small size in general. Particularly remarkable are the rock blocks fallen from the ridge controlled by Las Viñas Fault (marked with an arrow). Picture on right shows a close-up of the damage produced by one of this rock blocks.

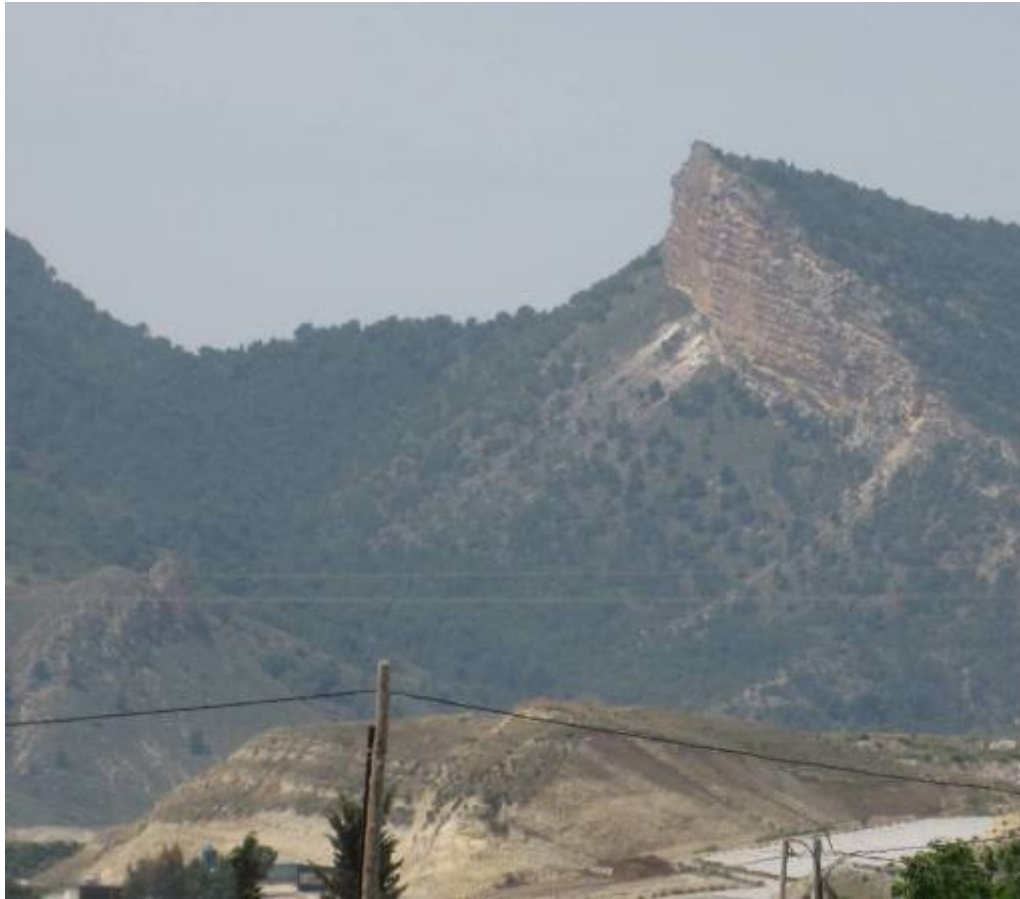
Figura 4.4.2: Rock-falls and rock-debris at the Cejo de los Enamorados.

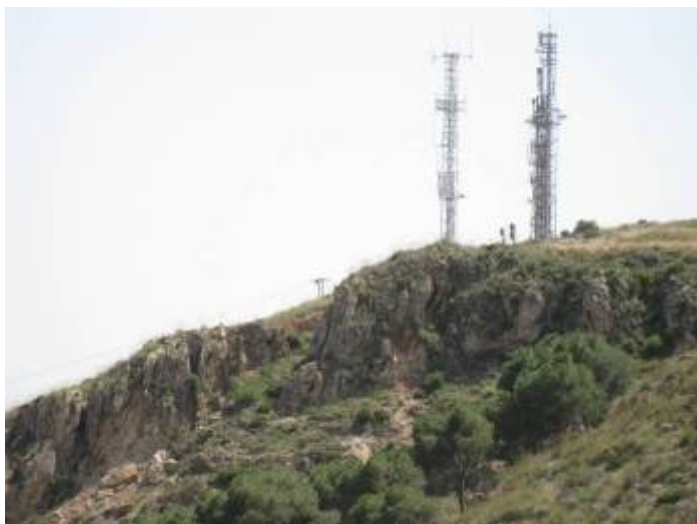
Figure 4.5: Communications towers founded on a hill situated in front of the westernmost end of Lorca's castle cliff. Two recent instabilities are shown, which are attributed to the 11 May earthquakes.

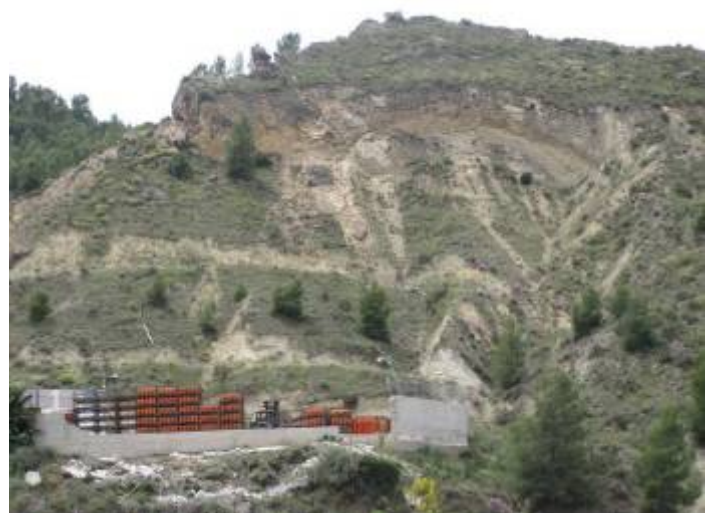
Figure 4.6: View of the slope enclosing a butane-gas storage site on the Pantano de Puentes road. No slope instabilities that could be attributed to the earthquakes were identified here, although the collapse of the concrete-brick wall is attributed to them.

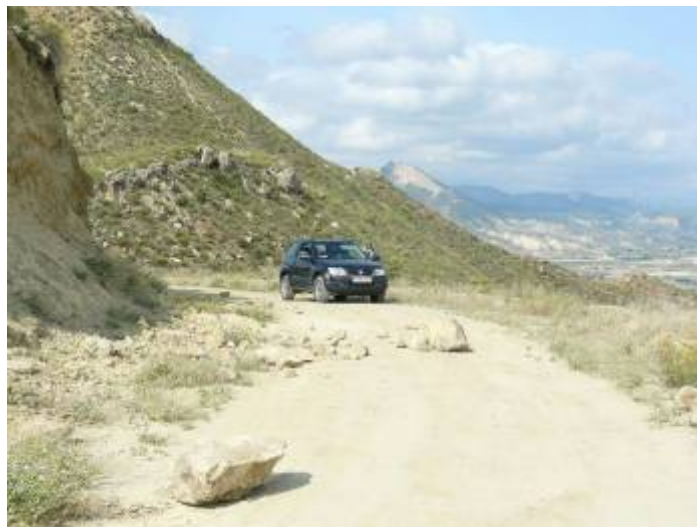
Figure 4.8: Rock falls on a dirt road that runs across the epicentral area (photo courtesy of J.J. Martínez-Díaz).

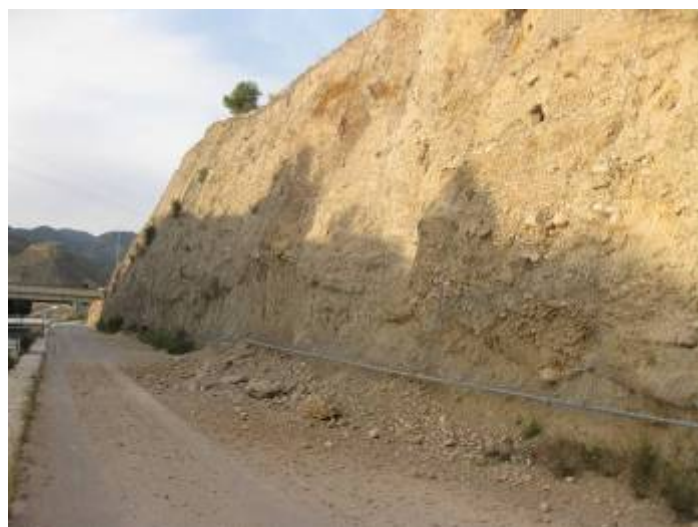
Figure 4.9: Shallow debris falls attributed to the May earthquakes on a service road of the Tajo-Segura canal.

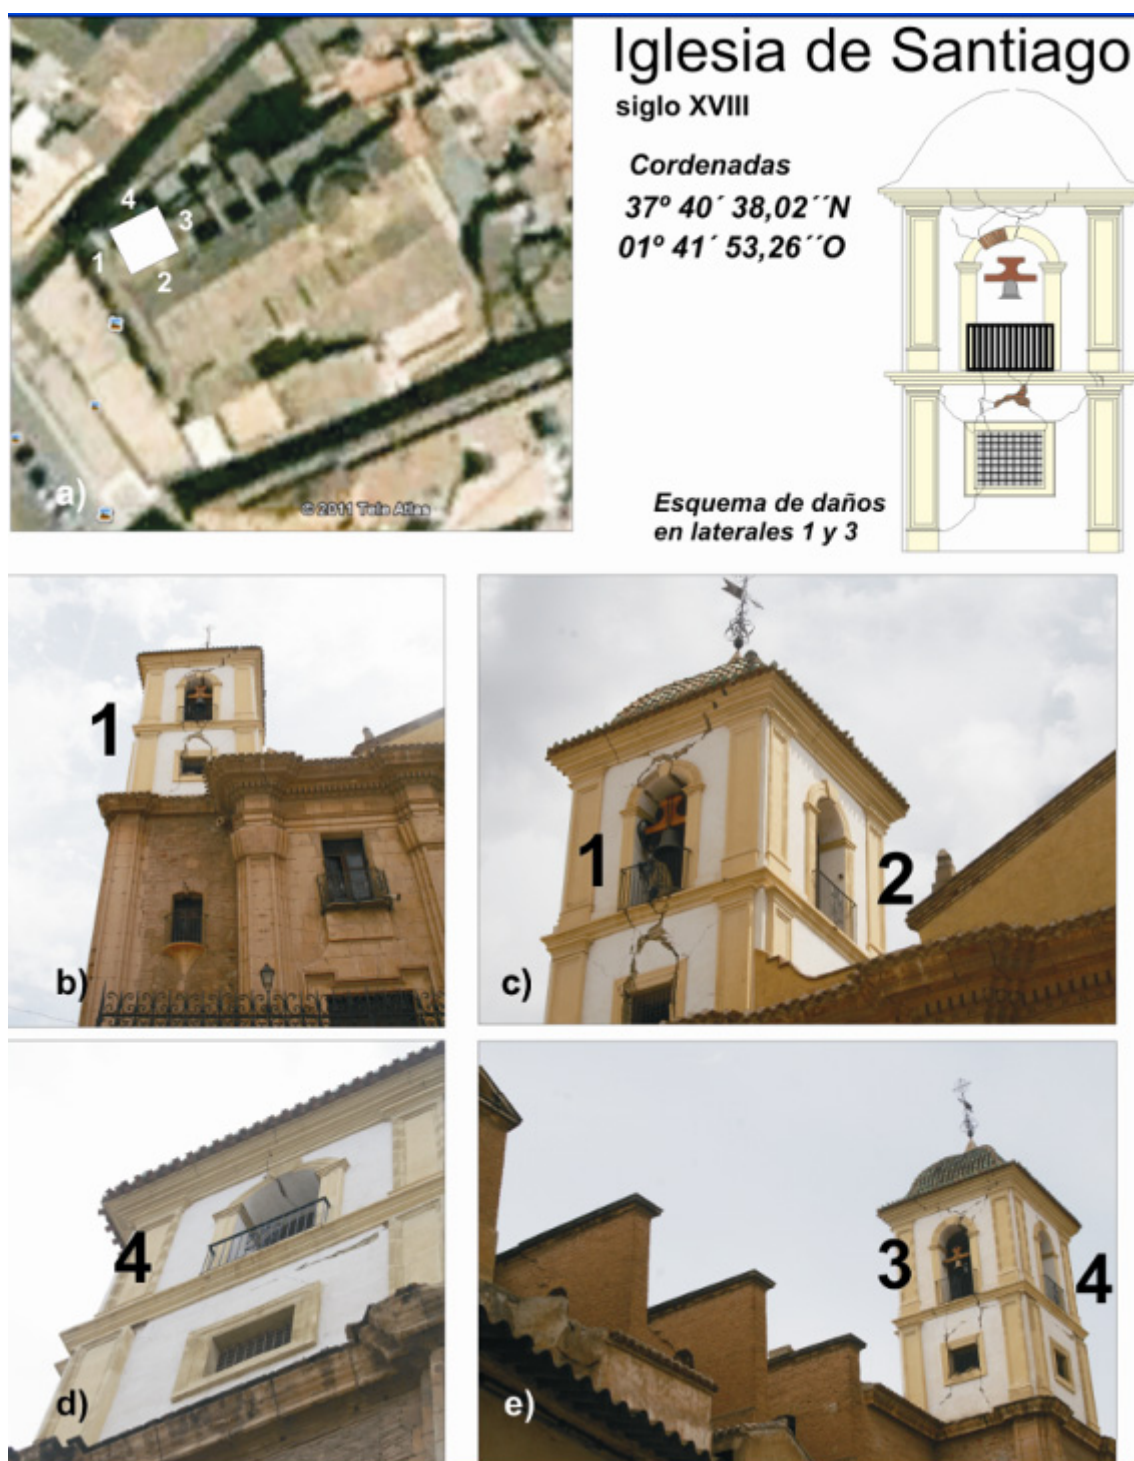
Figure 5.3: Damage in the church's tower of Santiago.

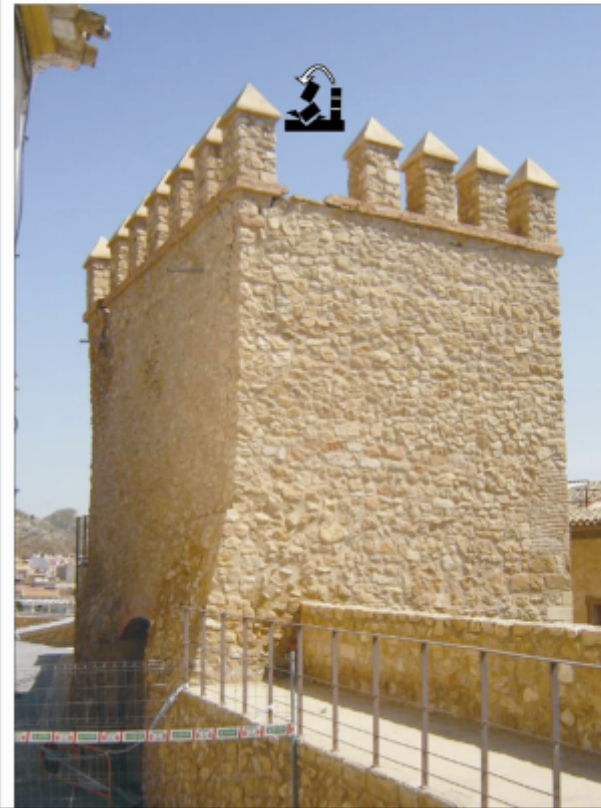
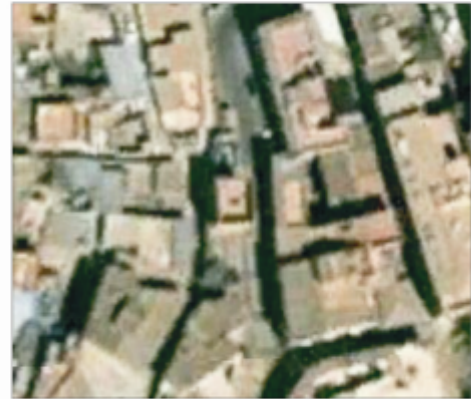
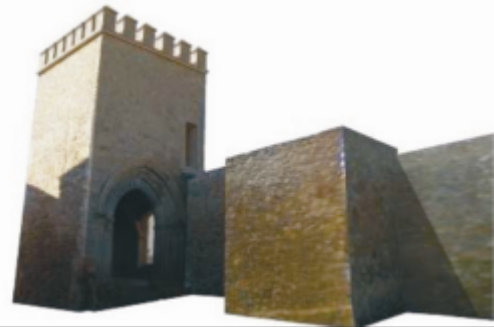
Figure 5.4: Damage in the battlements of the entrance of San Antonio (Tower of the old defensive wall of the Islamic Period).

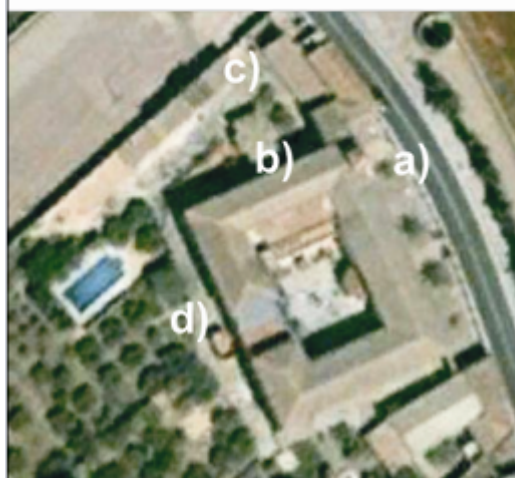
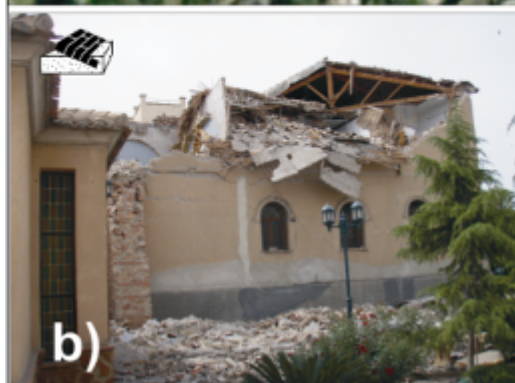
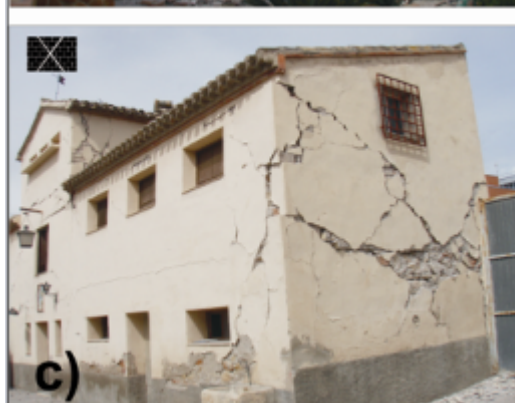
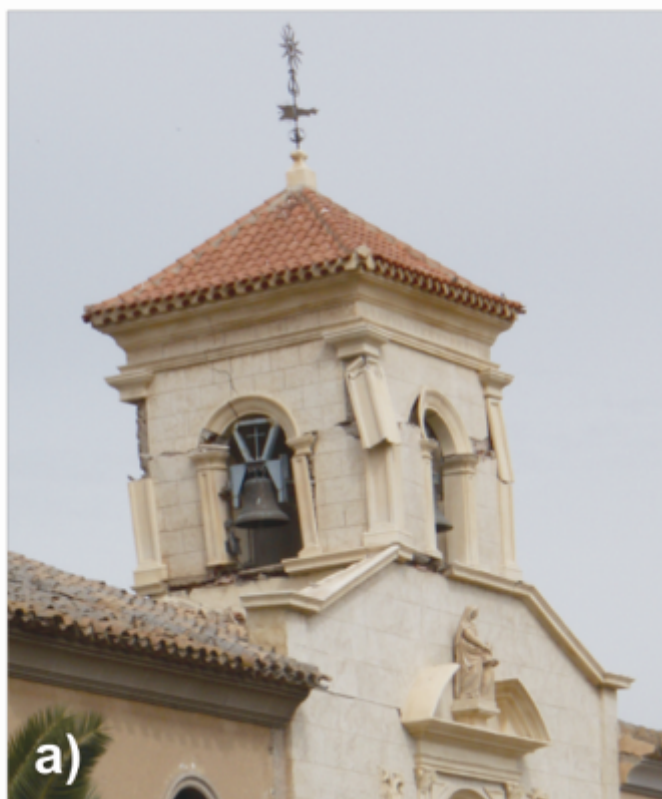
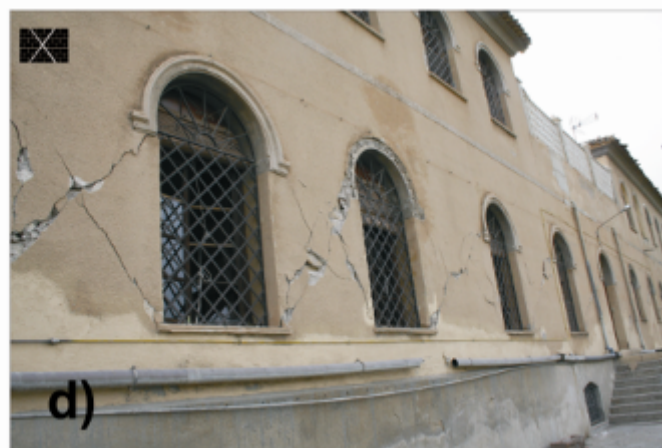
Figure 5.5: Damage in the tower and main buildings of the Clarisas' Convent.

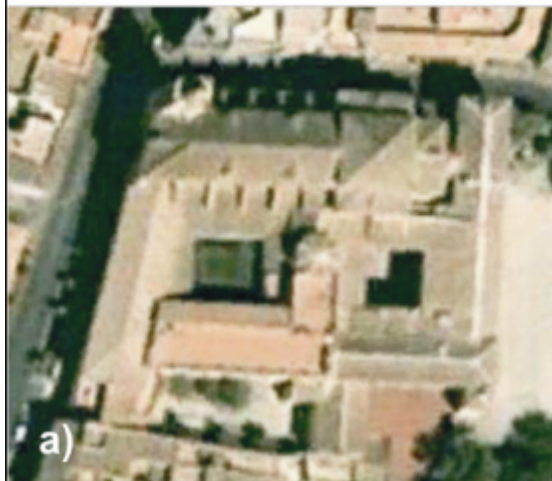
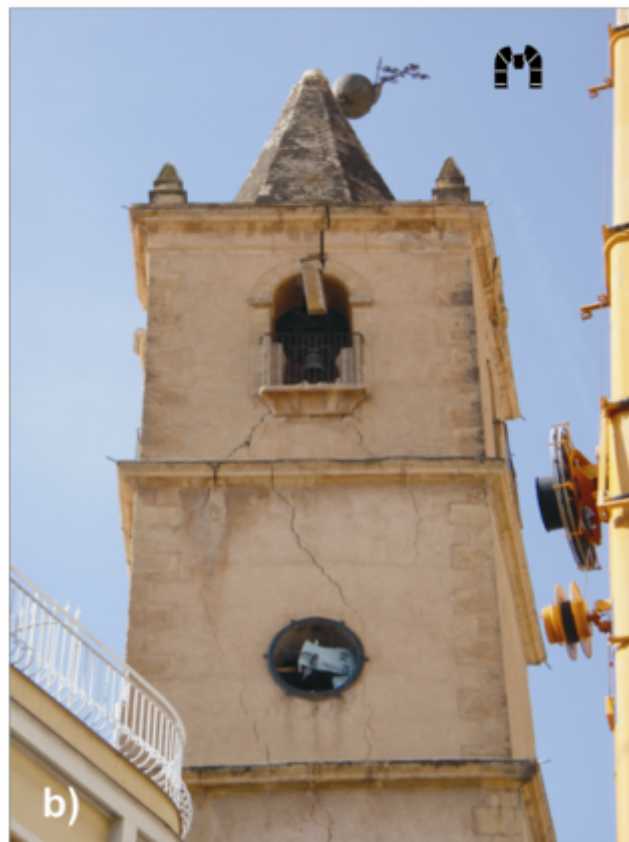
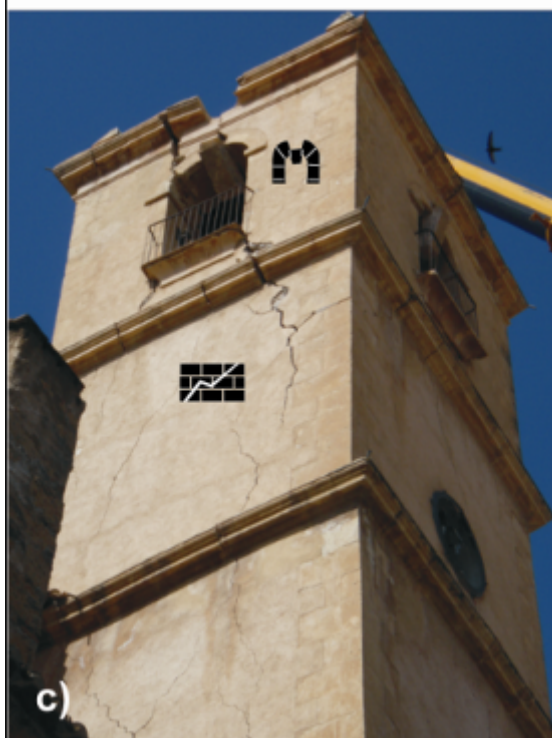
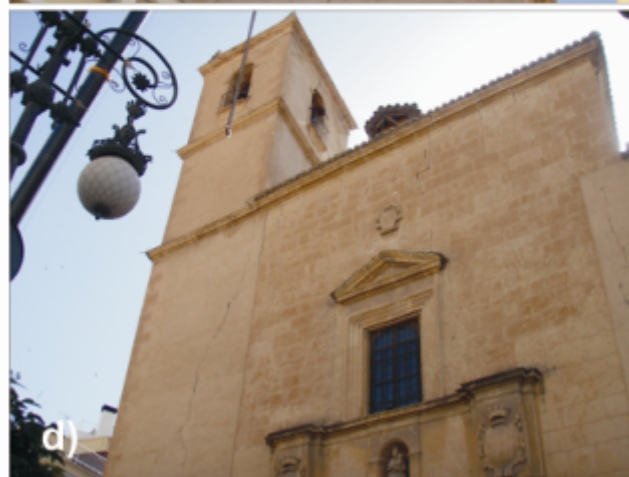
Figure 5.6: Damage in the San Francisco's Church.
