Date: 20th May, 2011

GEOLOGICAL PRELIMINARY FIELD REPORT OF THE LORCA EARTHQUAKE (5.1 M_w , 11TH MAY 2011)

Translation from the original report in Spanish

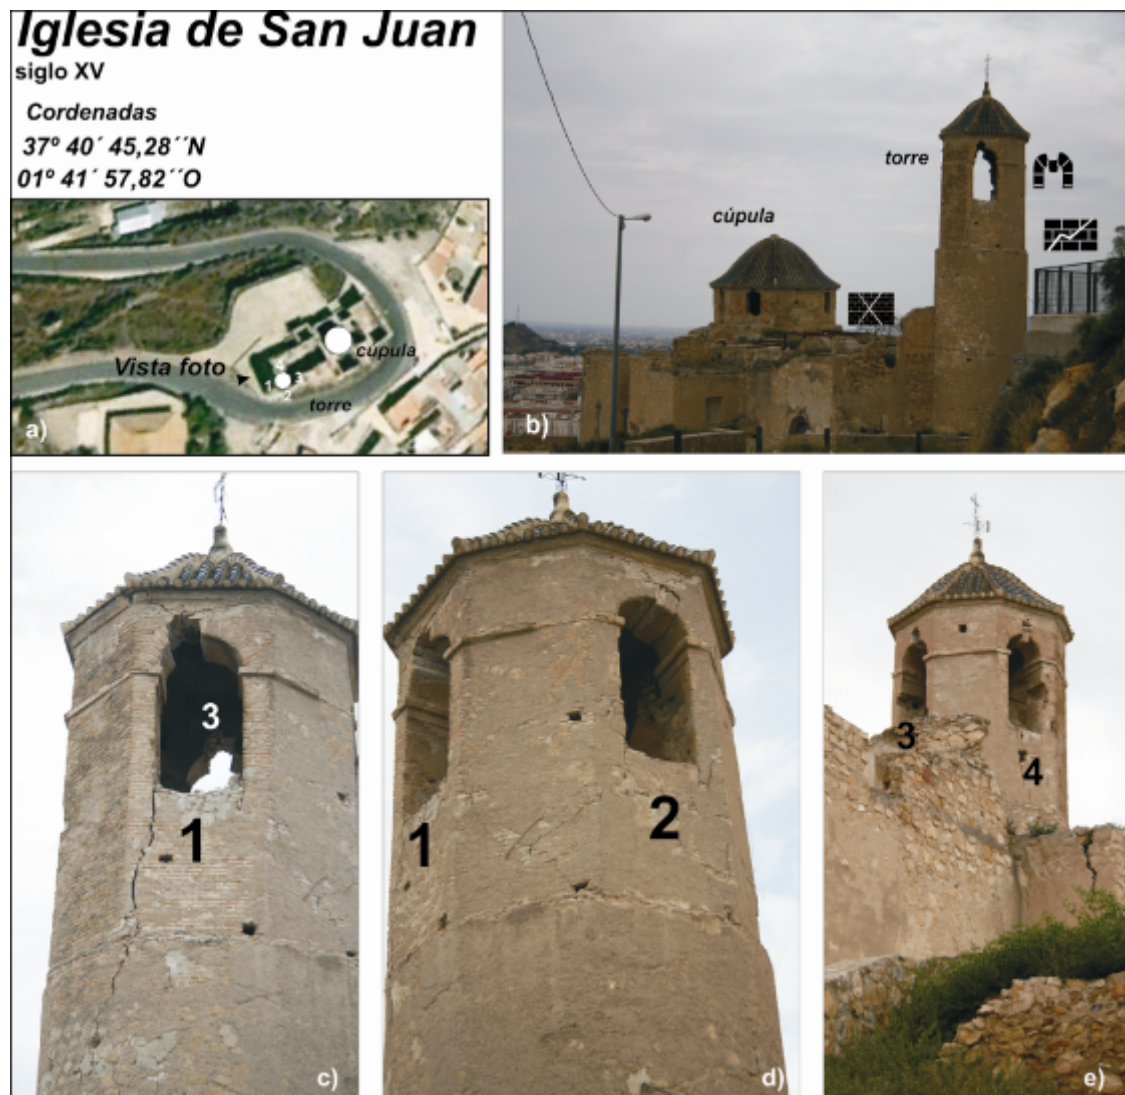
Figure 5.7: Damage in the San Juan's Church.

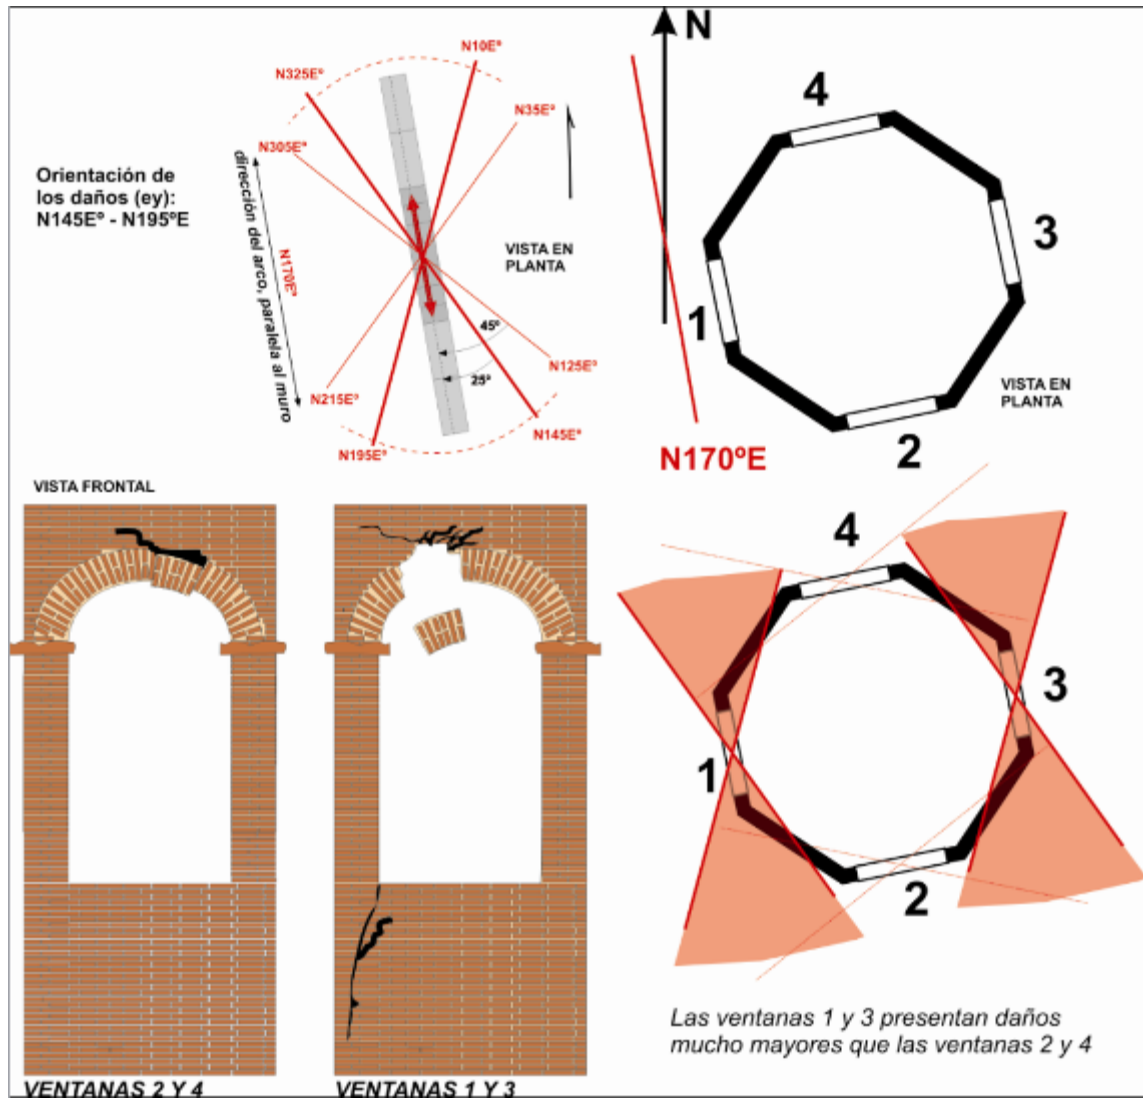
Figure 5.8: Example of analysis of deformation structures and the results of the orientation assessment of the strain (San Juan's Church).

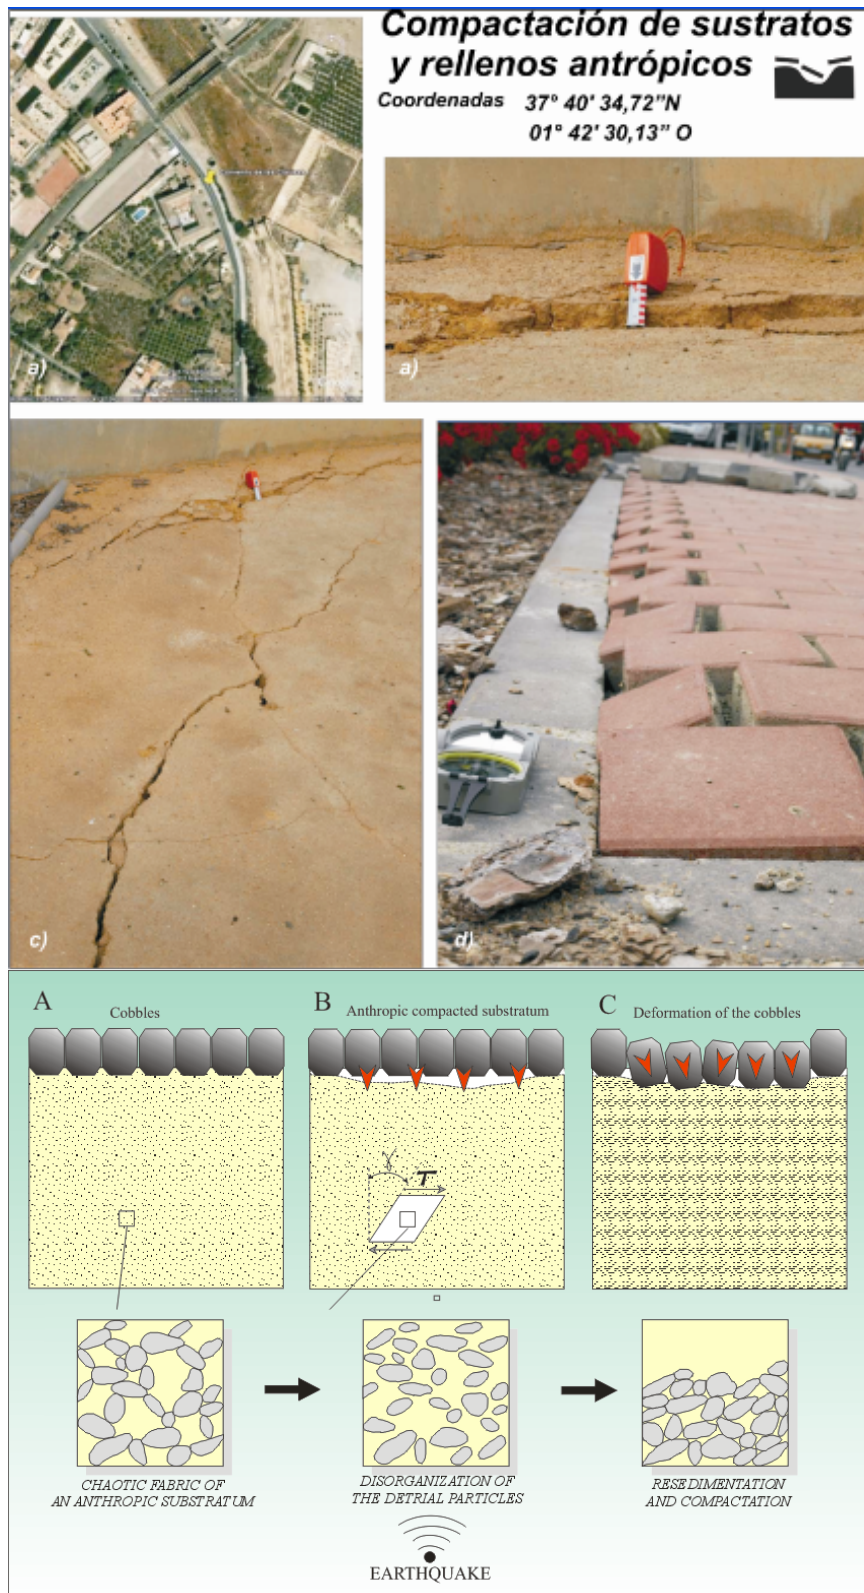
Figure 5.9: Anthropically compacted substratum by seismic shock related to the Clarisas's Convent. New EAE structure.

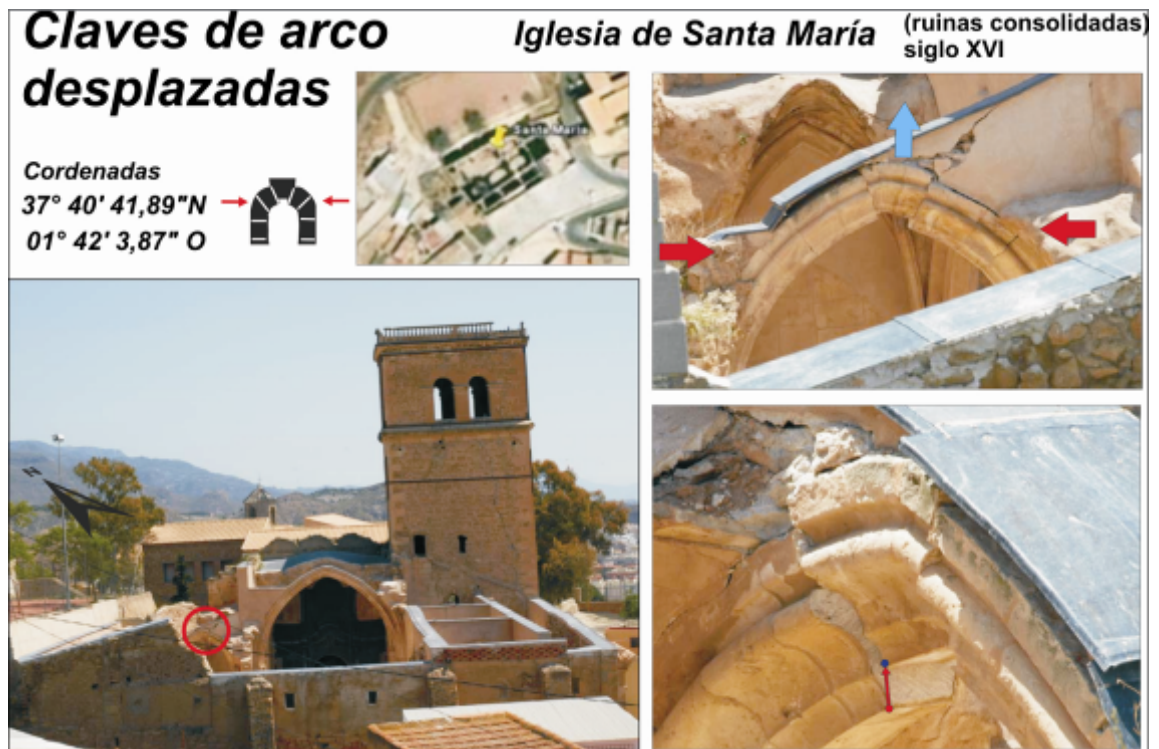
Figure 5.10: Santa Maria's Church. Pop up of a clave stone.
