# The Haiti Earthquake Mw = 7.0 of January 12<sup>th</sup> 2010: structural and geotechnical engineering field observations, near-field ground motion estimation and interpretation of the damage to buildings and infrastructure in the Port-au-Prince area

Panayotis Carydis\*, Efthymis Lekkas\*\*

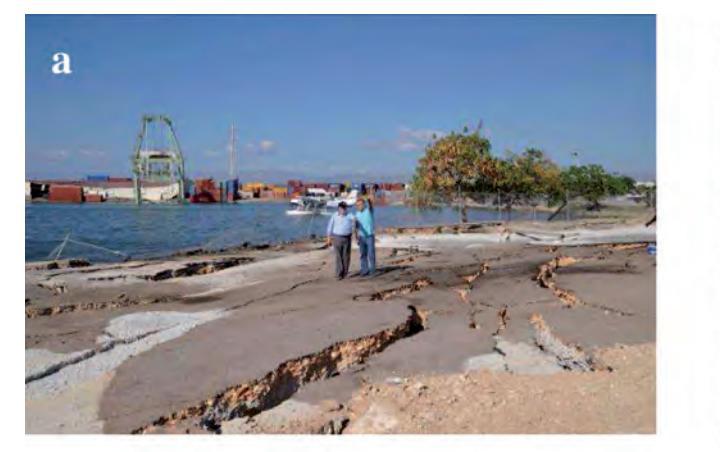
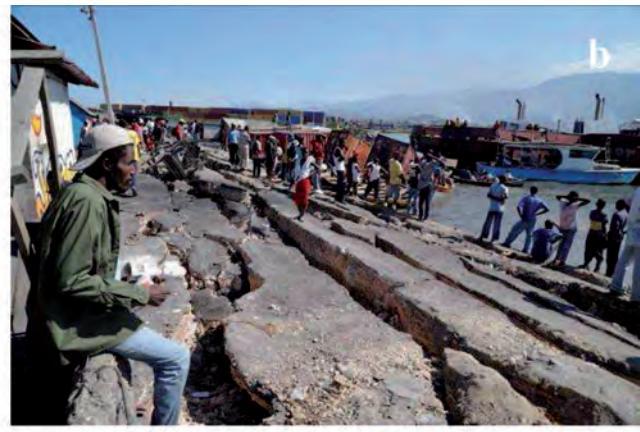
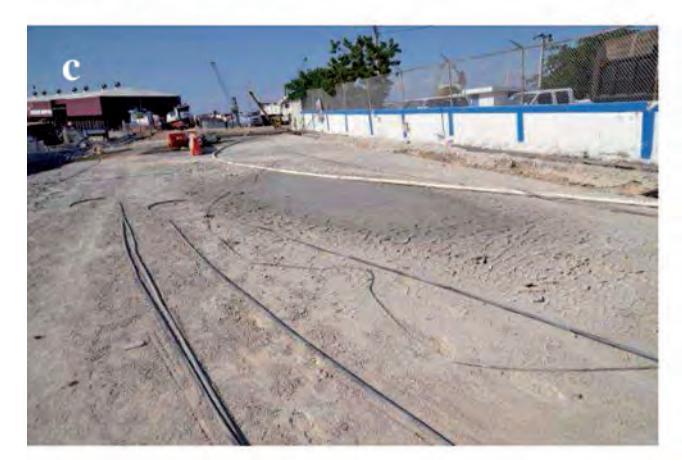
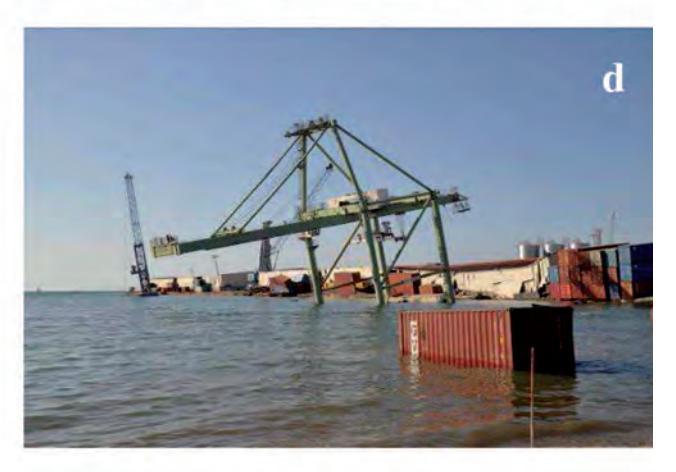
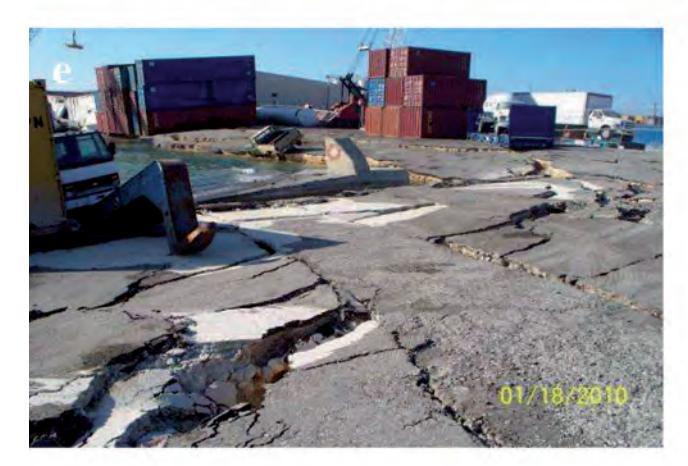
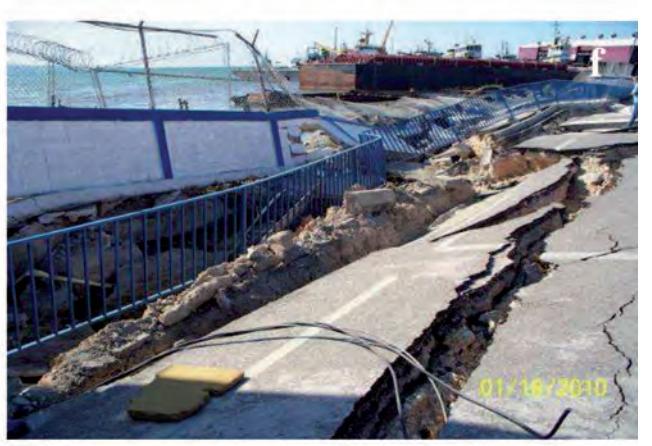
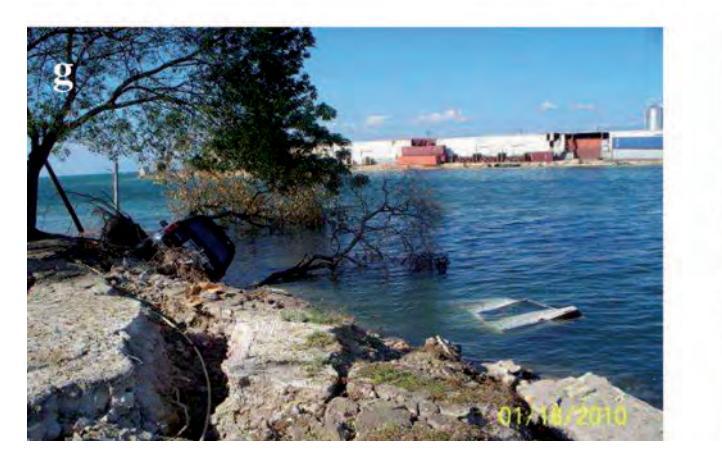
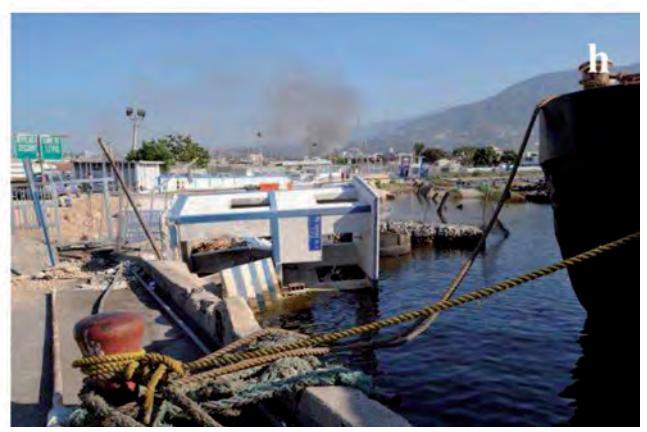
Fig. 3a-h. Extensive liquefactions and lateral spreading phenomena caused significant damages in the port facilities of Port-au-Prince. Marine transportations and shipping were interrupted during the initial period after the main shock.

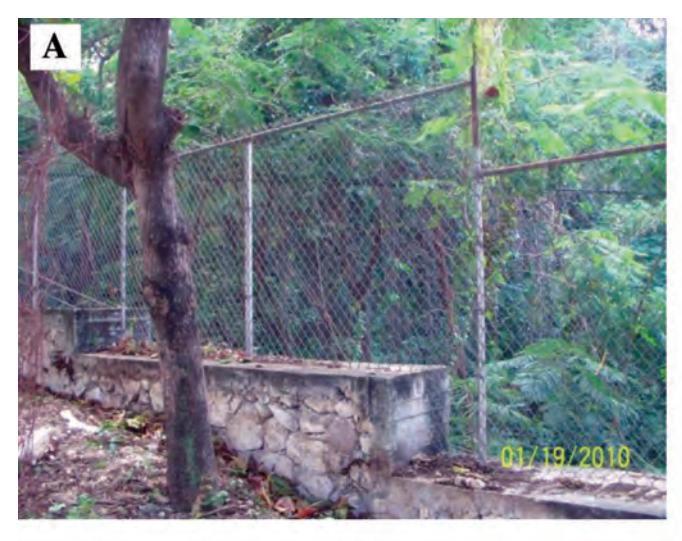
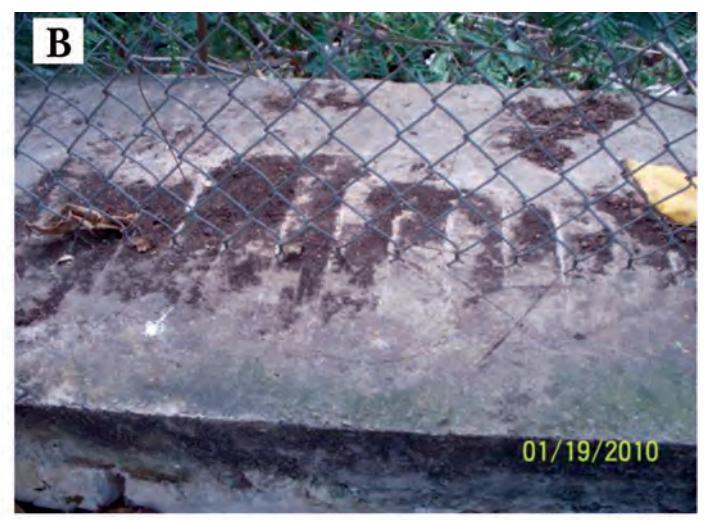
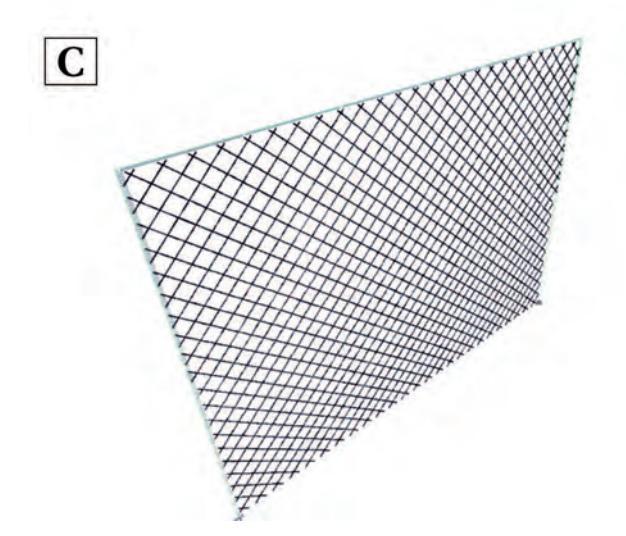
Fig. 4. A fence was functioning during the earthquake as a primitive seismoscope.

(a) General view. The plane of the fence is along NW-SE direction.

(b) Details A of the observed imprints – light scrtches, by the lower wires on the steel net on the concrete base. The direction of the motion is NE-SW.

(c) A print out of the analyzed model usign ETABS computer code, in which a symmetry of the boundary conditions is maintained along the two vertical posts of the panel.

- direction of the motion. The NE-SW direction, at least at this particular site, is dominant. On the contrary, no sign of significant motion on the NW-SE direction was found, although the respective natural periods of the fence were almost identical as already mentioned.

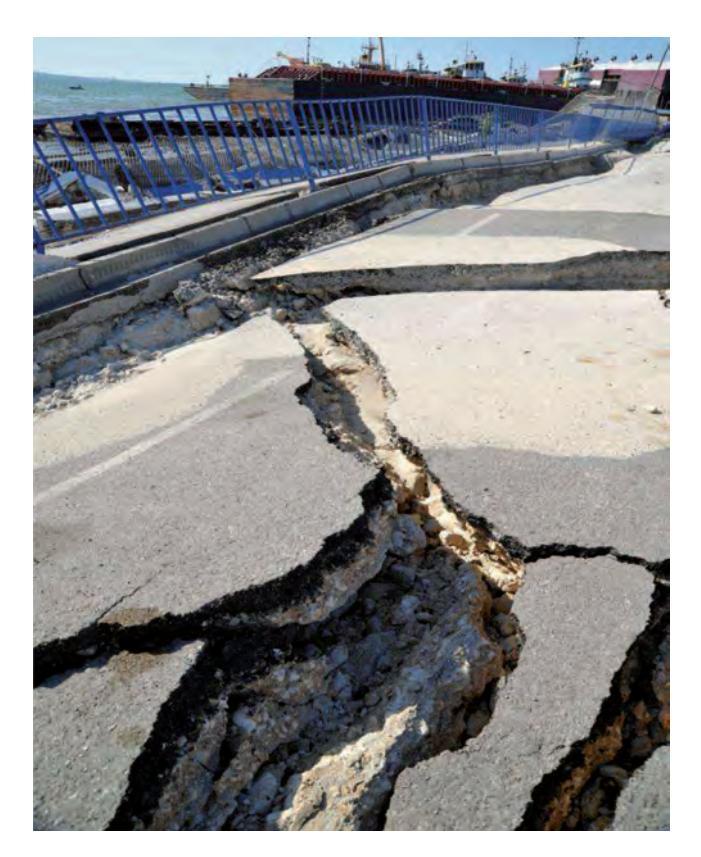
Fig. 5. Port–au–Prince port area. The ejected material could form a continuous surface if the broken pieces are assembled together like in a puzzle. This shows that sand and water ejections started before the actual liquefaction and the lateral spreading phenomenon took place.

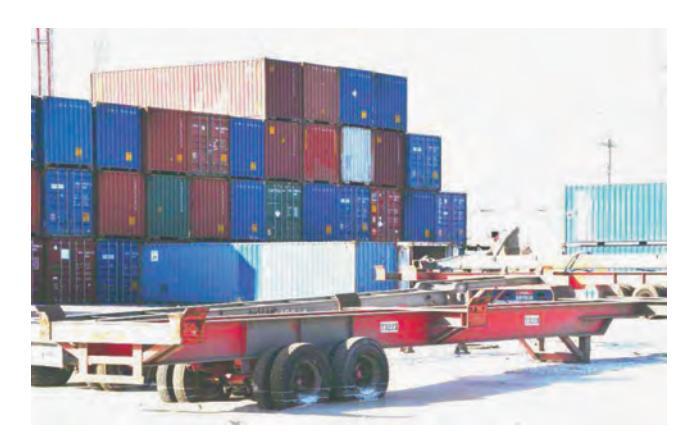
Fig. 6. Another documentation that the sand and water spouts in the port started before the strong ground shaking (please note the two parallel horizontal white signs on the tires which are due to bounding of the lorry platform on the ground during the strong phase of the ground motion. The ejected material was already there).

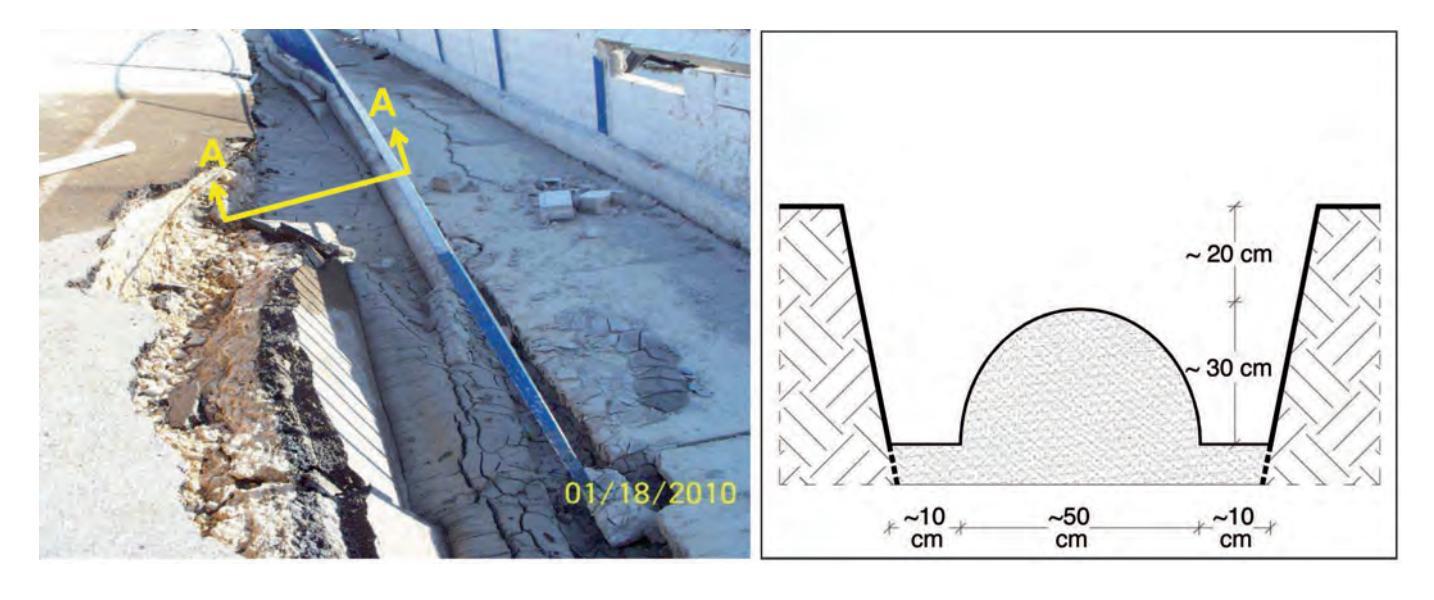
(a) General view of the trenche with ridge of liquefied material inside it.

Fig. 7a, b. Ridges of liquefied material was observed inside the trenches. Their crest was almost in the center and parallel to the trenches axis. The visible thickness of the ridge was about 30 cm almost uniform all along its length. The internal visible sides of the trenches were found clean, justifying in this way the spouted material continued taking place during the third phase too.

During the third phase, the ejection of ground material continues taking place, but gradually decreases until its completion. Not any significant ground deformation primary connected to the actual liquefaction phenomenon takes place. This phase is documented, among others, in Fig. 7 where fine liquefied material continuous to be ejected, well after the completion of the large ground deformations – main liquefaction phenomenon. According to this evidence, the ejected material - that possesses a high viscosity - formed inside the trenches symmetrical ridges along the central axis of the trench. This may mean that the material was still gushing up even after the integration of the destructive strong motion and the creation of the large ground displacements. If the liquefied material was inside the trench and after that, the trench became wider, the material should have come down having its concaves turned upwards. This is absolutely opposite to what it has been observed all over the many trenced created, Fig. 7.

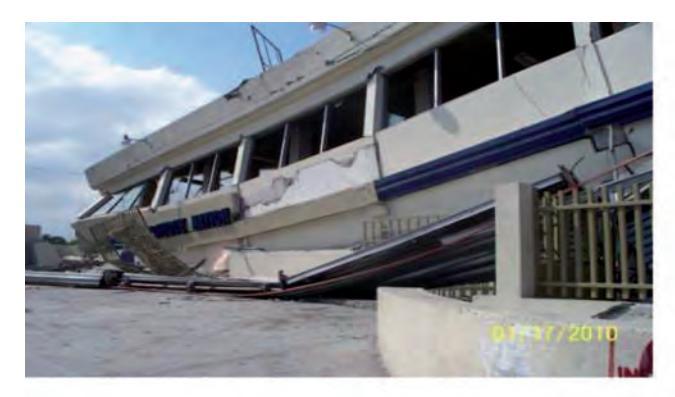
(a) Typical collapse of a contemporary building with reinforced concrete framework.

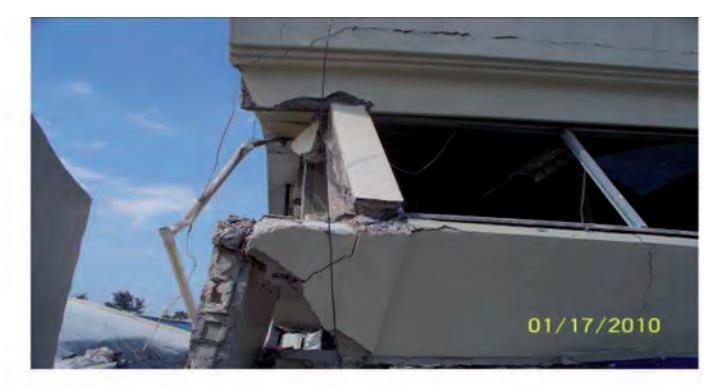
(b) A detail of (a), notice the inadequate reinforcement

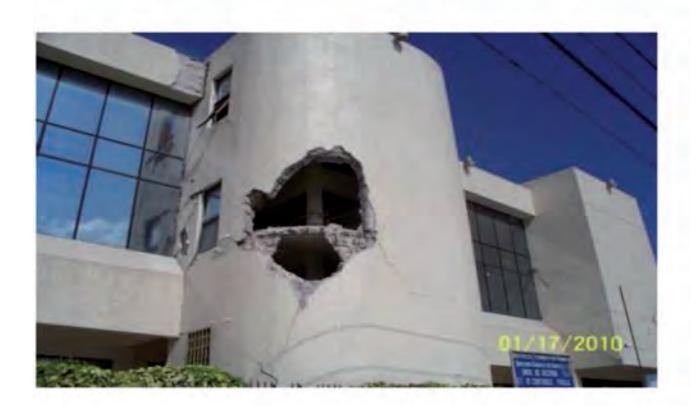
(c) Jet components from different places around the building. Glazing is intact!

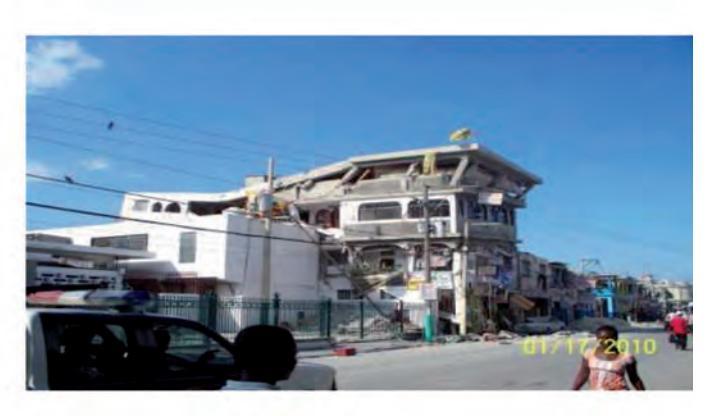
(d) Typical collapse of a multi-storied buildings with reinforced concrete framework.

Many multistoried buildings suffered extensive damage or collapsed. The type of collapse is of the pancake-type, where the upper floors fall over the lower ones without any horizontal translation. This is attributed to the strong vertical component at the very first phase of the seismic motion, due to the emerging waves (P). The buildings that were not damaged in the first phase of the earthquake were destroyed by the second one, as this can be justified from their horizontal displacements. The second phase is dominated by the horizontal seismic motion (S), which is more harmonic with longer predominant periods, larger displacements and longer duration.

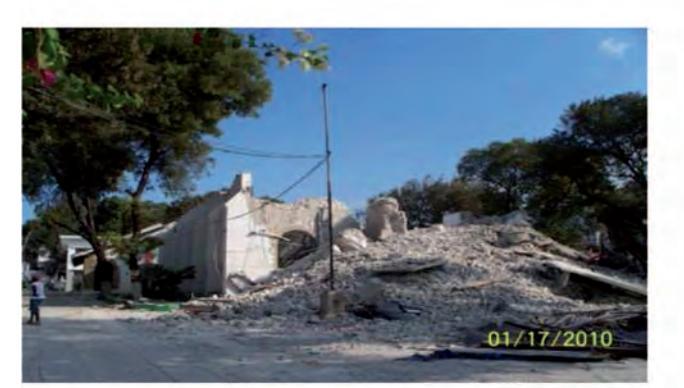
(e) The arch-like lintels over the windows survived.

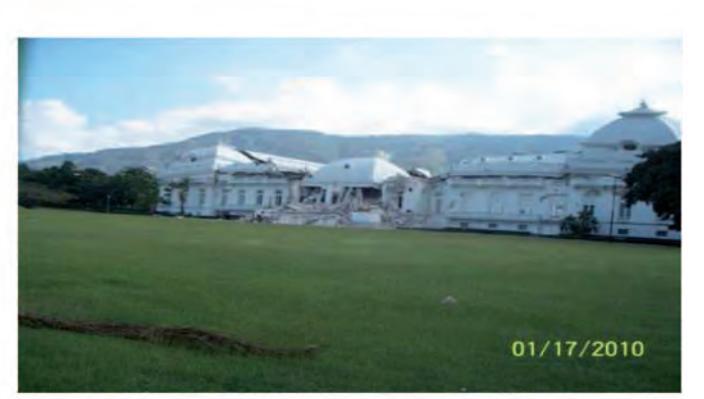
(f) The Presidential Palace. An almost symmetrical vertical collapse of the upper level.

The majority of these monumental buildings suffered from heavy damages to partial or total collapse. The collapse in the majority of the cases occurred within the perimeter of the buildings, Fig. 8f, while the most of the other walls remained standing in their position vertically. In accordance to this fact is the observation of unbroken glasses of the windows, even in cases that the building had suffered extensive structural damages. Furthermore, the arched lintels remained in their position, in spite of the fact that in many cases the rest of the building collapsed, Fig. 8e. This type of collapse could be attributed only to a strong vertical component of the ground motion which exceeds 1.0 g. The starting moment of the collapse should have been from 4 sec up to 7 sec, when the horizontal component of the emerging waves had not arrived yet. This was based on the fact that not any sign of significant horizontal motion had been noticed. The vertical collapse occurred abruptly, allowing no chance of reaction for escape or protection to the building occupants.

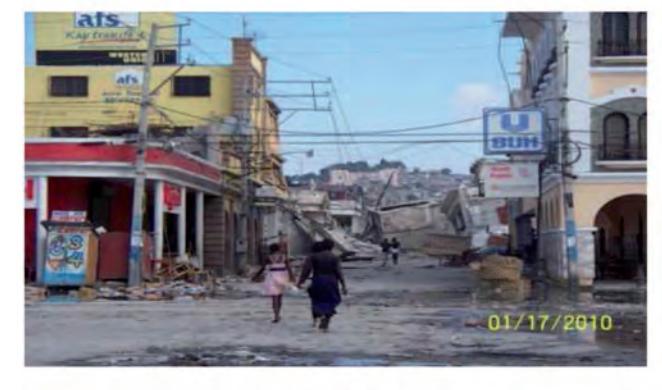
(g) Typical street view after the earthquake.

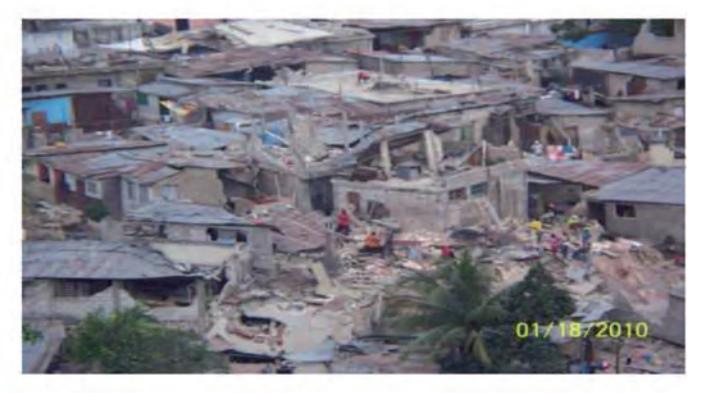
(h) Informal housing destroyed on sloping ground,

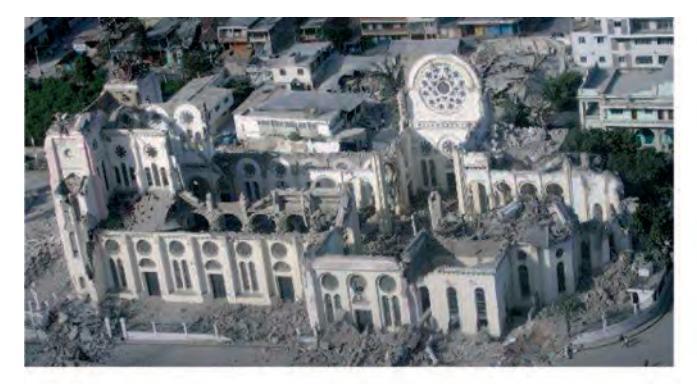
(a) Aerial view from S-E. The roof collapsed within the ground plan of the Port-au-Prince Cathedral.

Fig. 9. A study case of the damaged Cathedral Notre-Dame of Port-au-Prince. Comparison with other similar cases, in which the roof or dome collapsed inside the ground plan of the church while the walls and bell towers remained in their position.

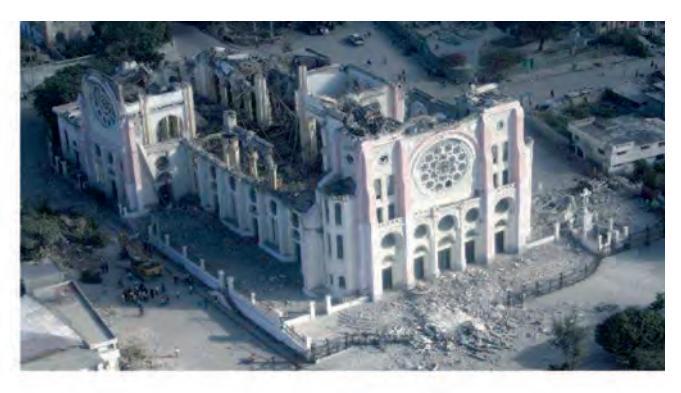
(b) Aerial view from N-W side. All main walls of the Cathedral remain intact, vertically.

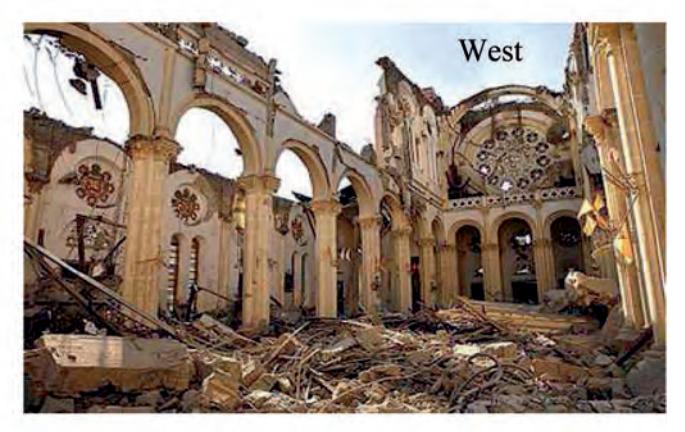
(f) Internal view of the Cathedral of Port-au-Prince. The roof collapsed within the plan of the church.

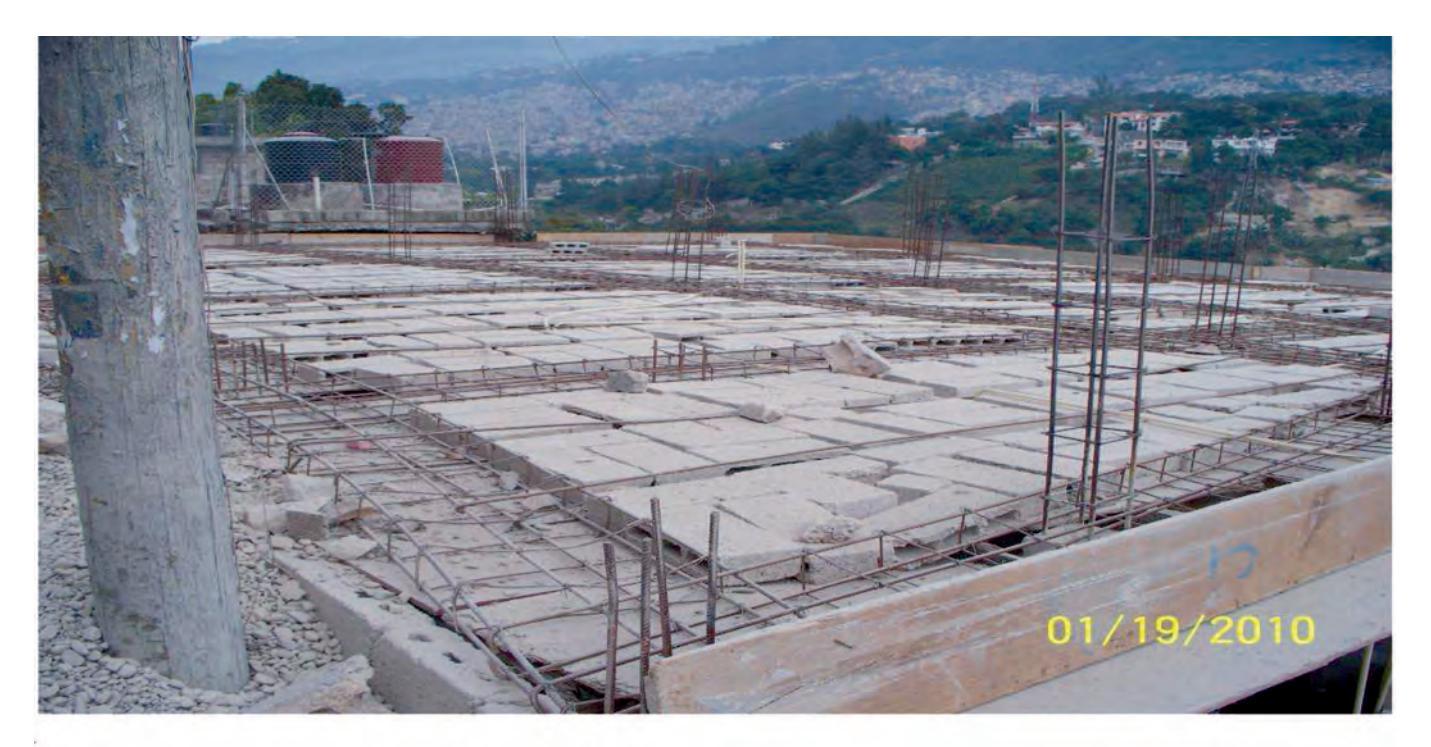
(a) Flat slab construction of the third floor. Inadequate reinforcement of small diameters and at large distances. Small dimensions of columns. Absence of any shear wall.

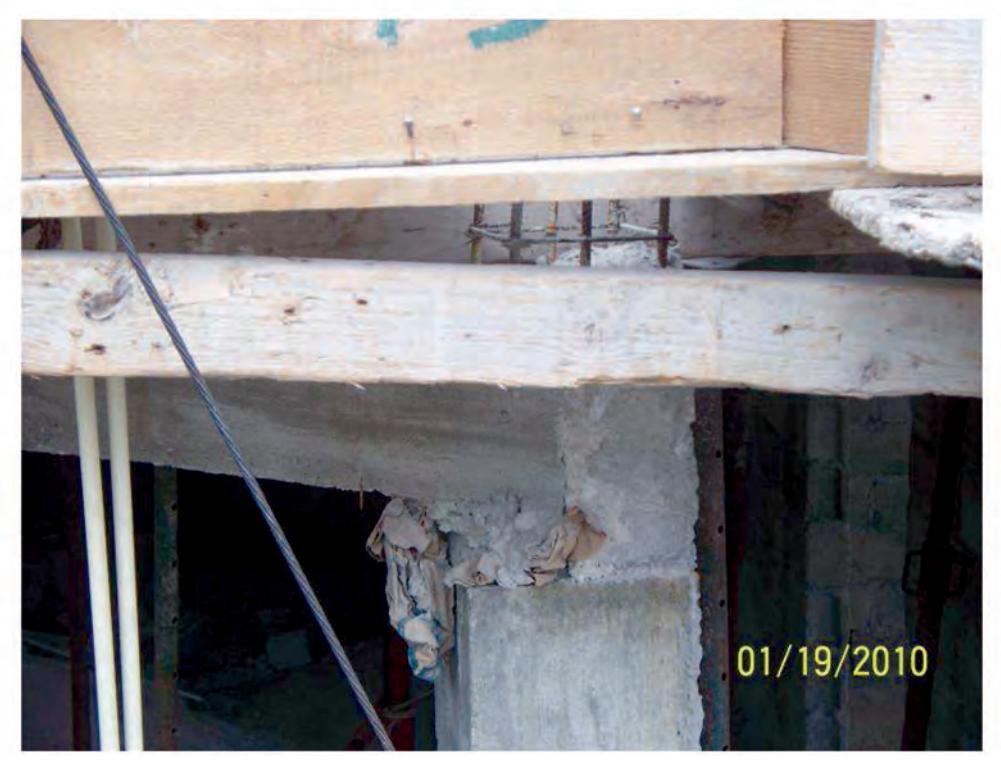
(b) A detail of a column to beam joint of the framing system shown in (a).

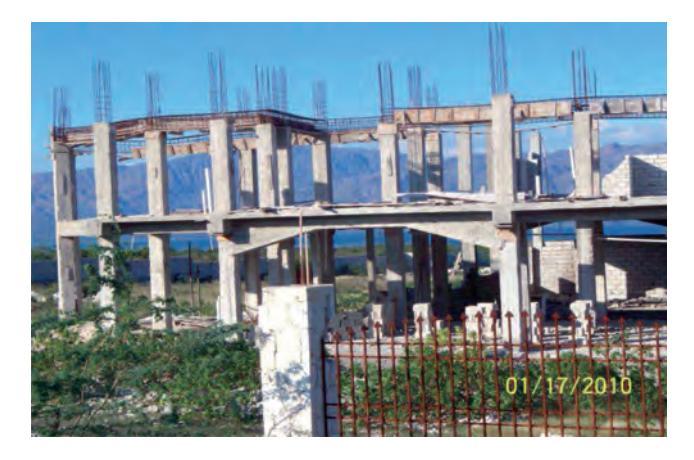
Fig. 12. A reinforced concrete framing system was ready for concreting before the earthquake as found after it. Total lack of any stiffening element. Note the beam at the center of ground floor with the triangle strut was added after the concreting of the floor.
