PRELIMINARY REPORT

VAN EARTHQUAKE - TURKEY (Mw 7.2 - 23 OCT 2011)

The October 23 ($M_W = 7.2$) and November 9 ($M_W = 5.7$), 2011 Van, Turkey earthquakes. A geoscientific and engineering report

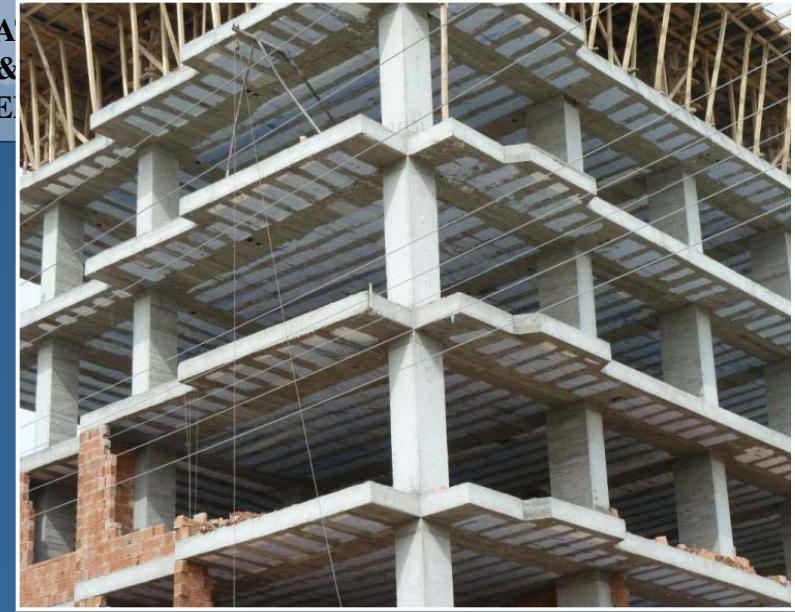
Another typical constructional example of flexible modern multistoried buildings. The brick wall partitions do not present considerable movement or crosswise cracks. Instead, crashing of layers of bricks at the lower stories is observed. Due to the strong vertical seismic component crashing of reinforced

concrete columns at the base is observed. The recorded toppling, and various modes of building failure may be attributed to this parameter.

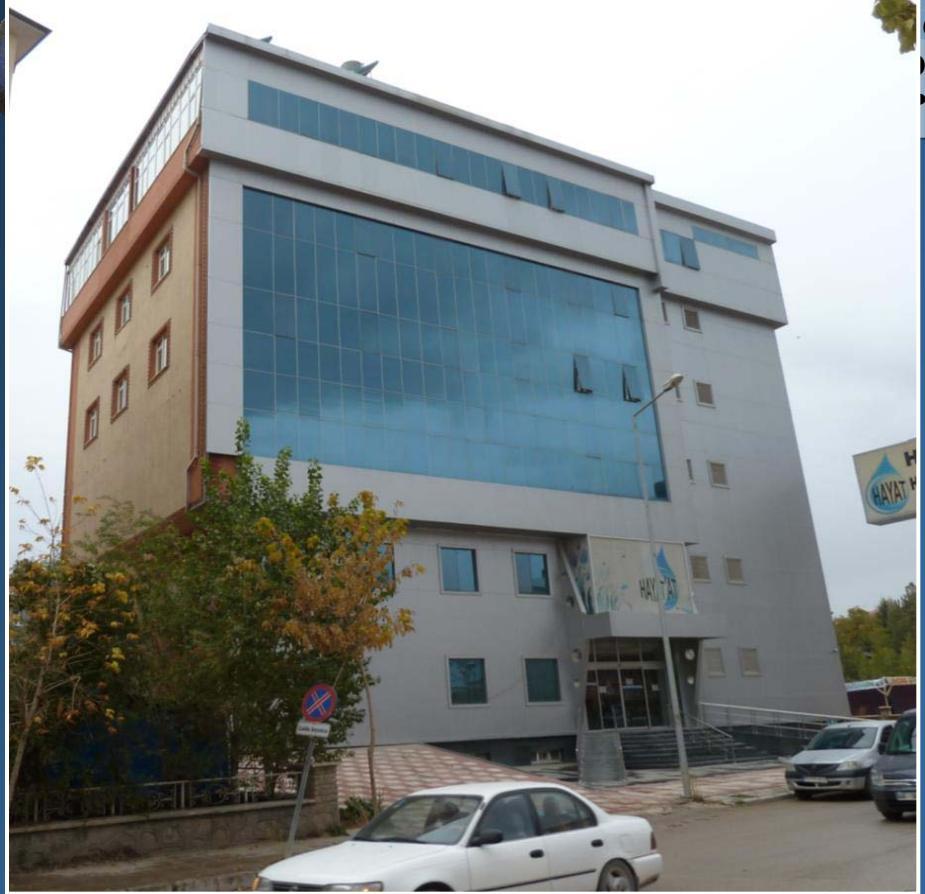
In the most of the cases the secondary elements are undamaged either all over the height of the building, or above the lower few stories. This indicates that in despite of the pronounced flexibility of the load bearing structural system, noticeable horizontal displacements are not developed.

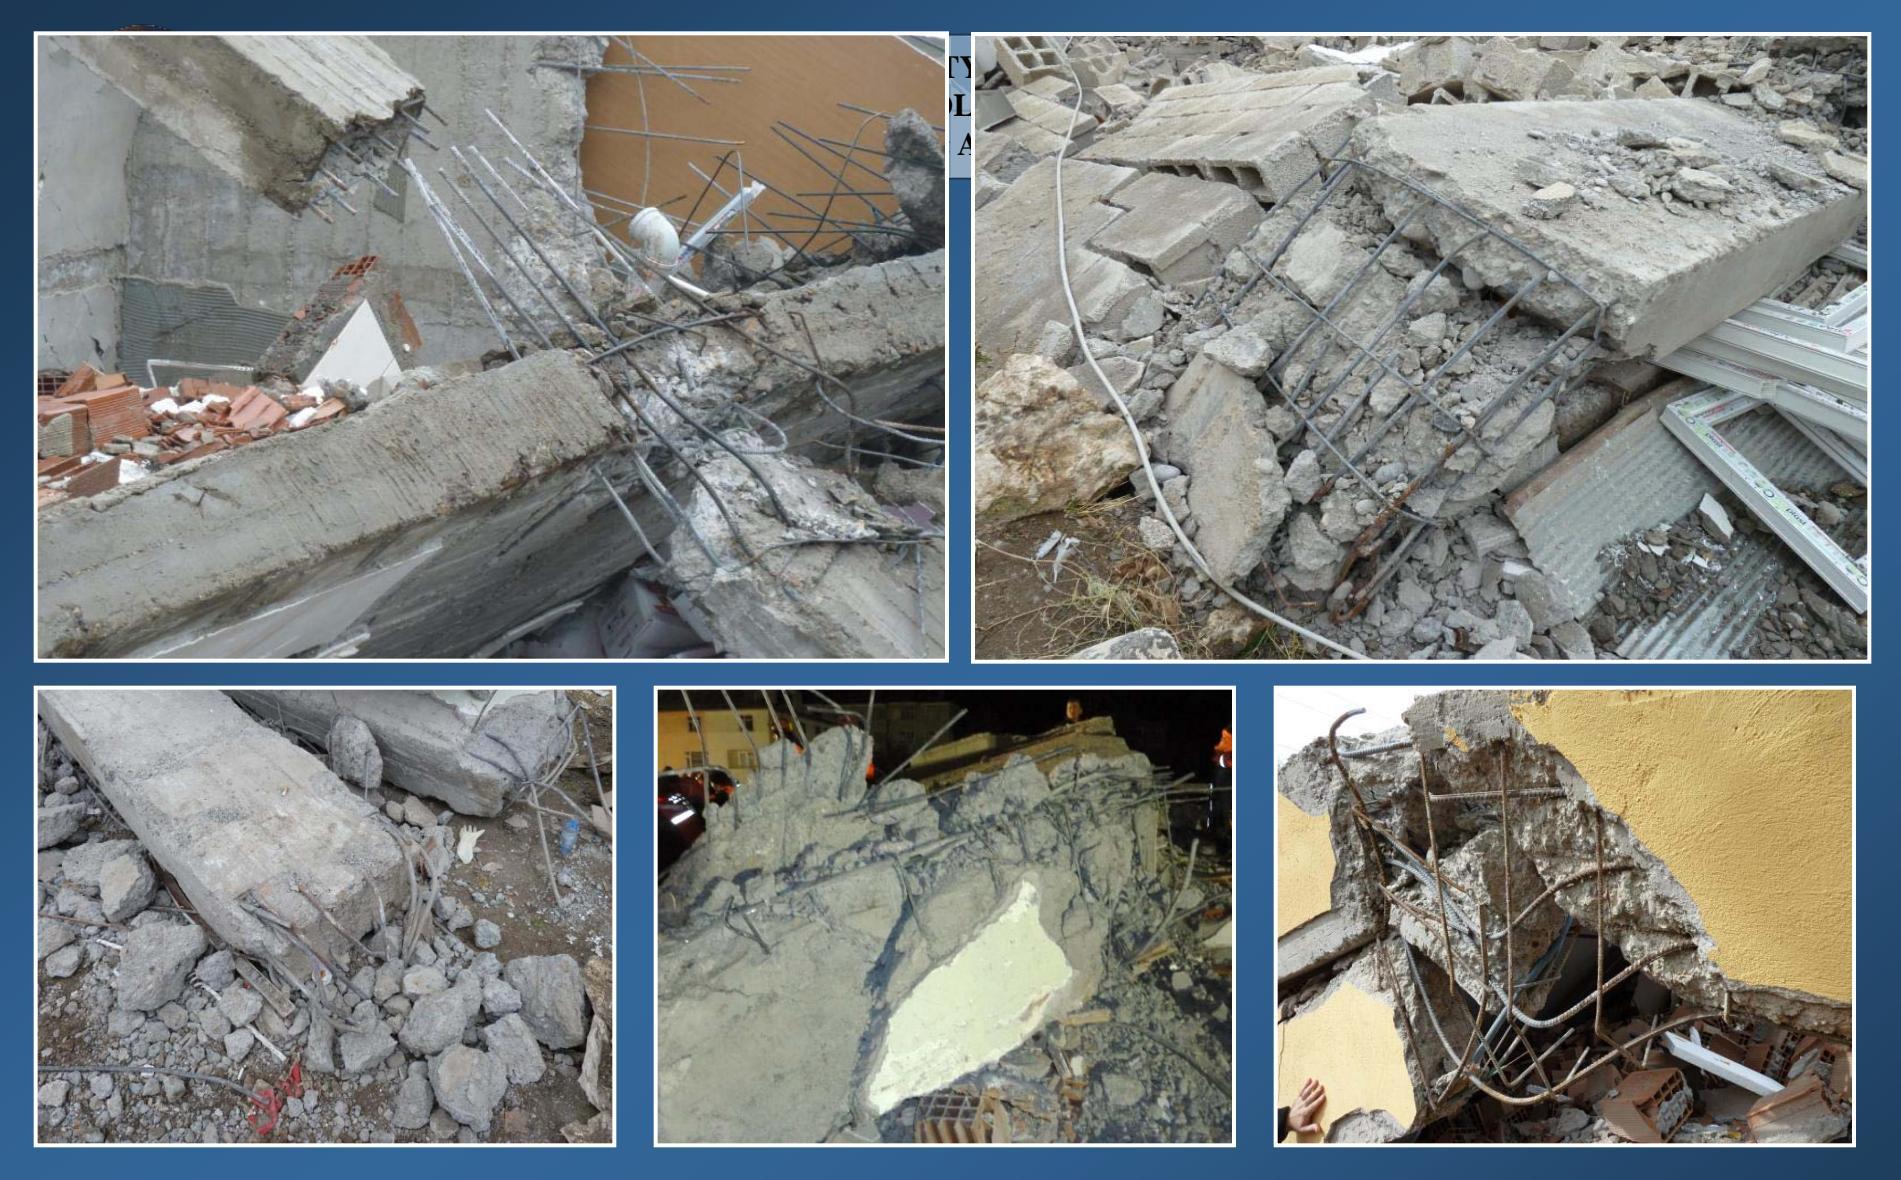
Engineered structures, with well constructed beam to column joints, stirrups and main reinforcement, suffered various modes of damage, collapse and rummage. On the contrary, one and two storied rural houses, all with light weight sheet-iron roofs, outreached the earthquake in the epicentral region almost without any damage.

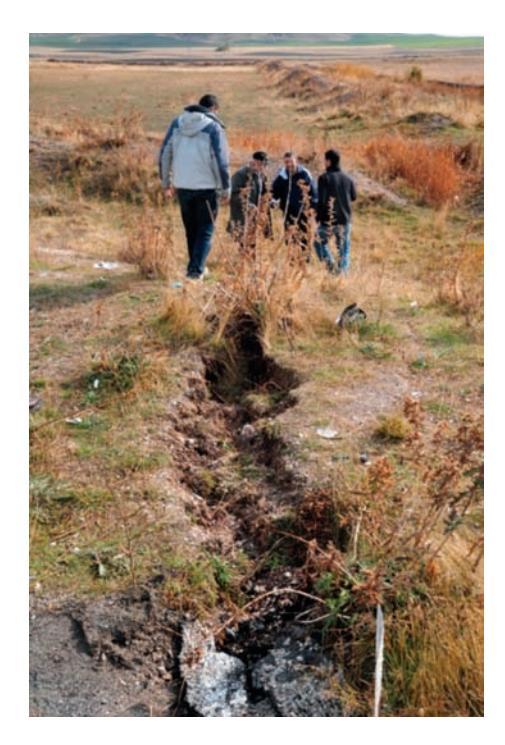
Fig. 2. The seismic rupture, crossing the main road of Van-Ercis, is very close to epicenter, which is associated with the October 23^{rd} , 2011 earthquake, see Fig. 5.

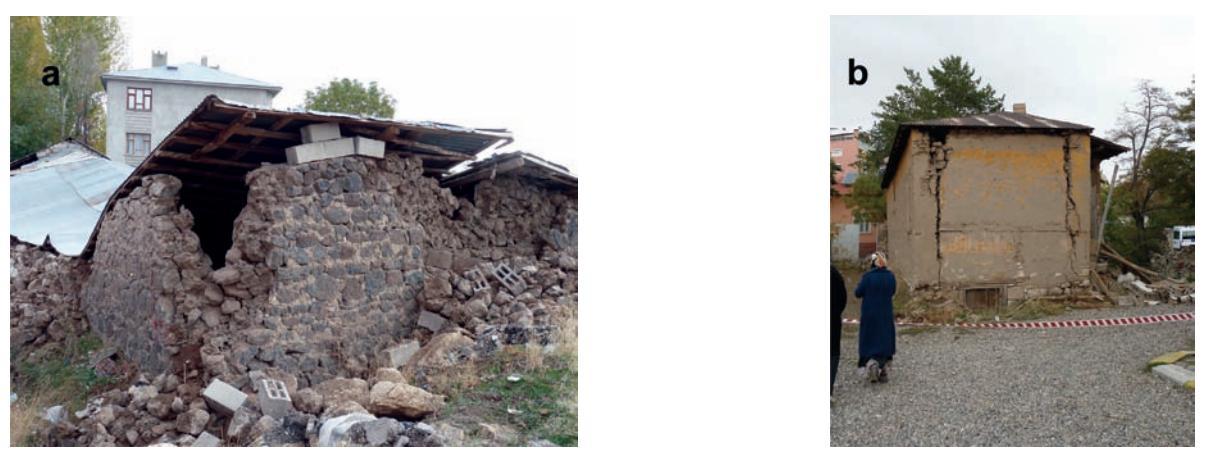
Fig. 16a, b. This manner of damage of simple houses indicates the dominance of vertical seismic component.

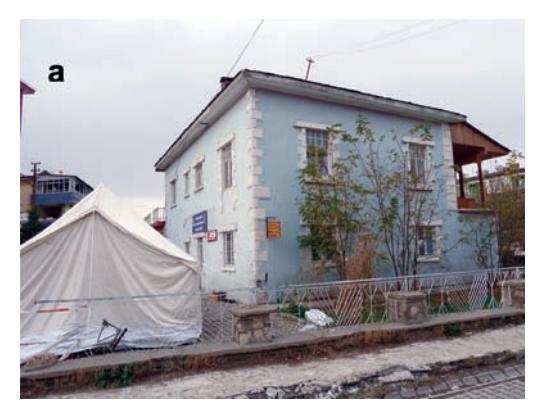
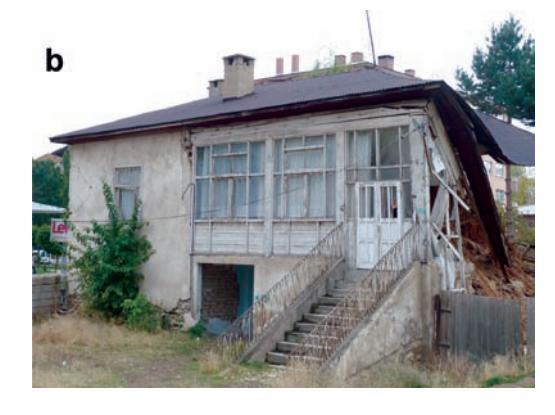
Fig. 17a, b. Traditional masonry buildings survived the main shock with minor or no damage.

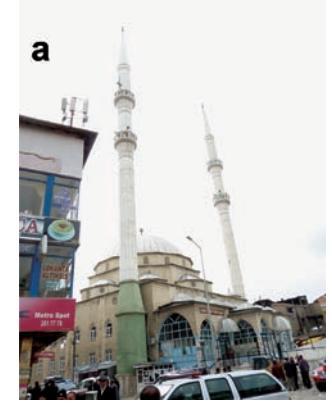
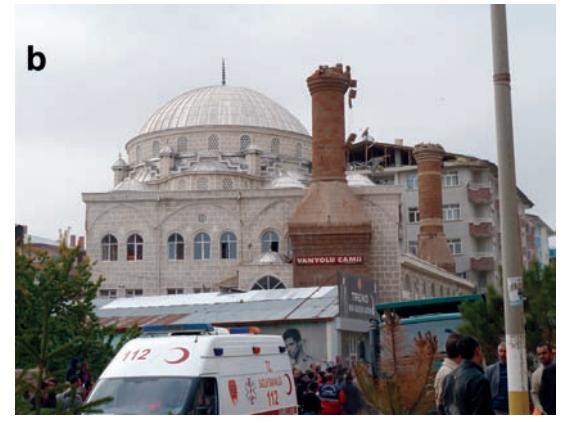
Fig. 18a, b. Most of the mosques with their minarets weathered the main shock without any damage. In a limited number of cases parts of minarets toppled.

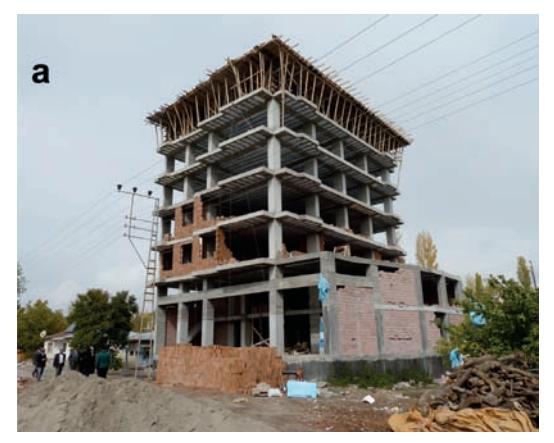
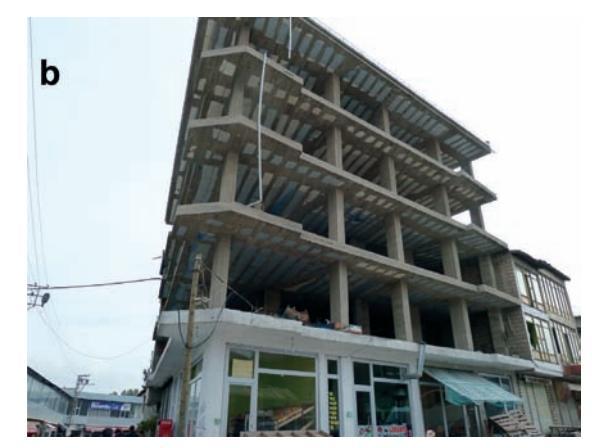
Fig. 19a, b. Flexible buildings with rather large openings and without shear walls, as well as those with a one way flat-slab construction system are prevalent in new structures.

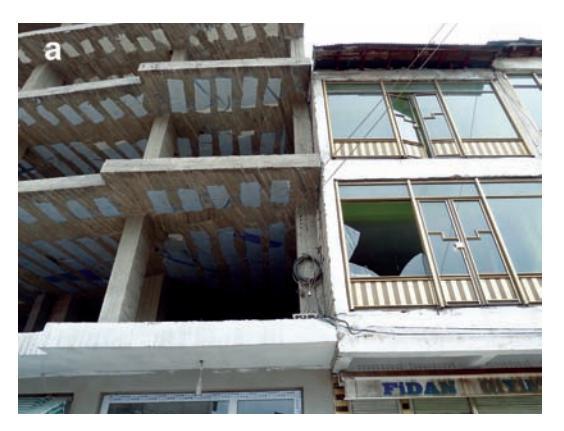
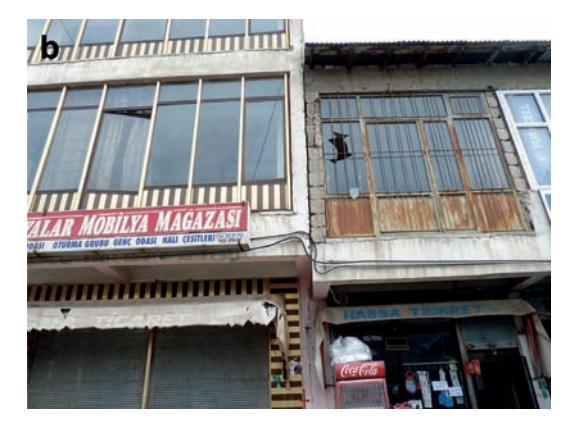
Fig. 21a, b. No evident horizontal motion, or breaking of glass panels, or pounding between adjacent buildings was observed.

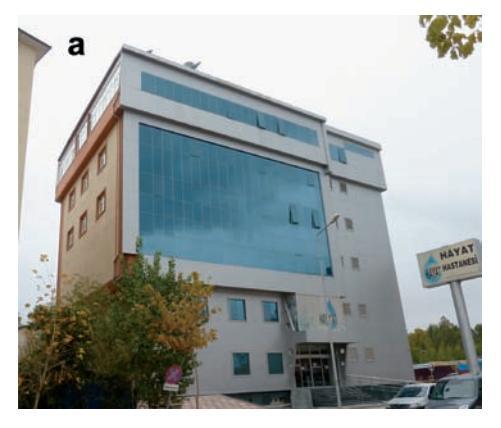
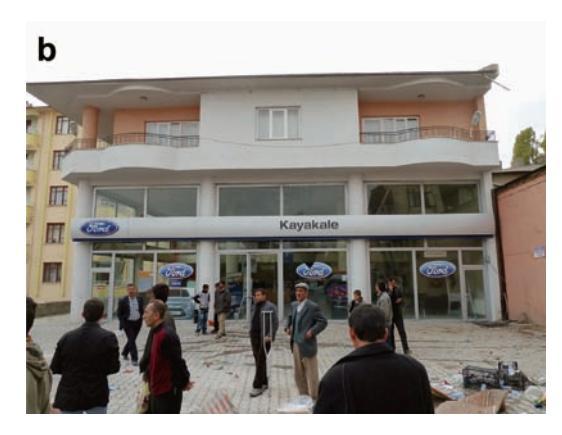
Fig. 22a, b. Externally, some well designed and constructed strong modern buildings, did not present any damage. Internally, the secondary elements and the content suffered extensive damage.

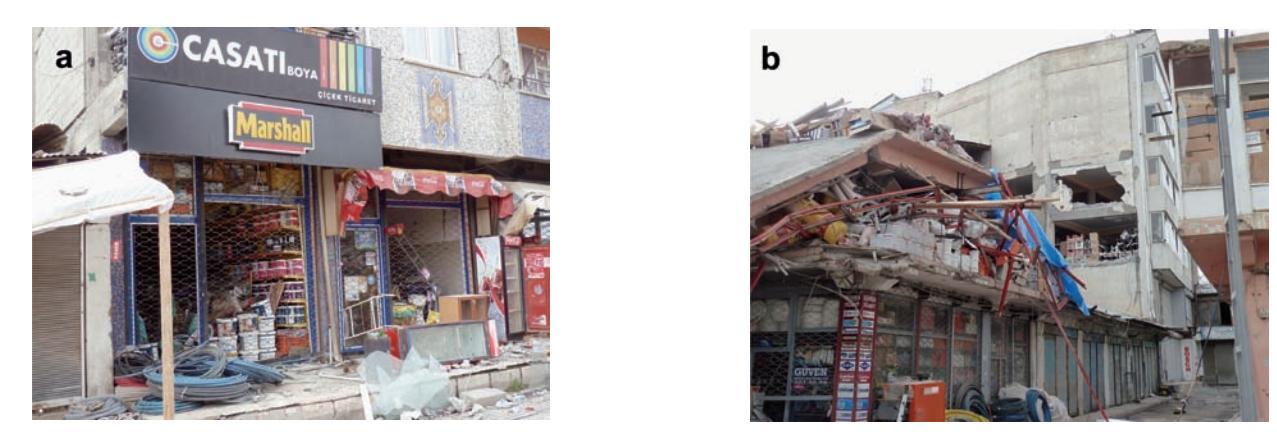
Fig. 23a, b. The content and appendages in old / flexible / soft buildings weathered the events with rather limited losses.

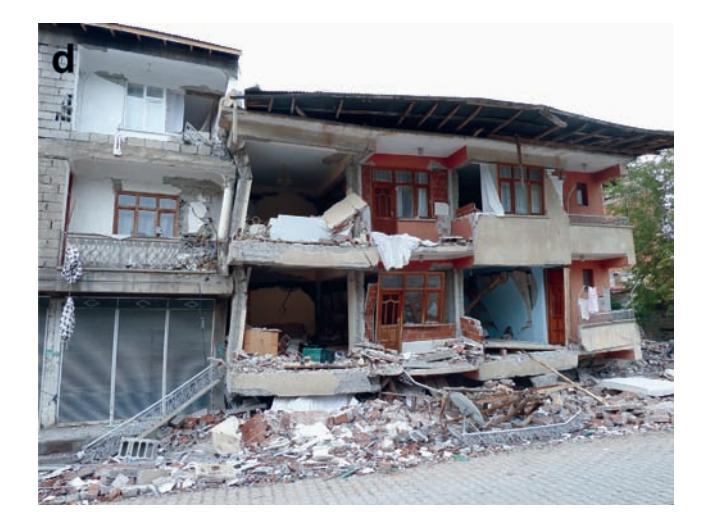
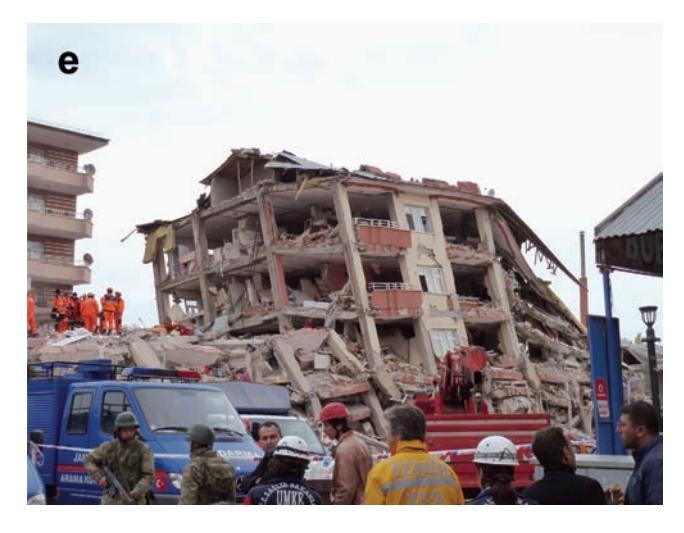
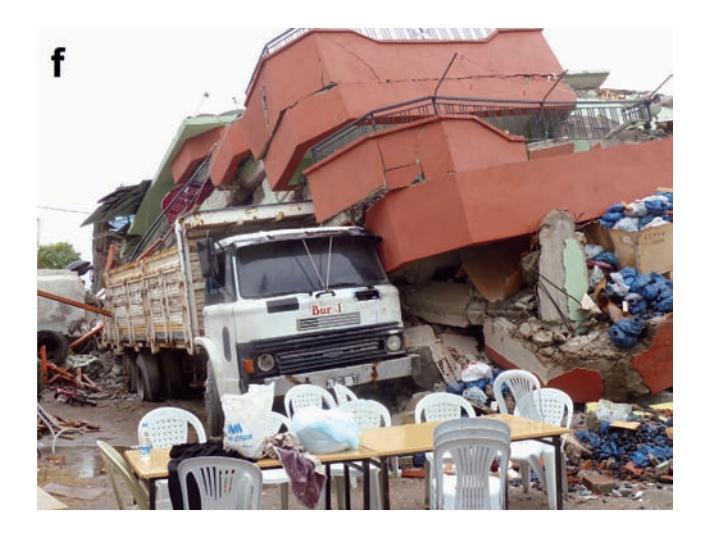
Fig. 27a-f. Heavily damaged and collapsed buildings in Ercis city.

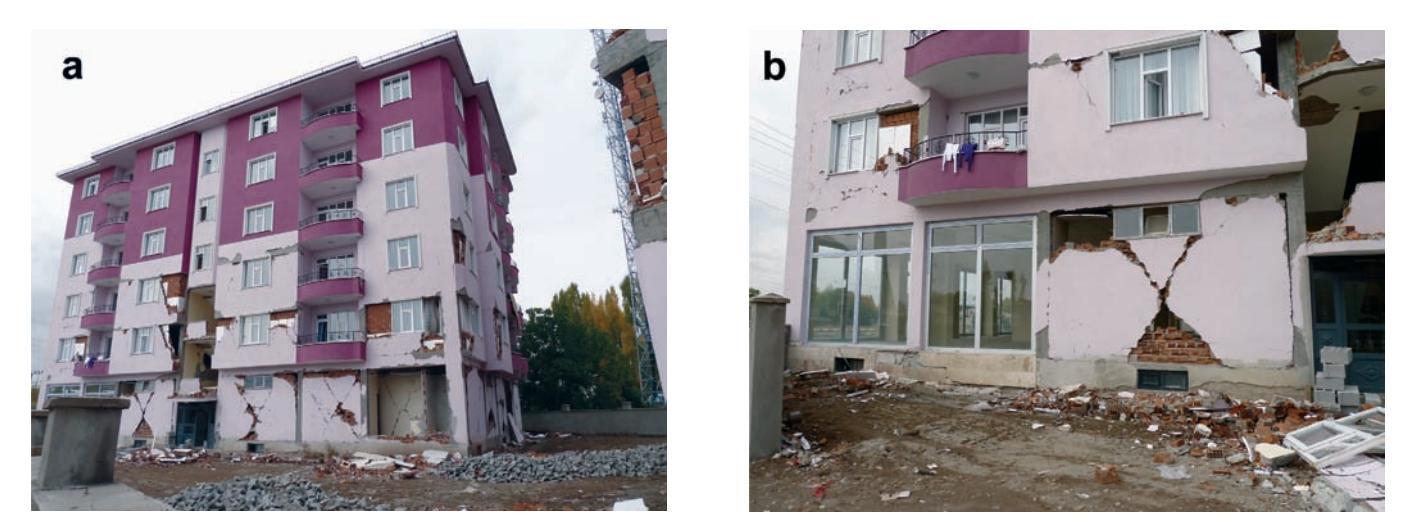
Fig. 28a, b. Note that the glass panels are intact while the walls are damaged especially at the lower levels. This is the case for almost the majority of the damaged-not collapsed multi-storeyed buildings, in Ercis city.

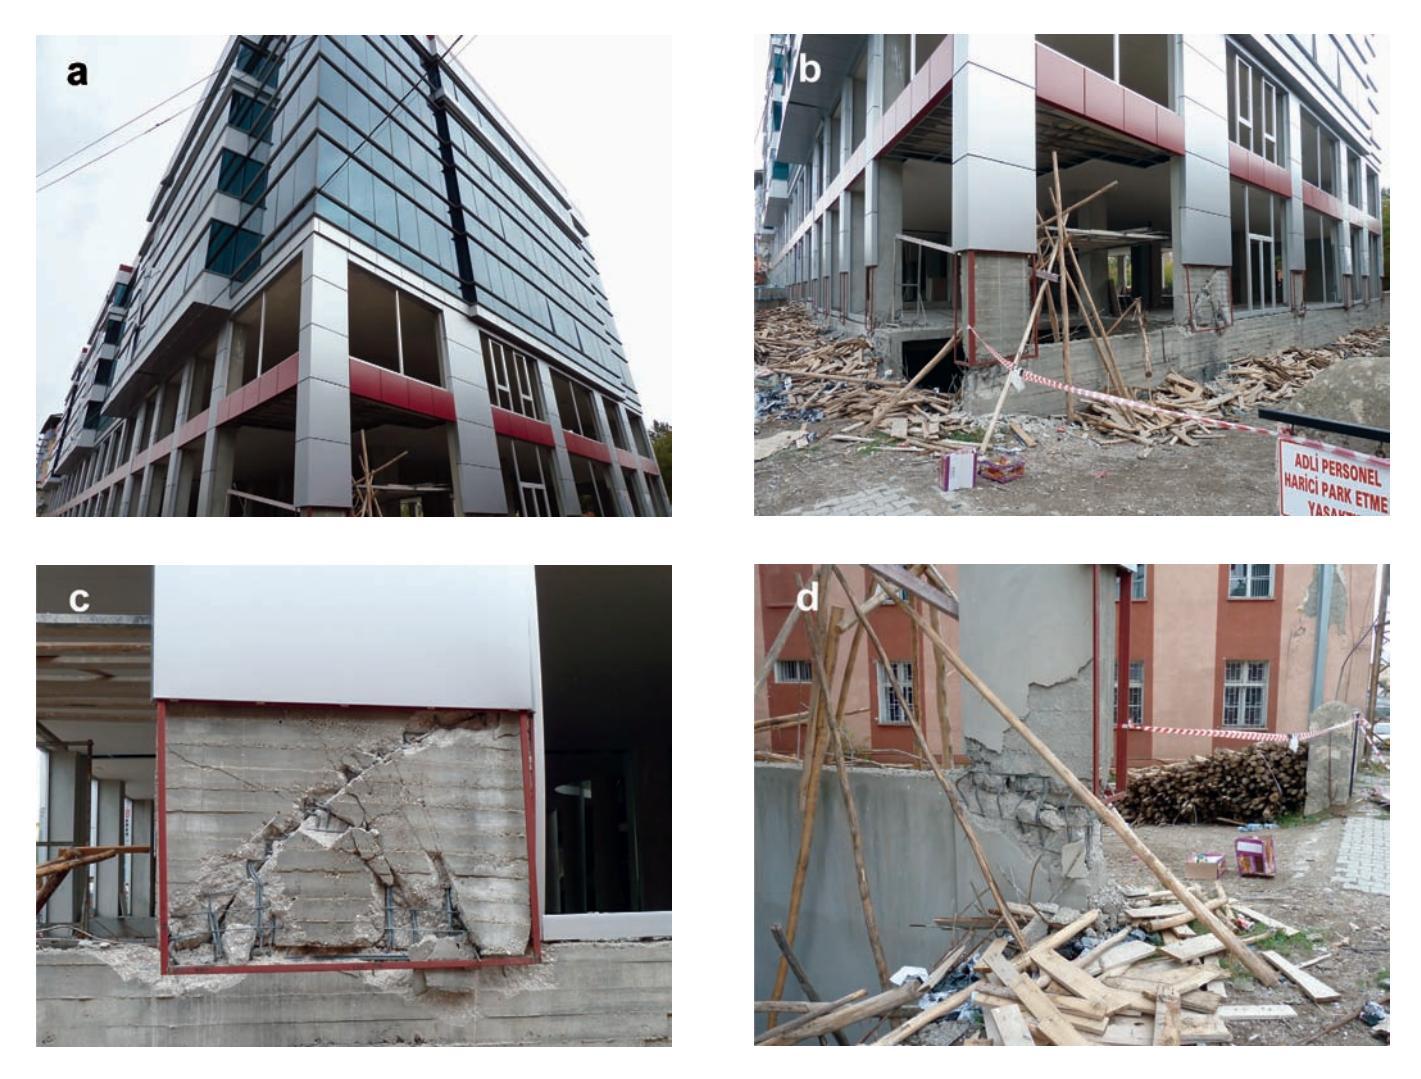
Fig. 29a-d. A just erected building with acceptable reinforcement detailing. The majority of the columns in the ground floor suffered mainly compression damages. There are no noticeable horizontal displacements.

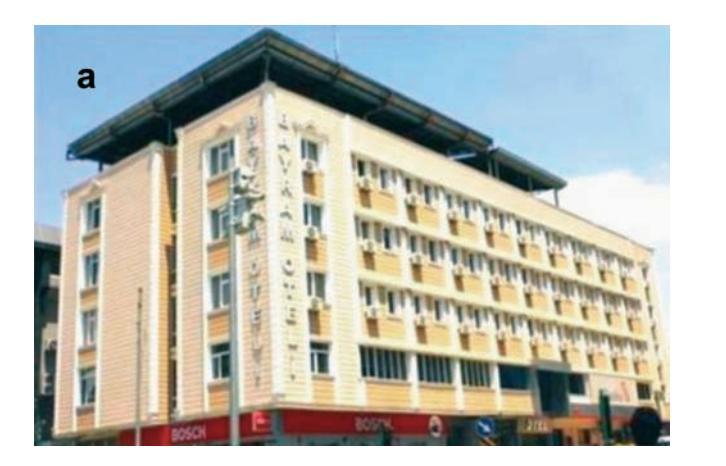
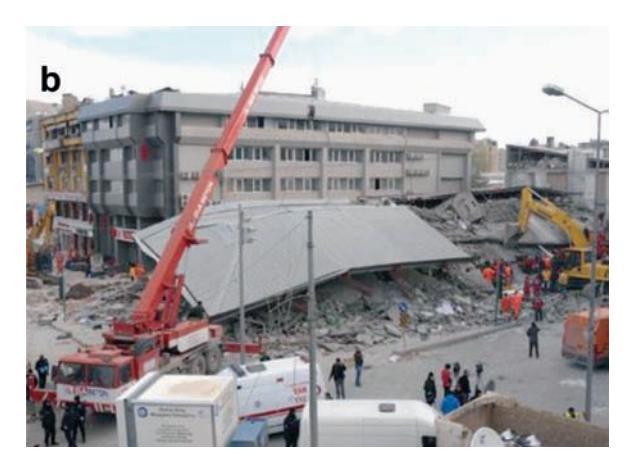
- 5. The collapse of Bayram Hotel, as it is shown in the relevant picture, took place almost within its foundation plan. This is a typical characteristic of the effect of a strong vertical seismic component, a parameter dominating in epicentral regions of shallow focus earthquakes. The structure was optically inspected by Prof. Carydis following widely acceptable rules applied to more than 15.000 buildings already inspected by himself. He found the building safe. He found that the building is above average from an earthquake engineering point of view, possessing rather large cross sections of columns in a rather dense grid, with strong beam to column joints, a symmetry in plan and without any damage to the load bearing elements

Fig. 30. a) The free standing Bayram Hotel before the earthquake and after the addition of a floor with a light weight roof. b) The collapsed roof is covering the plan, of the collapsed building in a parallel way to the pavements.
