The 15/Oct/2013 M7.1 Bohol Earthquake (Philippines)

Stéphane Baize (<u>stephane.baize@irsn.fr</u>), Marc Cushing, Sébastien Hok Institut de Radioprotection et Sûreté Nucléaire, France *Updated 24.10.2013*

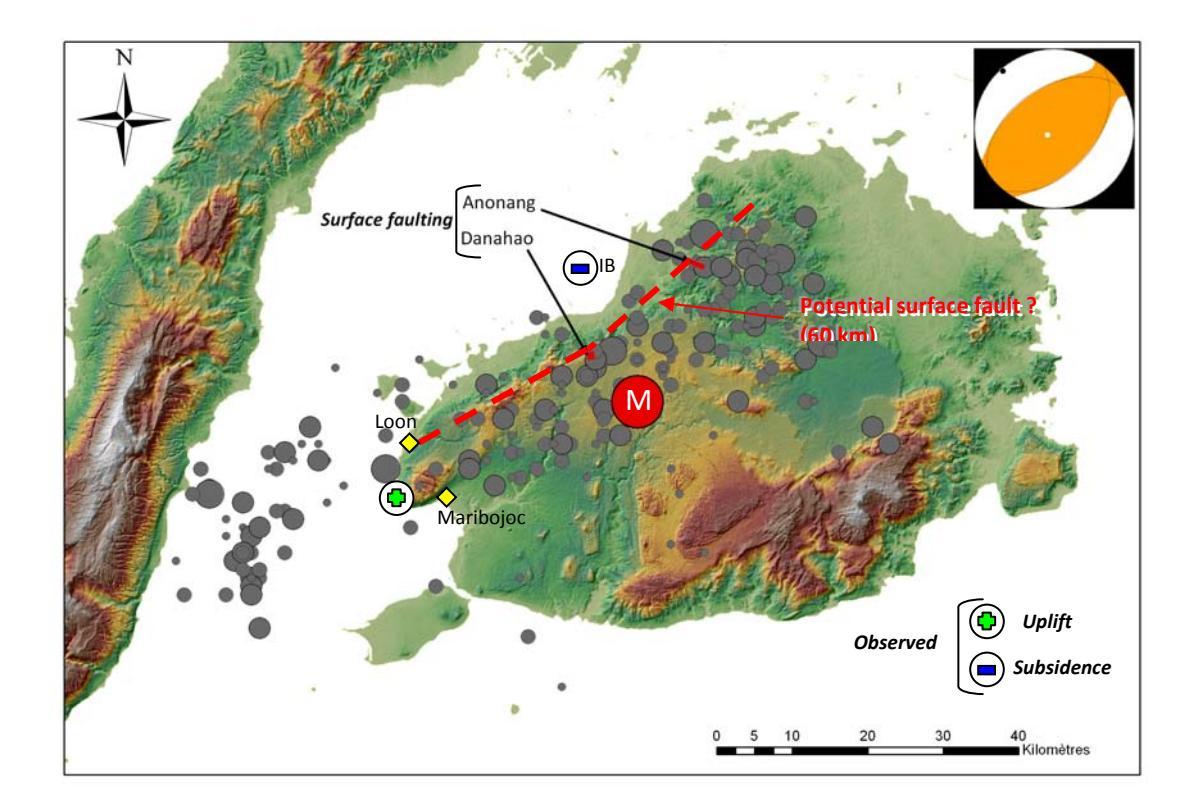
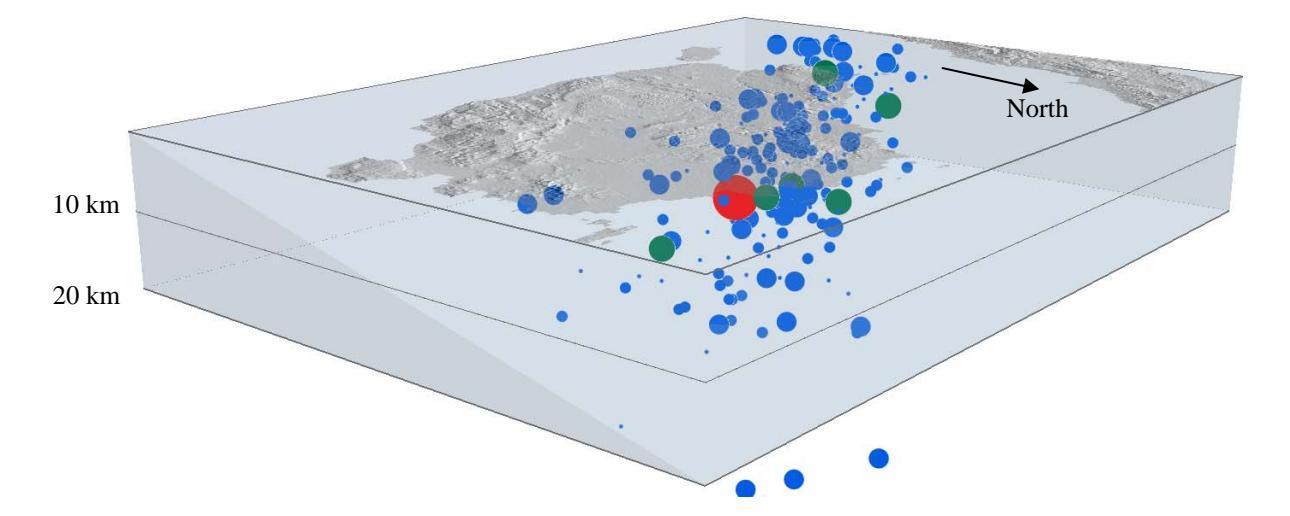
However, the aftershocks tend to extend from the epicentre towards the north, not towards the south and the East Bohol fault. The post-seismic field observations indicate that a previously unknown fault is the source of the event, running inland all along the NW coastline (Figures 13 and 14).

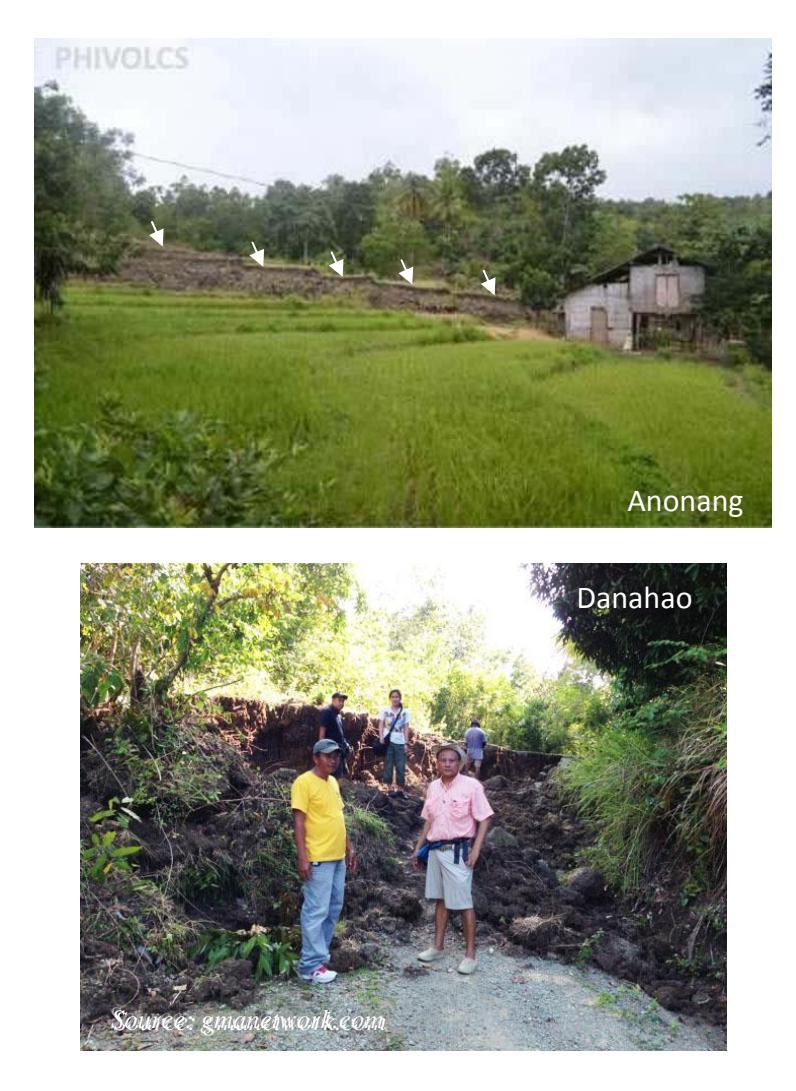
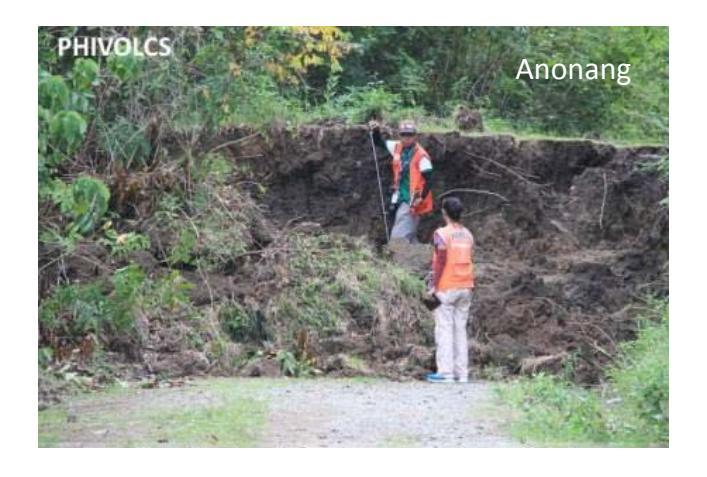
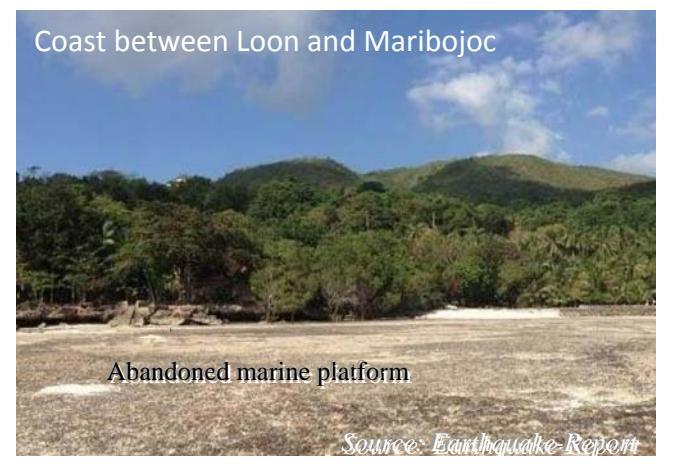
Figure 14: Several pictures of the surface deformations in the Bohol Island (location of sites on Figure 13).

Surface faulting has been observed along the northern coastline of the island, at Anonang and Danahao, in the northern part of the aftershocks' box (Figures 13 and 14). According to the PHIVOLCS geologists (Press reports), the vertical separation across the fault reaches 3 m and the fault uplifted the southern block. In addition, they indicate that the fault trace was tracked over at least 5 km. Another direct environmental effect of coseismic faulting is the off-fault uplift and subsidence of some parts of the island. According to the Earthquake Report site (witness reporting), the Batasan Island (7 km off the coast of Inabanga; Figure 4) is experiencing subsidence, whereas the coast between Loon and Maribojoc is retreating (uplift).

At Anonang and Danahao, the fault scarp was observed by PHIVOLCS geologists. Note the anthropic terrace risers that could help in estimating the horizontal component of slip. Between Loon and Maribojoc, the shoreline retreated, exposing the

marine platform.

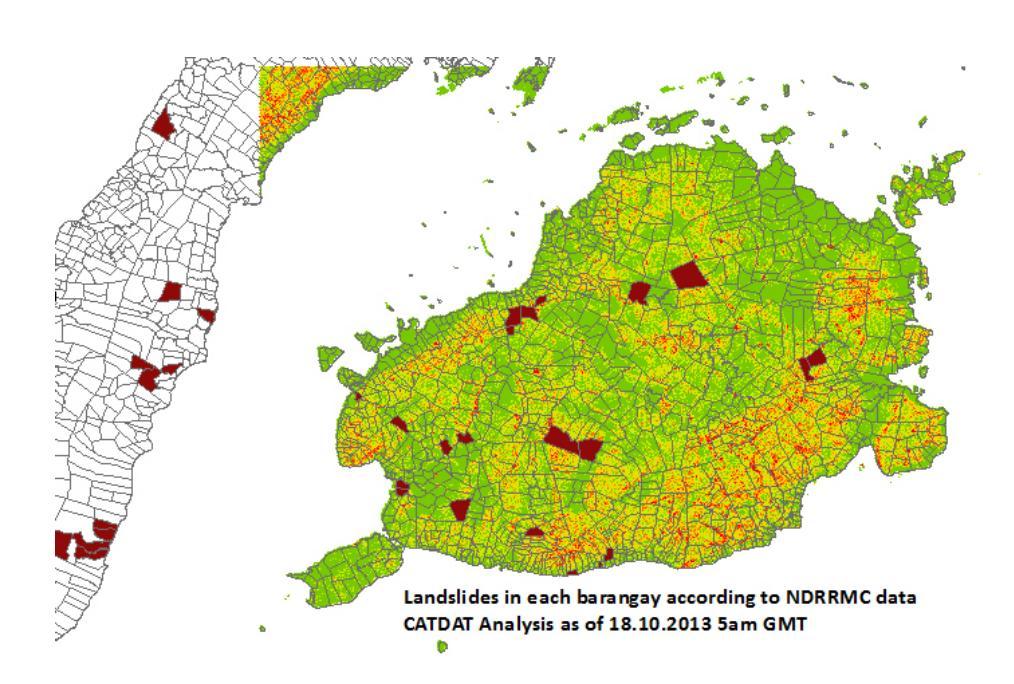
Figure 15: Map of landslides (source: Erathquake report, according to NDRRMC data) and examples of rock falls (top) and deep-seated landslide in the Chocolate Hills (bottom).

Secondary effects are also reported. The Mw=7.2 earthquake triggered many superficial landslides and block falls all over the Bohol and Cebu islands, especially affecting the coneshaped Chocolate Hills. As illustrated on Figure 15, some of the landslides are deep-seated in the Chocolate Hills' rock and involve relatively large volumes. Liquefaction has also been described (Figure 16), with a limited extent as indicated on the susceptibility map (see hereafter, Figure 18). Other effects like settlement, lateral spreading or maybe sinkhole collapse have occurred (Figure 16).

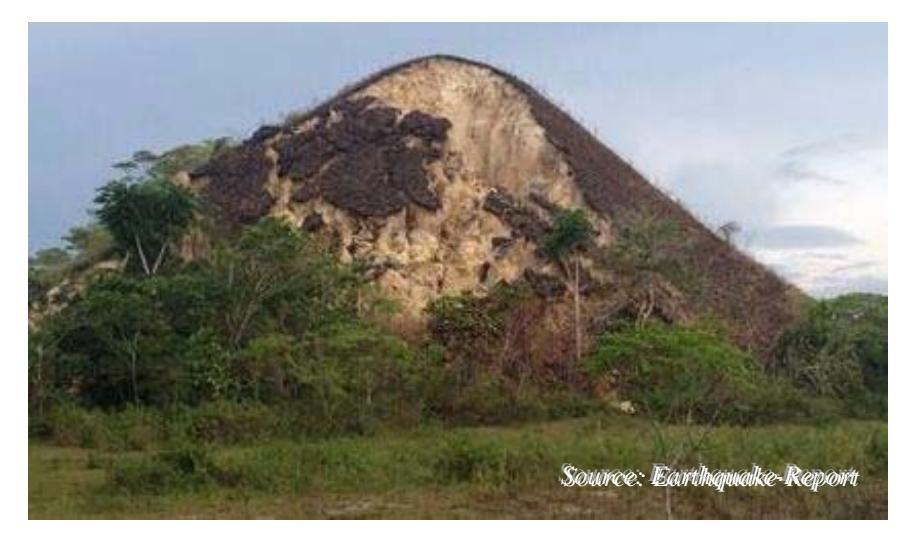
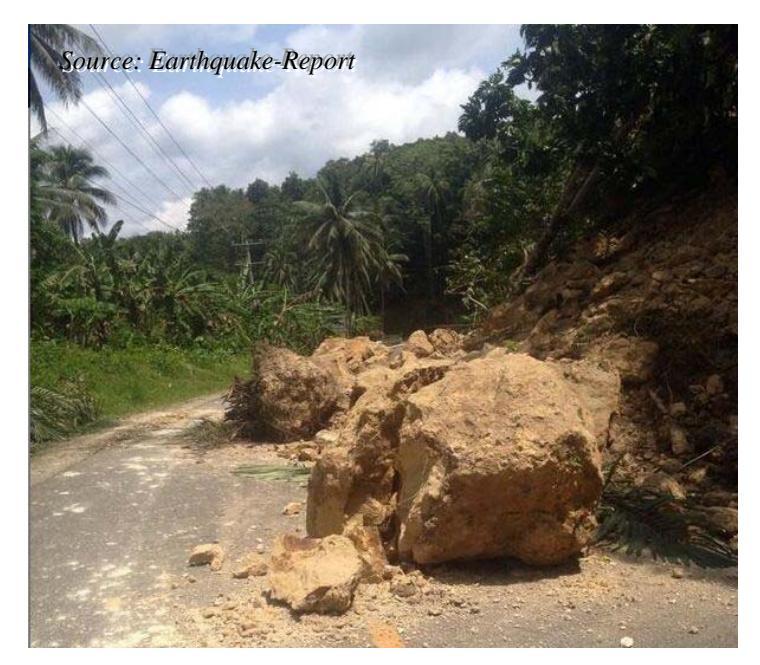
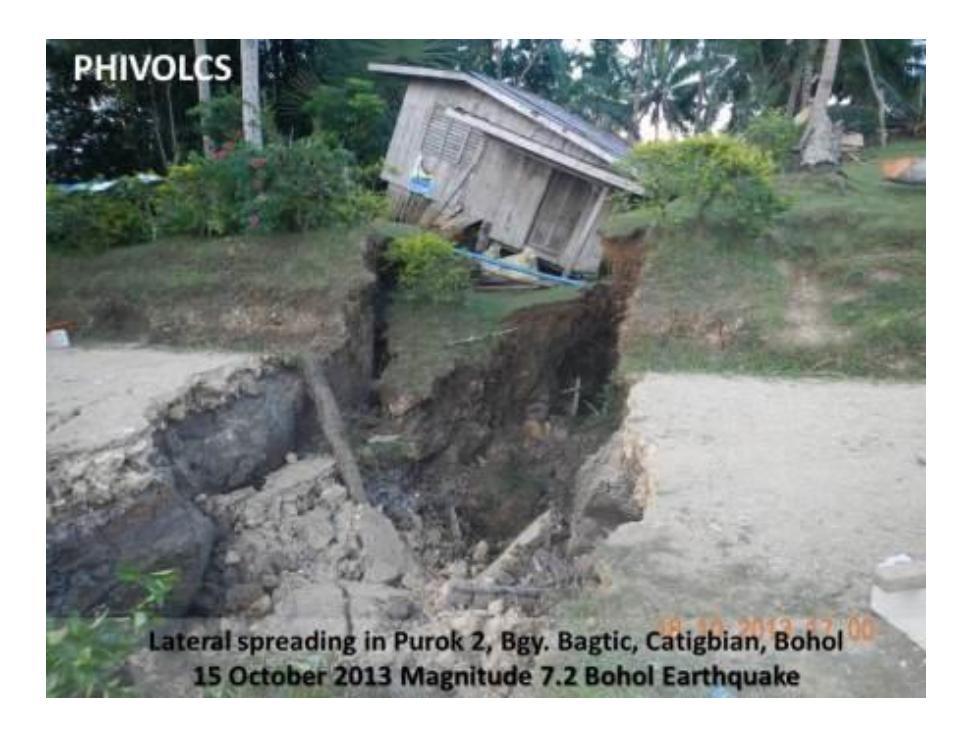
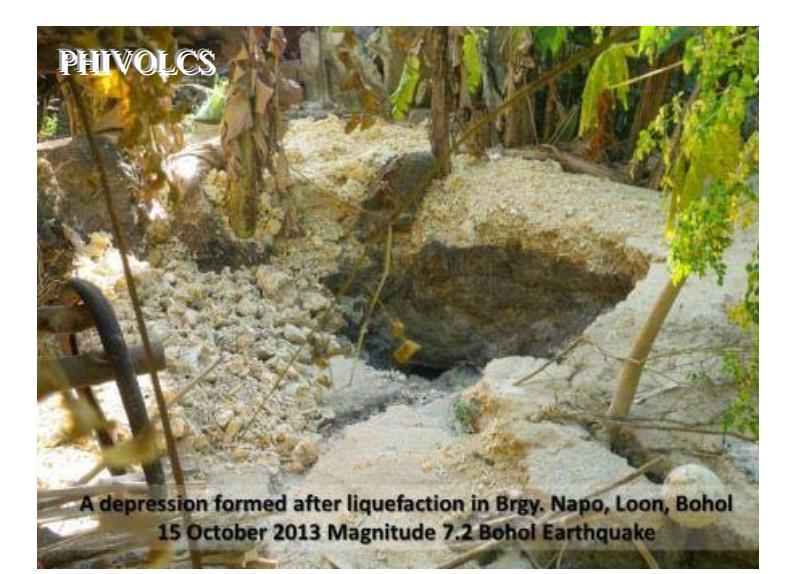
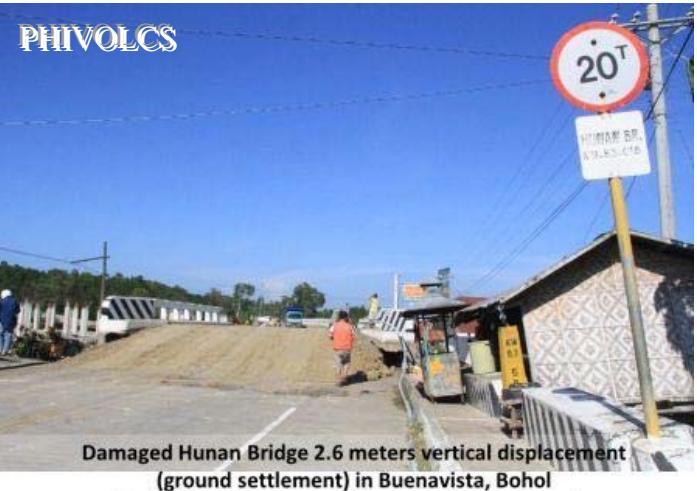
Figure 16: Some other secondary effects (liquefaction, settlement, lateral spreading or sinkhole collapse?)

(ground settlement) in Buenavista, Bohol 15 October 2013 Magnitude 7.2 Bohol Earthquake

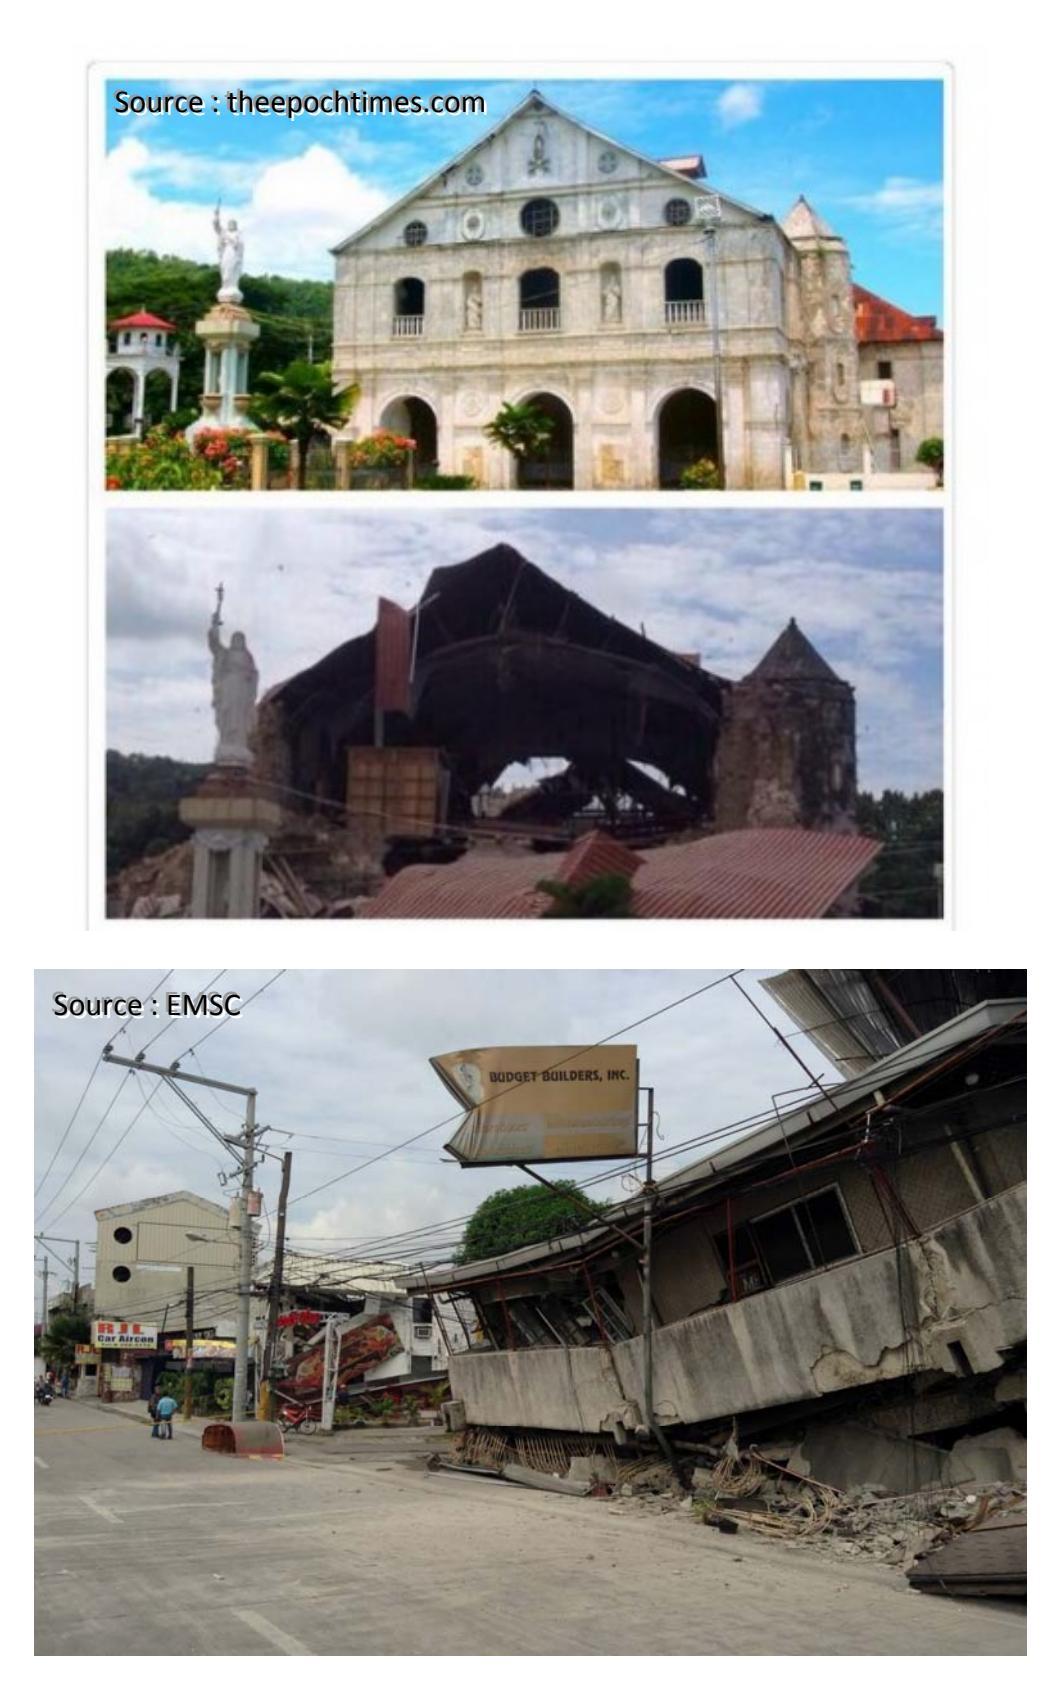
Figure 17: Collapsed church (17th century) in Bohol Island (Loboc) and buildings in Cebu

Many houses (more than 50,000), schools, hospitals and churches were affected or collapsed all over the Bohol Island and the region of Cebu (Figure 17). Airports and seaports of Bohol and Cebu islands also collapsed or were partly damaged. Many roads and bridges were affected, in particular by the numerous landslides. Some of the roads and bridges then became not passable.
