Report

on field survey after May 22, 2012 Pernik earthquake

June 6, 2012

Coseismic geological effects

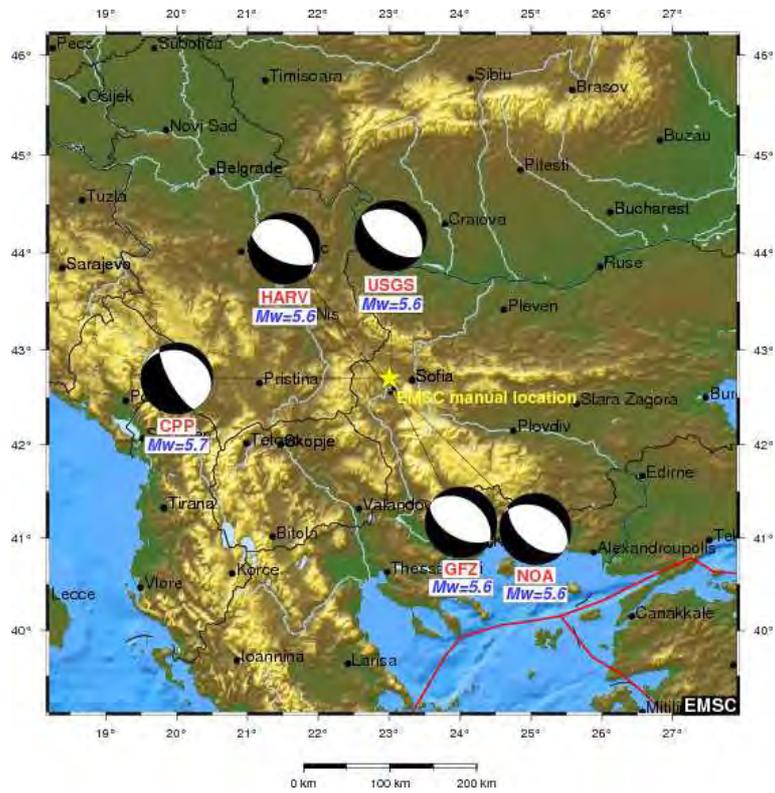
Soon after the earthquake, available focal mechanisms from abroad were similar (figure 1.1). Two suspected fault lines were consistent with a fault plane that has strike=124°, dip=49°, and rake=-104° (USGS focal mechanism). These two fault lines run along the NE borders of the Pernik basin and the Radomir basin (figure 1.2). The strike of the line at Radomir basin is 133°, and the strike of the line at Pernik basin is 128°. EMSC and USGS located the epicenter in the Pernik basin, and NOTSSI-BAS located it very close to the fault line in the Radomir basin.

Figure 1. Focal mechanisms of the May 22, 2012 Pernik earthquake. Source EMSC (<http://www.emsc-csem.org/>)

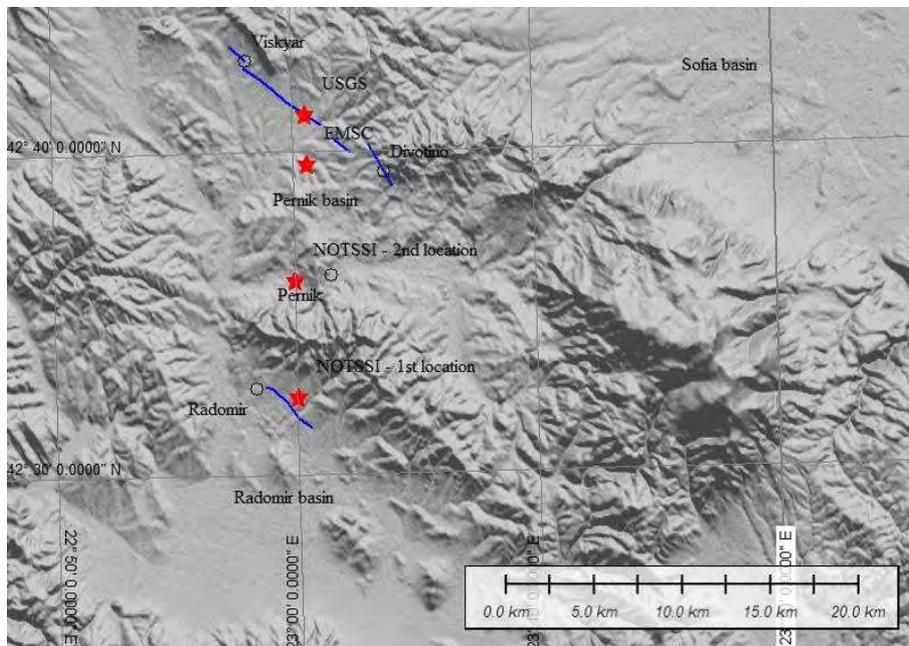
We visited the area of Radomir on the day of earthquake. Degraded scarps in a floodplain and alluvial fans were identified along the suspected fault line. However, we did not observe any fresh ground cracks or other coseismic effects that might be related to the earthquake in the night. After field work finished, we saw that the NOTSSI-BAS had shifted the epicenter in the Pernik basin. Strong rain started in the afternoon and continued next days. Rain destroyed very important occurrences on the ground surface.

Figure 2. Different estimates of the May 22, 2012 epicenter (red stars) and visited suspected fault lines (blue lines).
