PRELIMINARY REPORT

VAN EARTHQUAKE - TURKEY (Mw 7.2 - 23 OCT 2011)

The October 23 ($M_W = 7.2$) and November 9 ($M_W = 5.7$), 2011 Van, Turkey earthquakes. A geoscientific and engineering report

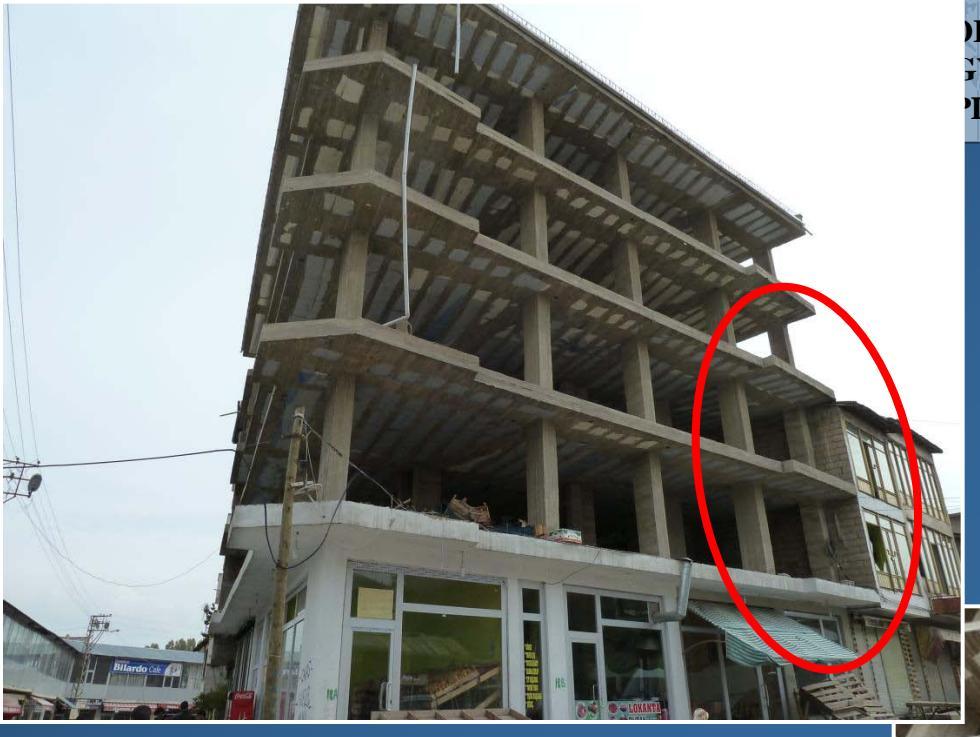
Flexible structures, without shear walls, with rather large openings and with a flatslab construction system are dominating among the modern structures. Nevertheless, not any eminent horizontal motion or impact was noticeable between adjacent buildings.

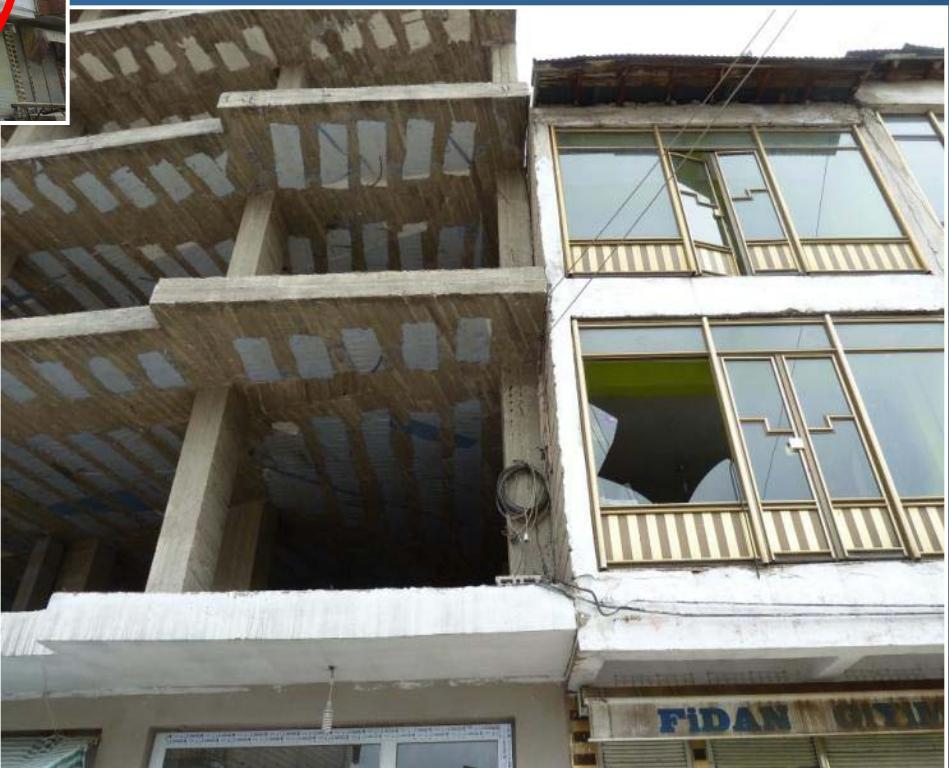
Flexible structures. In general, no shear walls are used.

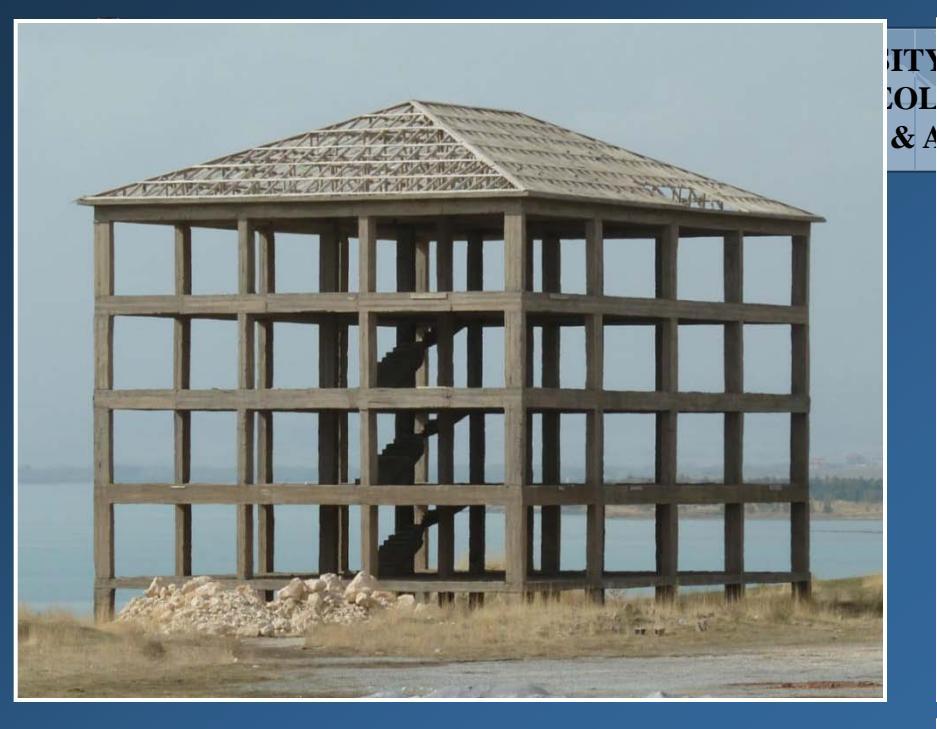
Flat-slab construction. In some cases stronger beams around the perimeter are used.

Usually, one or two stories at the top are added. In general, a light weight and flexible roofing system is used. Partitions out of hollow bricks or hollow concrete blocks are used. Usually, the balconies are externally closed with masonry and other secondary elements.

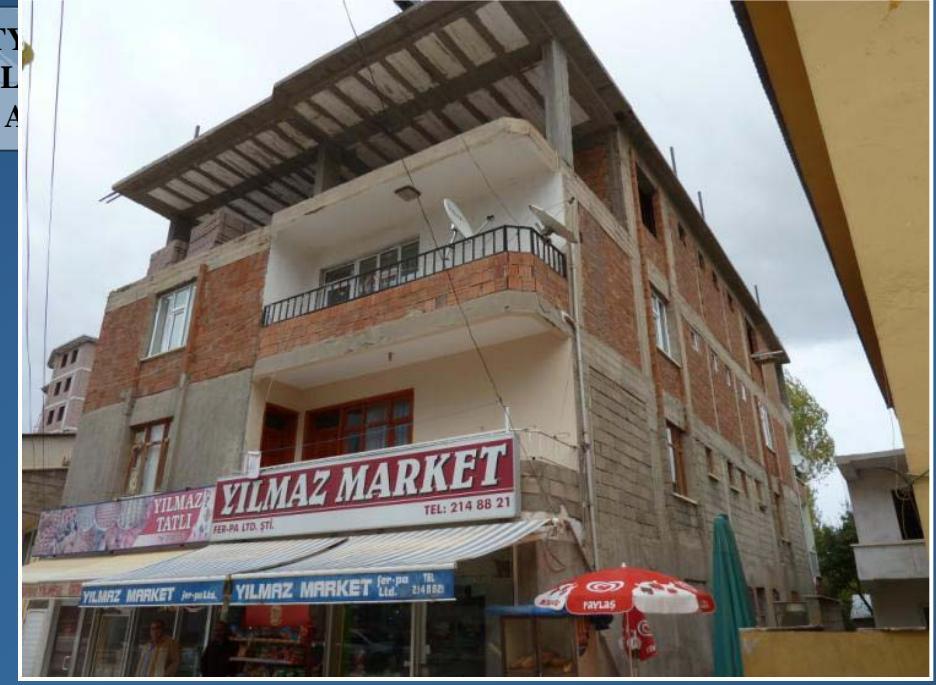
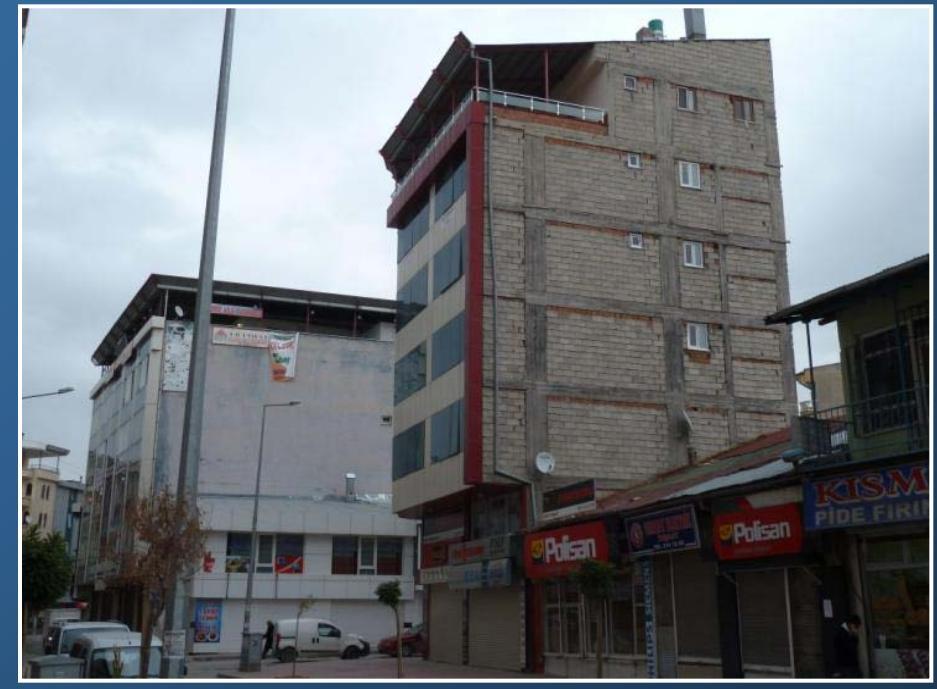
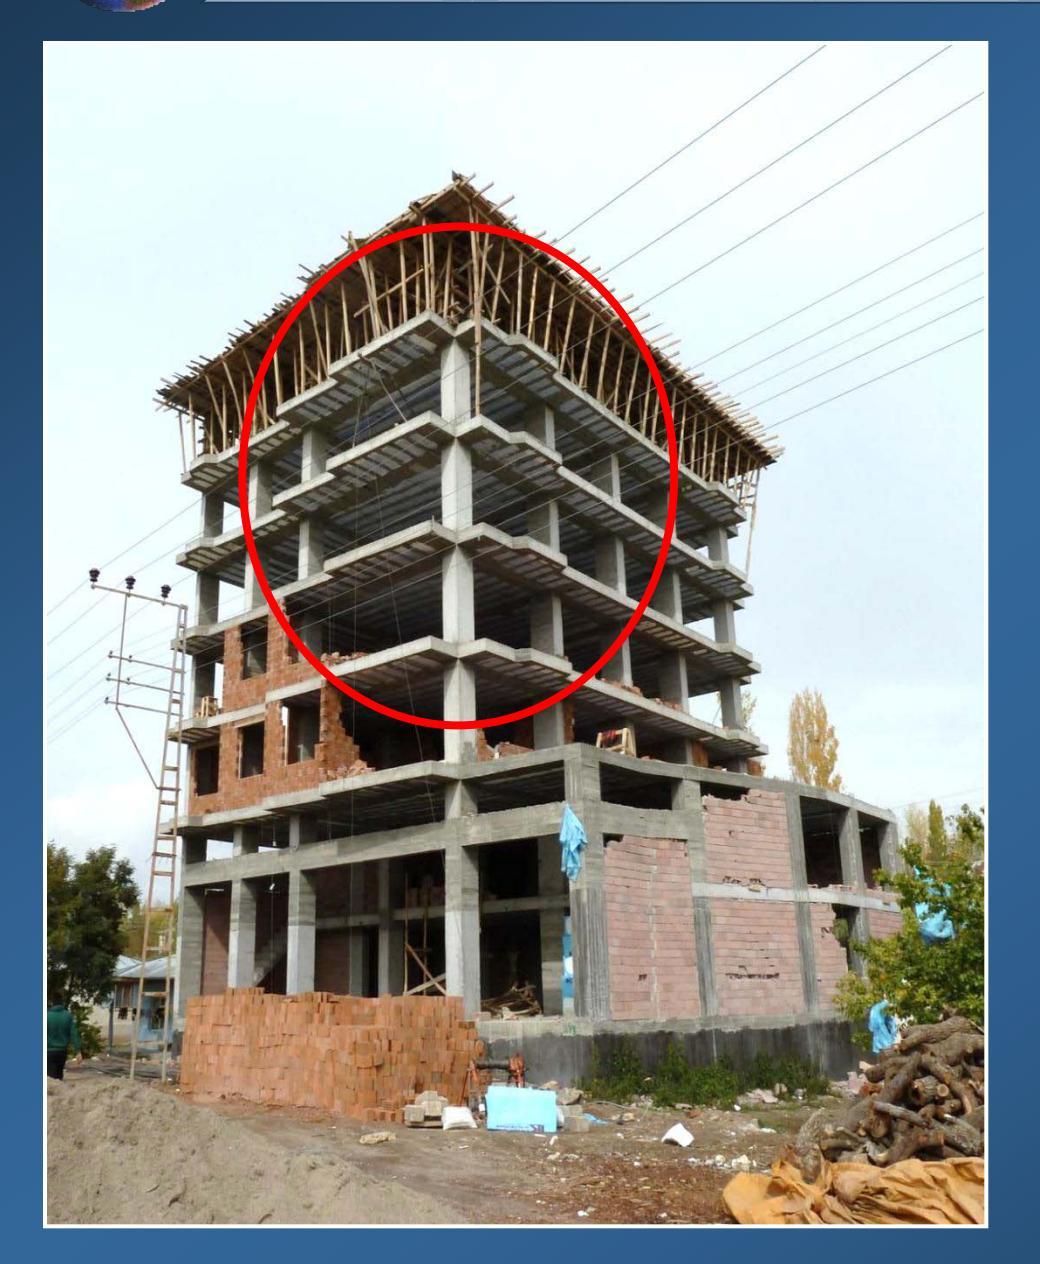
Another typical constructional example of flexible modern multistoried buildings. The brick wall partitions do not present considerable movement or crosswise cracks. Instead, crashing of layers of bricks at the lower stories is observed. Due to the strong vertical seismic component crashing of reinforced

concrete columns at the base is observed. The recorded toppling, and various modes of building failure may be attributed to this parameter.

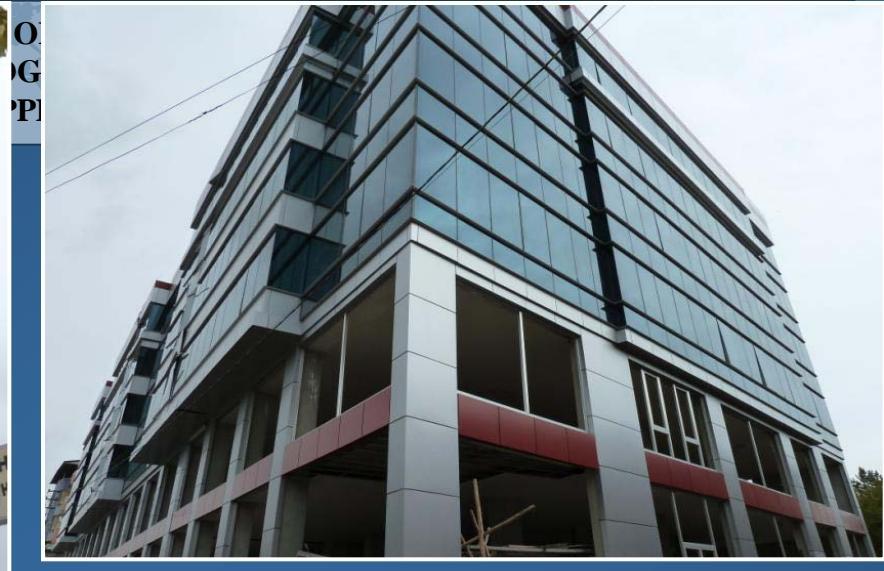
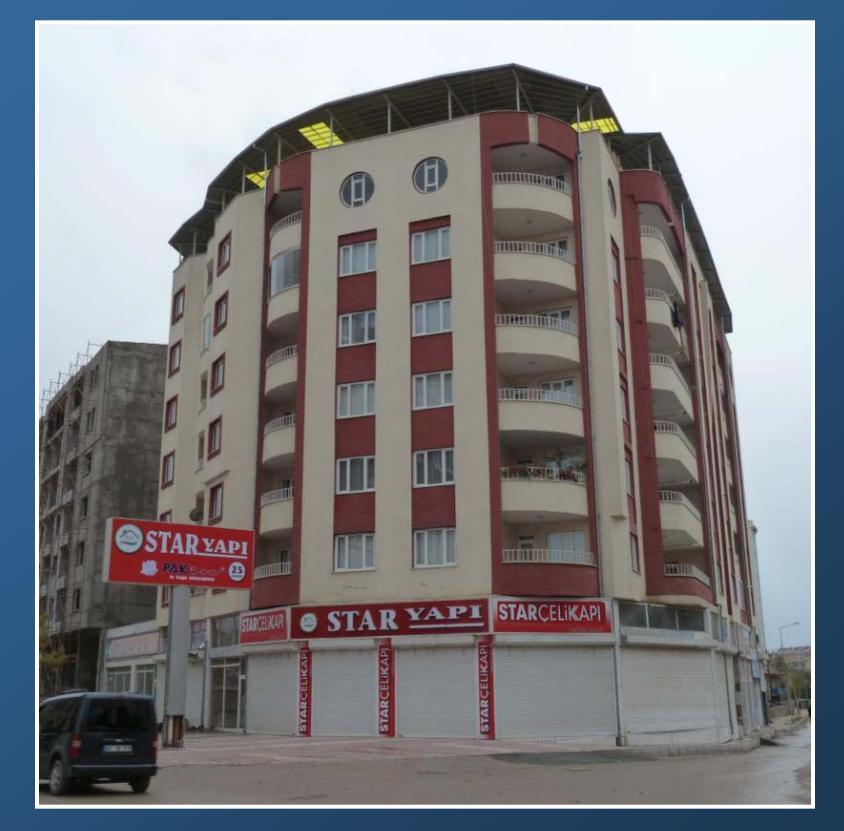
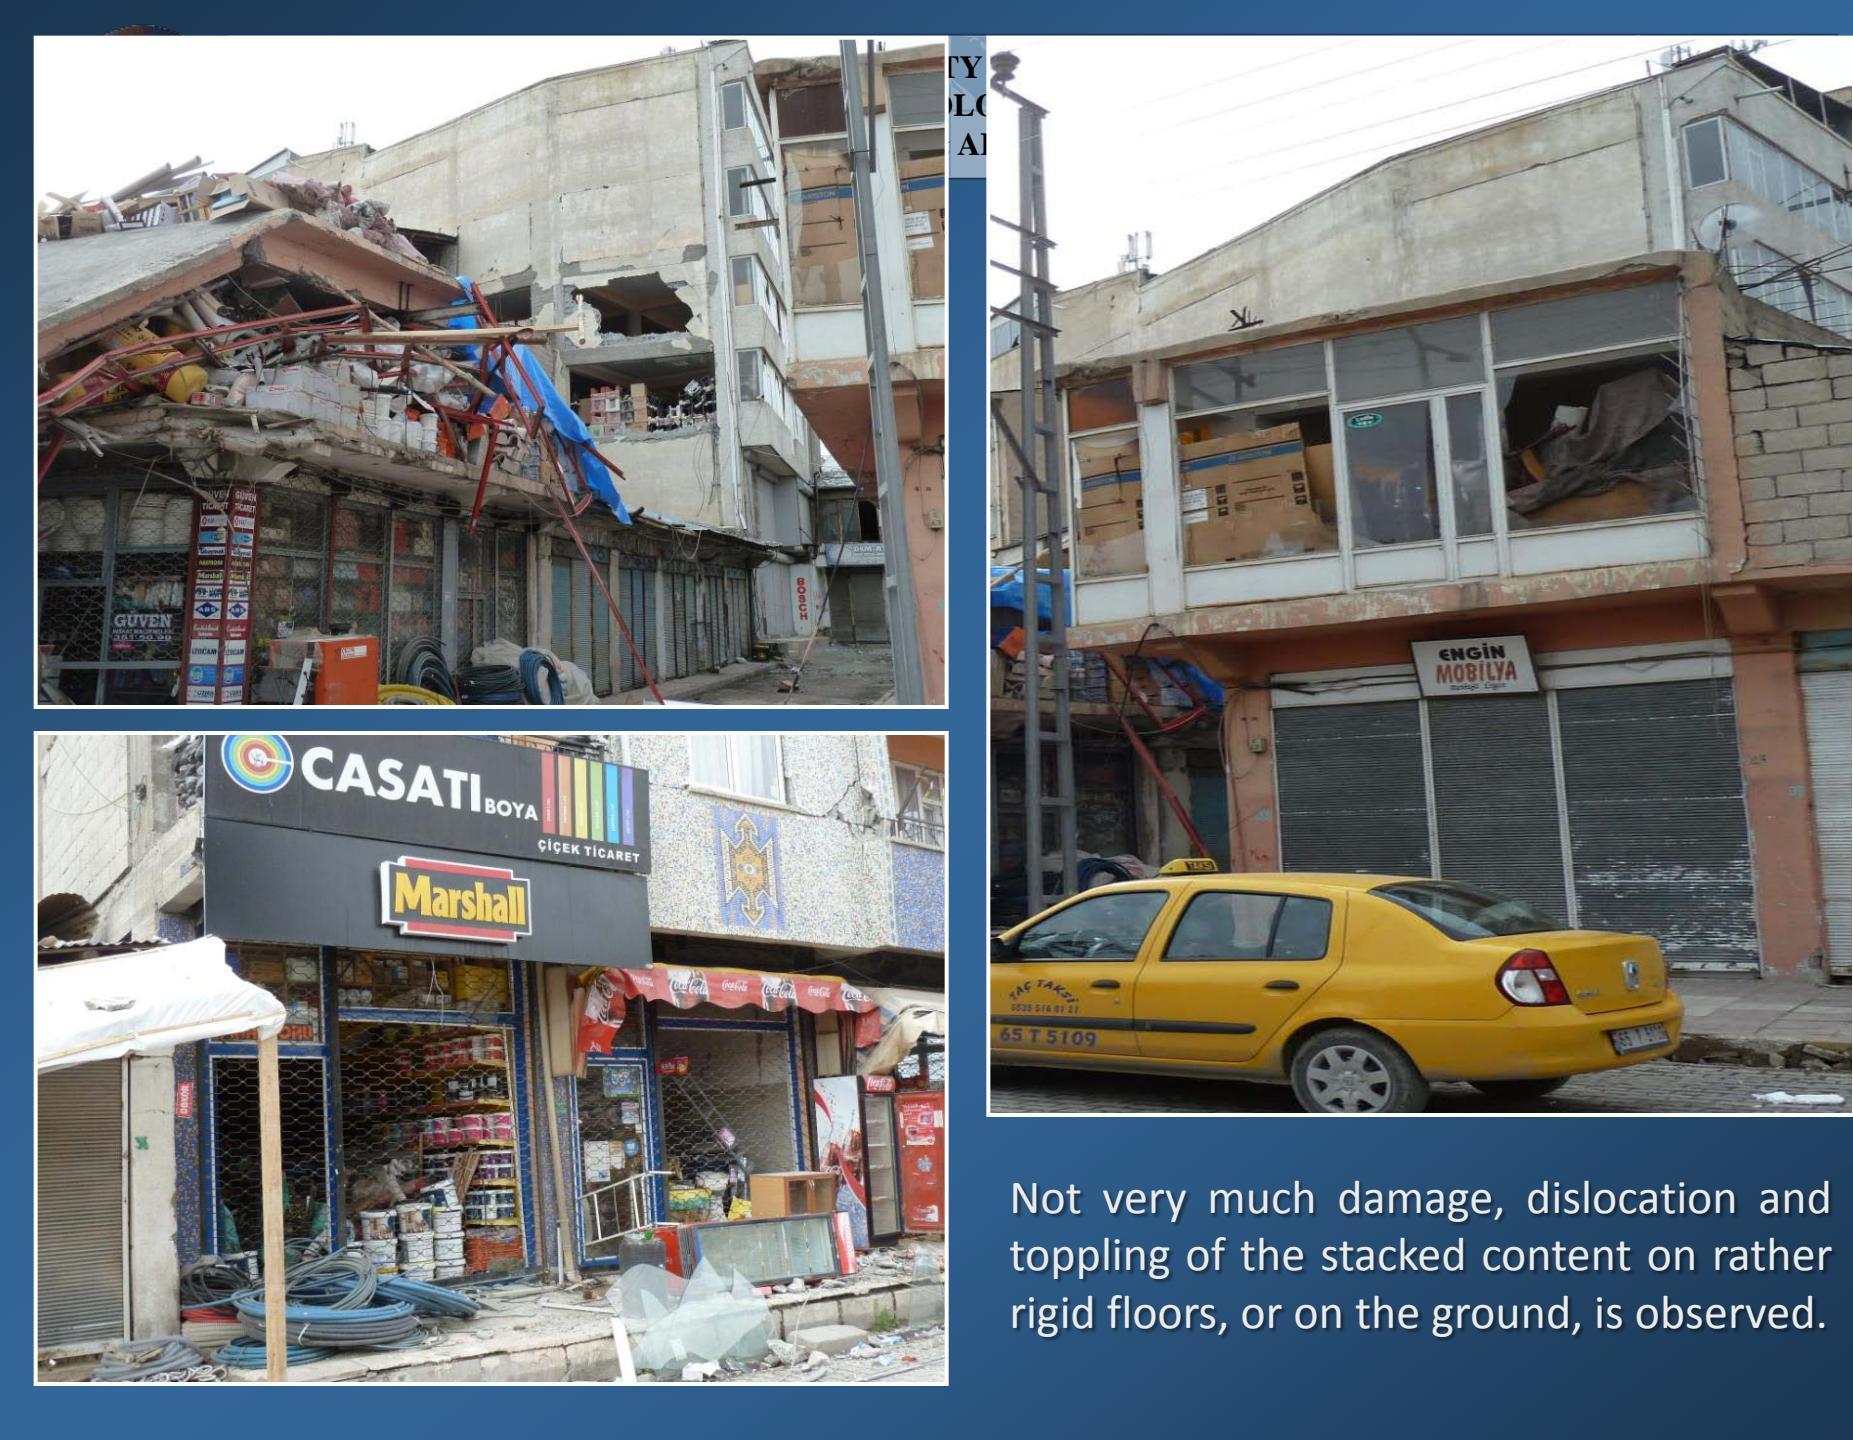
In the most of the cases the secondary elements are undamaged either all over the height of the building, or above the lower few stories. This indicates that in despite of the pronounced flexibility of the load bearing structural system, noticeable horizontal displacements are not developed.

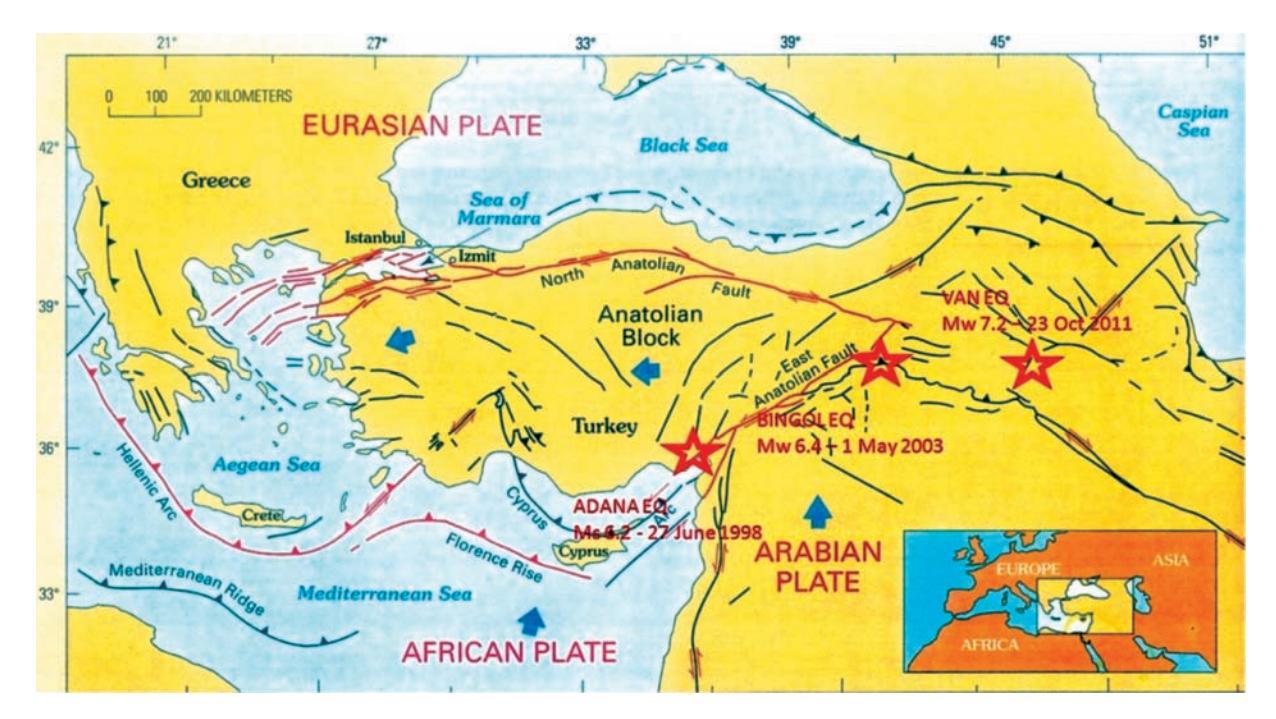
Fig. 1. Geotectonic Map of the area and the epicenters of the main catastrophic earthquakes of the last 15 years at the front of the Arabian Plate.

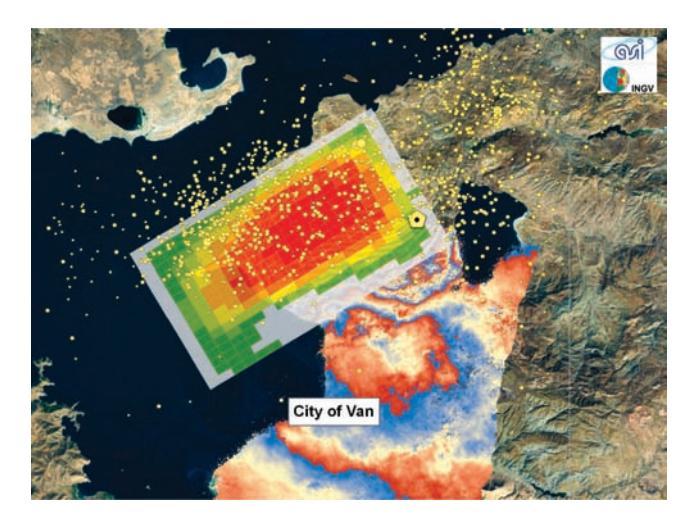
Fig. 3. Surface projection of the North-dipping source modeled from the COSMO InSAR ground displacements. Also shown: seismicity and wrapped interferogram, after /10/.

The seismic activity of October 23^{rd} 2011 (Mw = 7.2), based on seismological and interferometry data, /10/, resulted from a fault of NEE-SWW direction, located 25-30 km north of Van and 35-40 km south of Ercis city. The outcrop of the fault, based on field observations, had a visible length of approximately 300 m and it crossed the main road of Van-Ercis. After consideration of all the data it can be concluded that this fault is a reverse fault of N80E direction and 70° dip, with the north block being the hanging wall, Fig. 3.

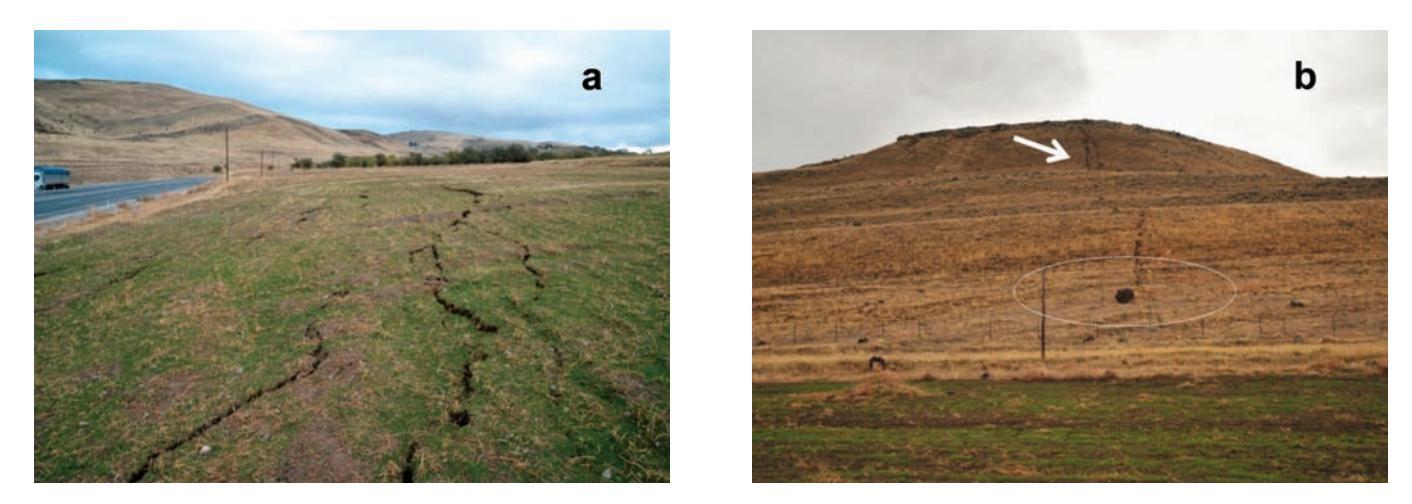
Fig. 4. (a) Landslides and (b) rockfalls at the north of the epicentral area (hanging wall).

This conclusion is in accordance with the macroscopic results and mainly with the fact that the greatest damage is observed at the north uplifting block in the area of Ercis and not at the south block in the area of Van. Maximum intensities were observed at the north block and were at least 2 degrees (EMS-1998) greater than in the south block. It is characteristic that in the city of Van, during the earthquake of October 23rd 2011 a rather small number of multistoried buildings with load-bearing structure of reinforced concrete collapsed, whereas in the city of Ercis, where similar geotechnical conditions exist, hundreds of similar multistoried buildings collapsed. Moreover, the extensive damage in the city of Ercis may be interpreted as a combination of adverse soil dynamic conditions and the reflection of the seismic waves at the rock basement. Finally, several landslides and rockfalls were observed at the north block, whereas at the south block they are absent, Fig. 4.

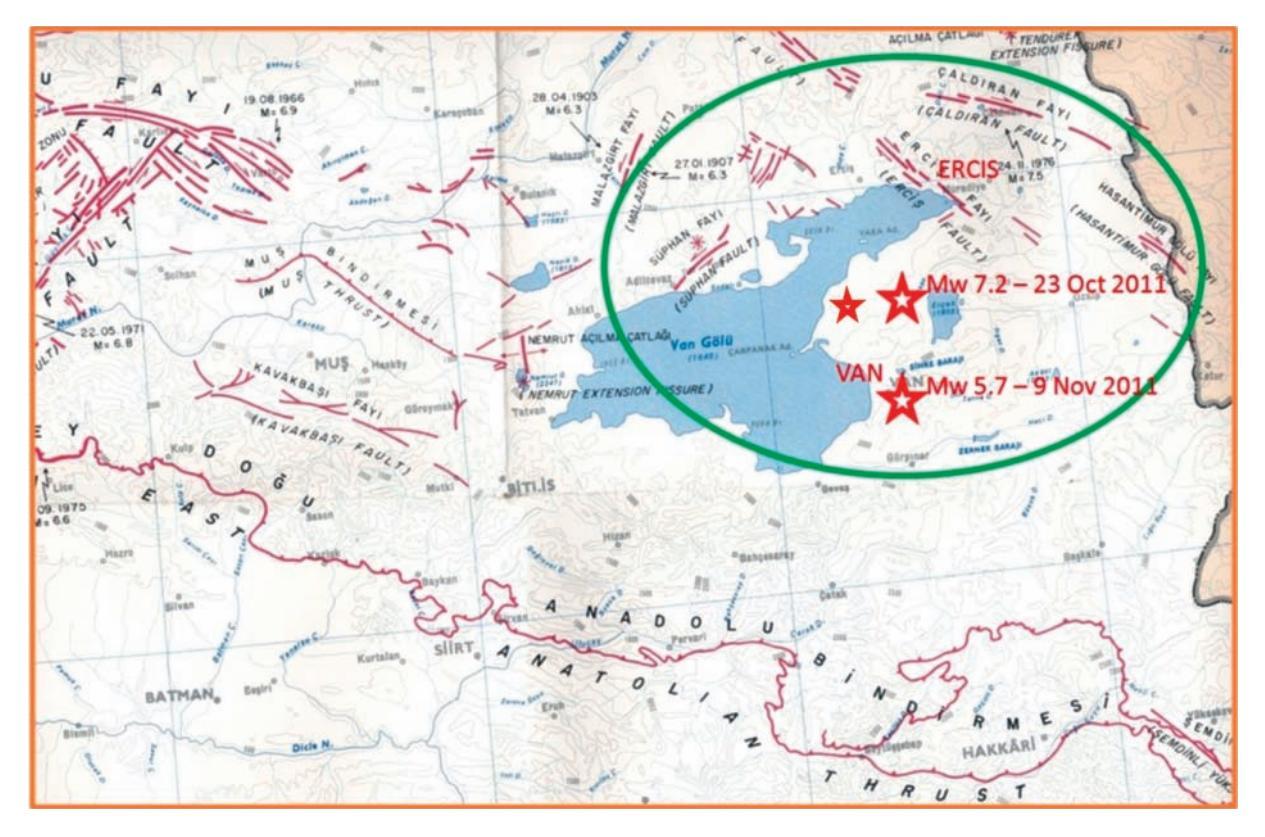
Fig. 5. The wider area of Van-Ercis and the epicenters of the two recent catastrophic earthquakes. With a smaller asterisk an aftershock of $M_L = 4.6$, 21 November 2011 is also shown. Respectively ground motion records are commented in section 3.

The second major seismic event of November 9th 2011 ($M_w = 5.7$), took place after the activation of the strike slip fault between the city of Van and Erçek Lake. This fault has a general NE-SW direction, along which characteristic pop-up and pop-down structures occur and crosses under the city of Van. The activation of the fault resulted in damage that was observed only in the city of Van and not further north, in contrast to the earthquake of October 23rd 2011, Fig. 5.

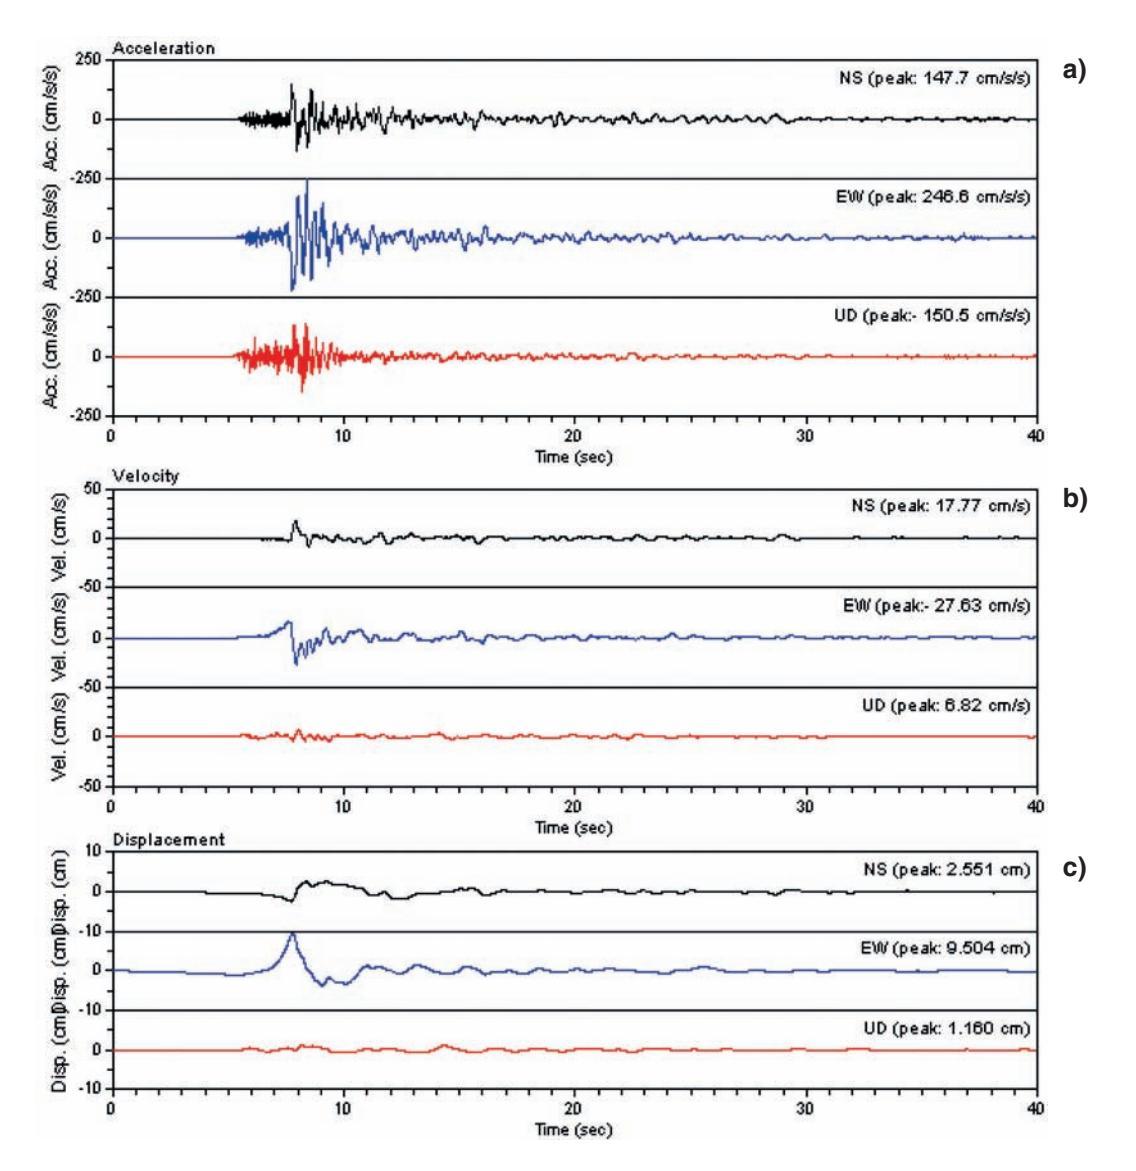
It is interesting to mention here that the peak acceleration of NS component reaches the value of 147.7 cmsec⁻², that of EW component 246.6 cmsec⁻² and that of the vertical component 150.5 cmsec⁻². The duration

Fig. 6. Corrected acceleration (a), velocity (b) and displacement (c), time histories for the $M_W = 5.7$, 9 November 2011, 21.23, LT event recorded in Van.

of the strong phase is of the order of 2.5 sec. The ratio of the peak acceleration values along NS is: V/A = 1.02and along EW is: V/A = 0.61. Both values differ from the commonly accepted V/A = 0.7, recommended by many codes. Nevertheless, one would expect much higher acceleration values of the ground motion and especially along the vertical component since the accelerograph is installed in the epicentral region of this specific earthquake.

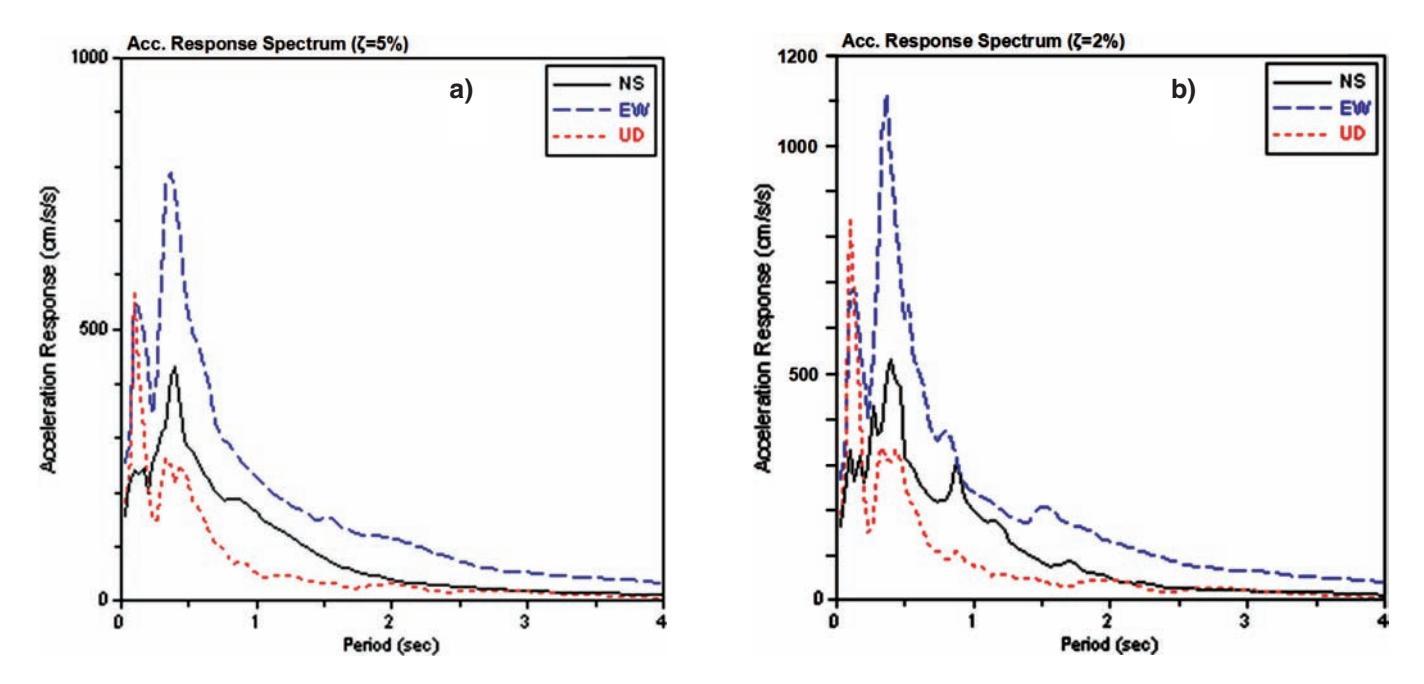
Fig. 7. Acceleration response spectra for the $M_w = 5.7$, 9 November 2011 event recorded in Van, for ζ : (a) 5% and (b) 2%.

The shapes of the acceleration response spectra are simple, giving peak values at almost the same periods, of about 0.40 sec, for both horizontal components. Along the vertical component the peak corresponds to a period of about 0.10 sec. This may be justified from Fourier amplitude spectra, shown in Fig. 8, where the peak values for the two horizontal components are at around 2.5 Hz and for the vertical one at 10 Hz. It is worth mentioning that for the vertical component, the richer in information Fourier spectrum is almost flat for frequencies from low values up to 10-12 Hz. It is thus confirmed the impact character of the vertical seismic component, which possesses the potential of affecting a wide range of structures and, practically, independently from their natural periods.

comparing the respective peak values in Figs 7a,b. For NS component $\eta = SA_{0.02}/SA_{0.05} = 525/440 = 1.19$; For EW, $\eta = SA_{0.02}/SA_{0.05} = 1100/800 = 1.38$; For UD, $\eta = SA_{0.02}/SA_{0.05} = 840/570 = 1.47$, while the EC-8 code formula for $\zeta = 0.02$ gives damping correction factor $\eta = \sqrt{10/(5+2)} = 1.20$. The higher value of η for the vertical is in agreement with the general opinion that the damping is more efficient for the vertical response of structures rather than for the horizontal one, since the vertical response is rich in higher frequencies.

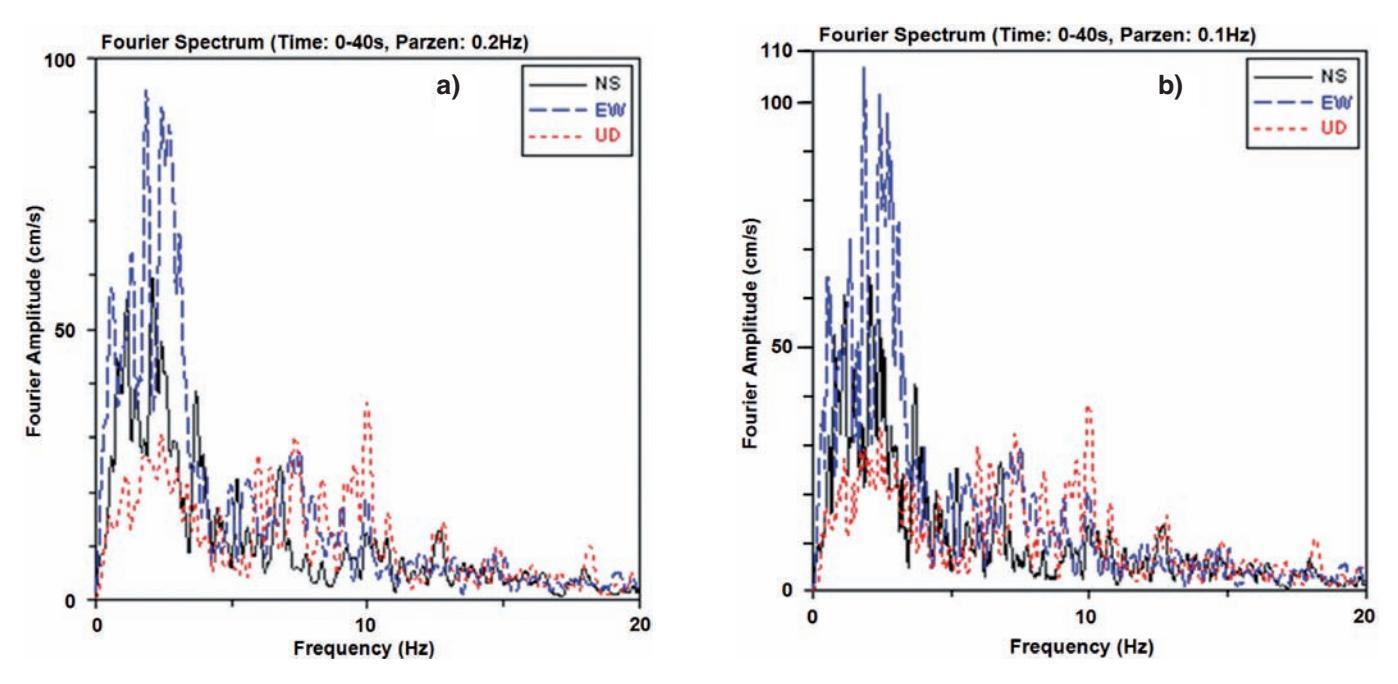
Fig. 8. Fourier velocity spectra for the $M_W = 5.7$, 9 November 2011 event, corresponding to running windows smoothing process with width n: (a) 0.2 Hz and (b) 0.1 Hz.

By comparing Figs. 8a and 8b, almost similar conclusions can be drawn. More specifically, with the decrease of the width of the running window smoothing process from 0.2 Hz (Fig. 8a) to 0.1 Hz (Fig. 8b) the Fourier spectrum of the vertical component is approaching or exceeding that of the two horizontal ones. The lack of acceleration records in the two cities due to main shock results in difficulties for robust conclusions on the explanation of the extensive degree of heavier damage observed in Ercis, compared to Van, although the epicentral distance of Ercis city is much greater than that of Van City.

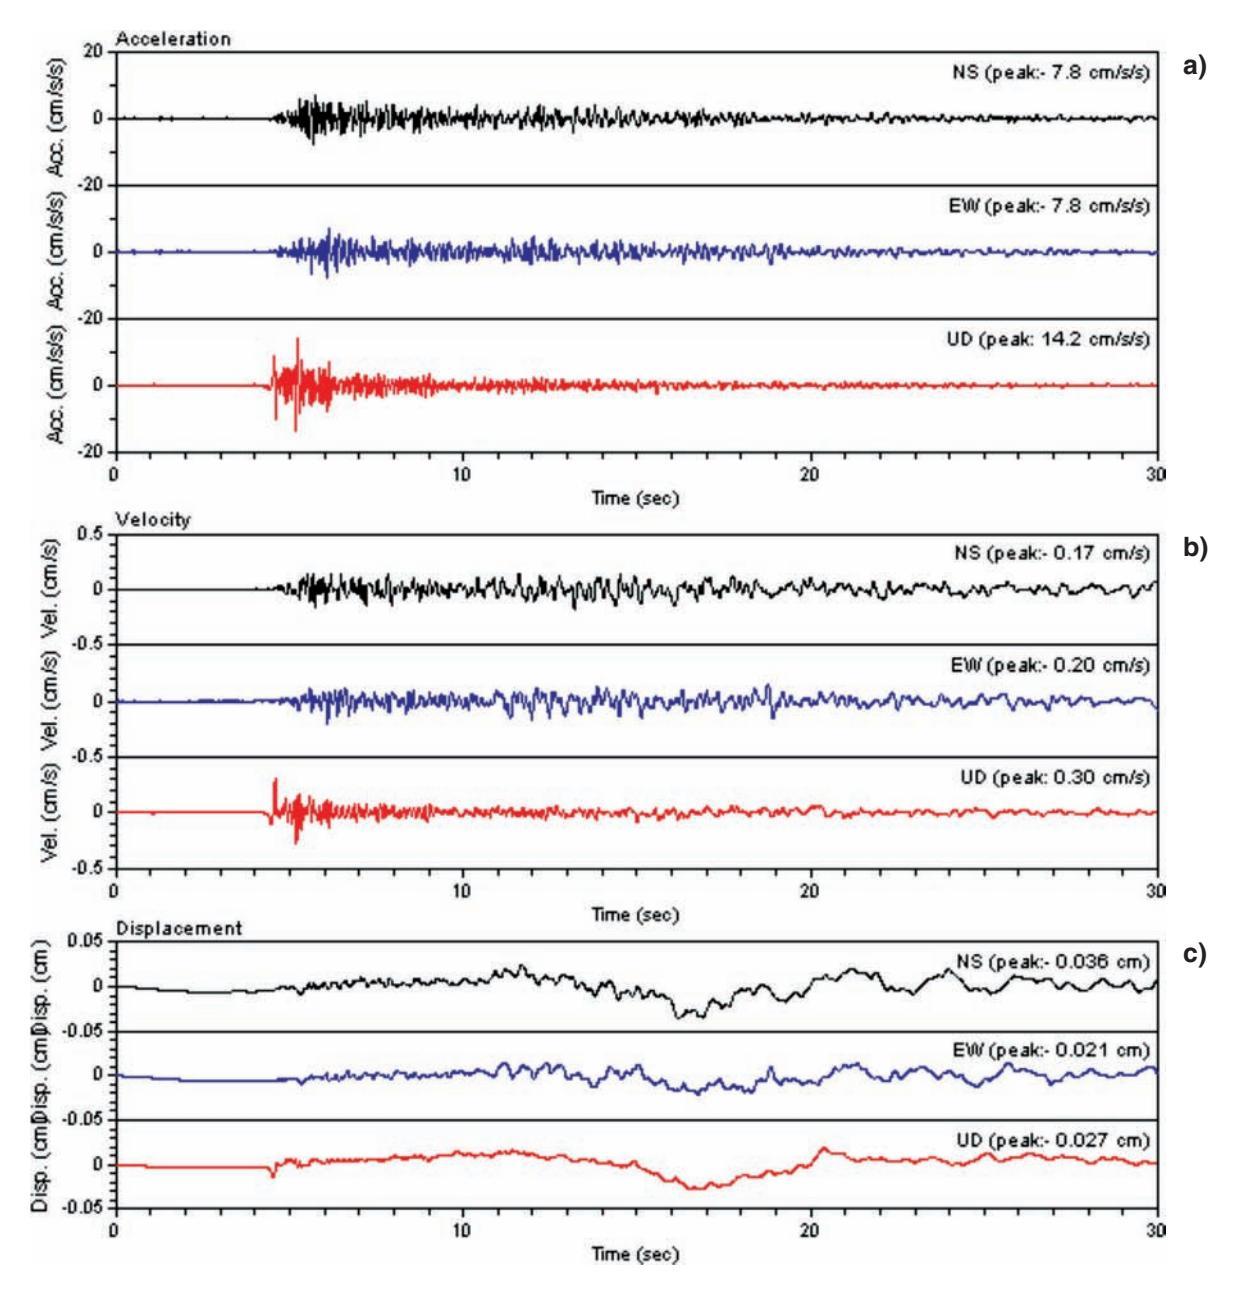
Fig. 9. Corrected acceleration (a), velocity (b) and displacement (c), time histories for the $M_L = 4.6$, 21 November 2011 aftershock, recorded in Ercis. Soil conditions are still unknown. The epicenter is shown in Fig. 5. The epicentral distance is about 39 km.

higher than that of the horizontal ones. An example is given in the corrected records in Fig. 9, at Ercis, located at epicentral distance of about 39 km, the peak acceleration value of the vertical component is 14.2 cmsec⁻² while that of both horizontal components are equal to about the half of it, namely 7.8 cmsec⁻². The peak values for the records at Van (epicentral distance of about 25 km) are 3.0, 3.2 and 2.5 cmsec⁻² for the UD, NS and EW components respectively. The respective corrected waveforms in Van city are shown in Fig. 12. In Figs 10 and 13 the acceleration response spectra and in Figs 11

Nevertheless, considering the waveform pattern in Ercis one may conclude that a possible interpretation of the heavy damage, due to the main shock, may be related to high amplitudes along the vertical component of the ground motion. A possible explanation could be the location of Ercis if we consider as the earthquake fault the one with strike 241 degrees which dips under Ercis. The town is located on the hanging wall, where shaking damage is generally greater and at fault-

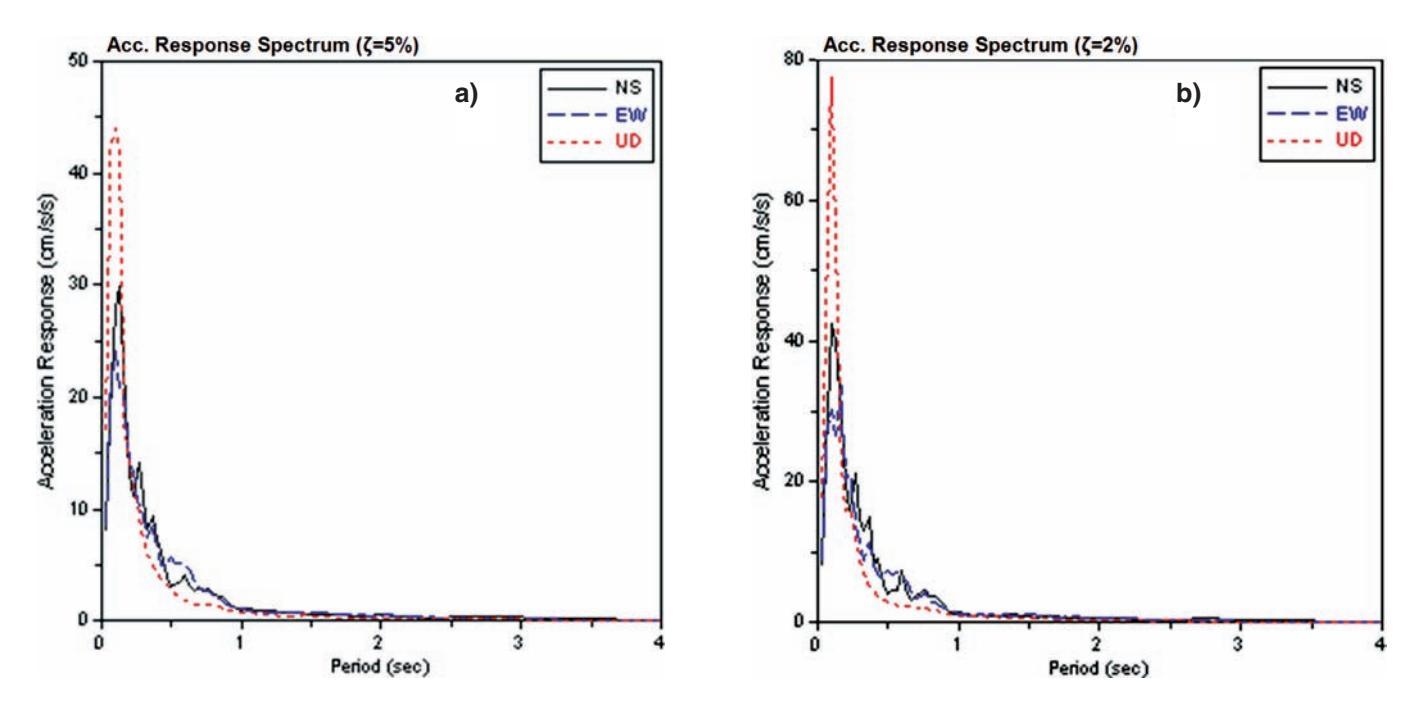
Fig. 10. Acceleration response spectra for the M_L = 4.6, 21 November 2011 aftershock recorded in Ercis for ζ : (a) 5% and (b) 2%.

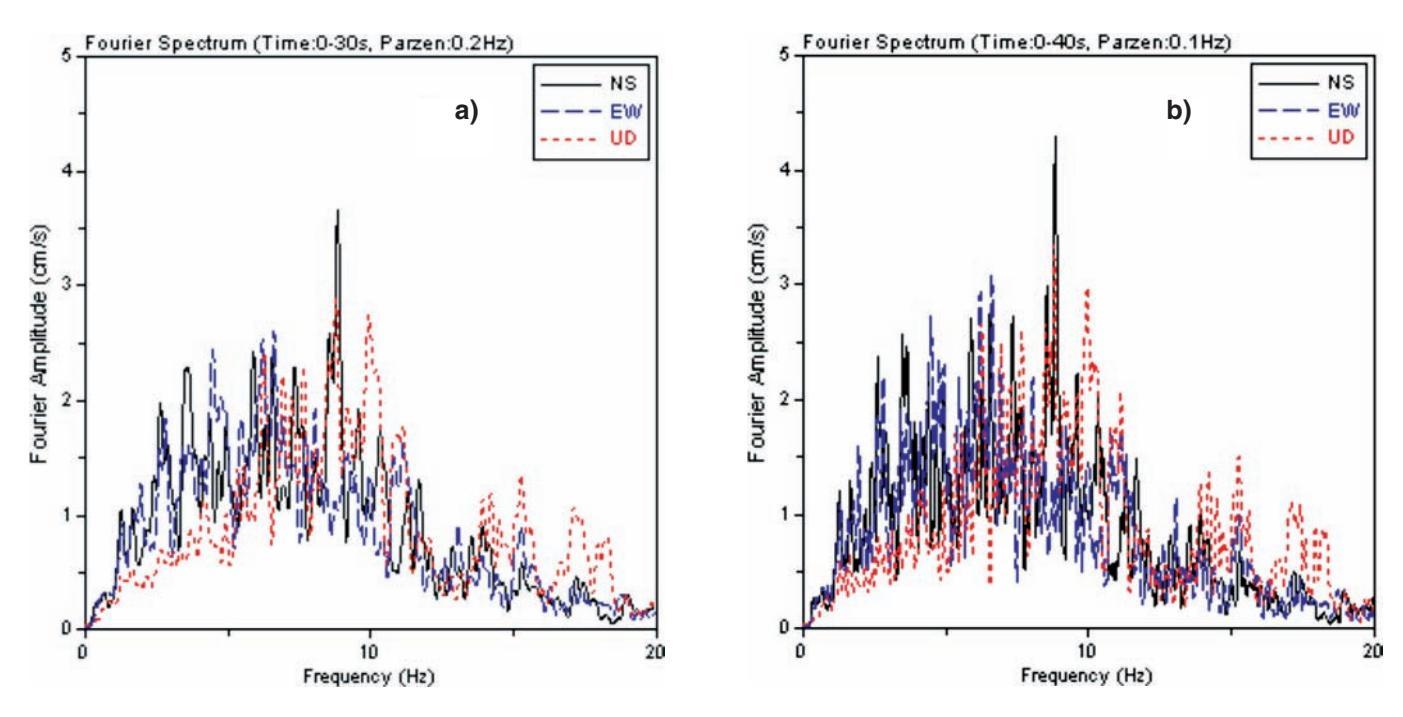
Fig. 11. Fourier velocity spectra for the M_L = 4.6, 21 November 2011 aftershock, recorded in Ercis and corresponding to running windows smoothing process with width n: (a) 0.2 Hz and (b) 0.1 Hz.

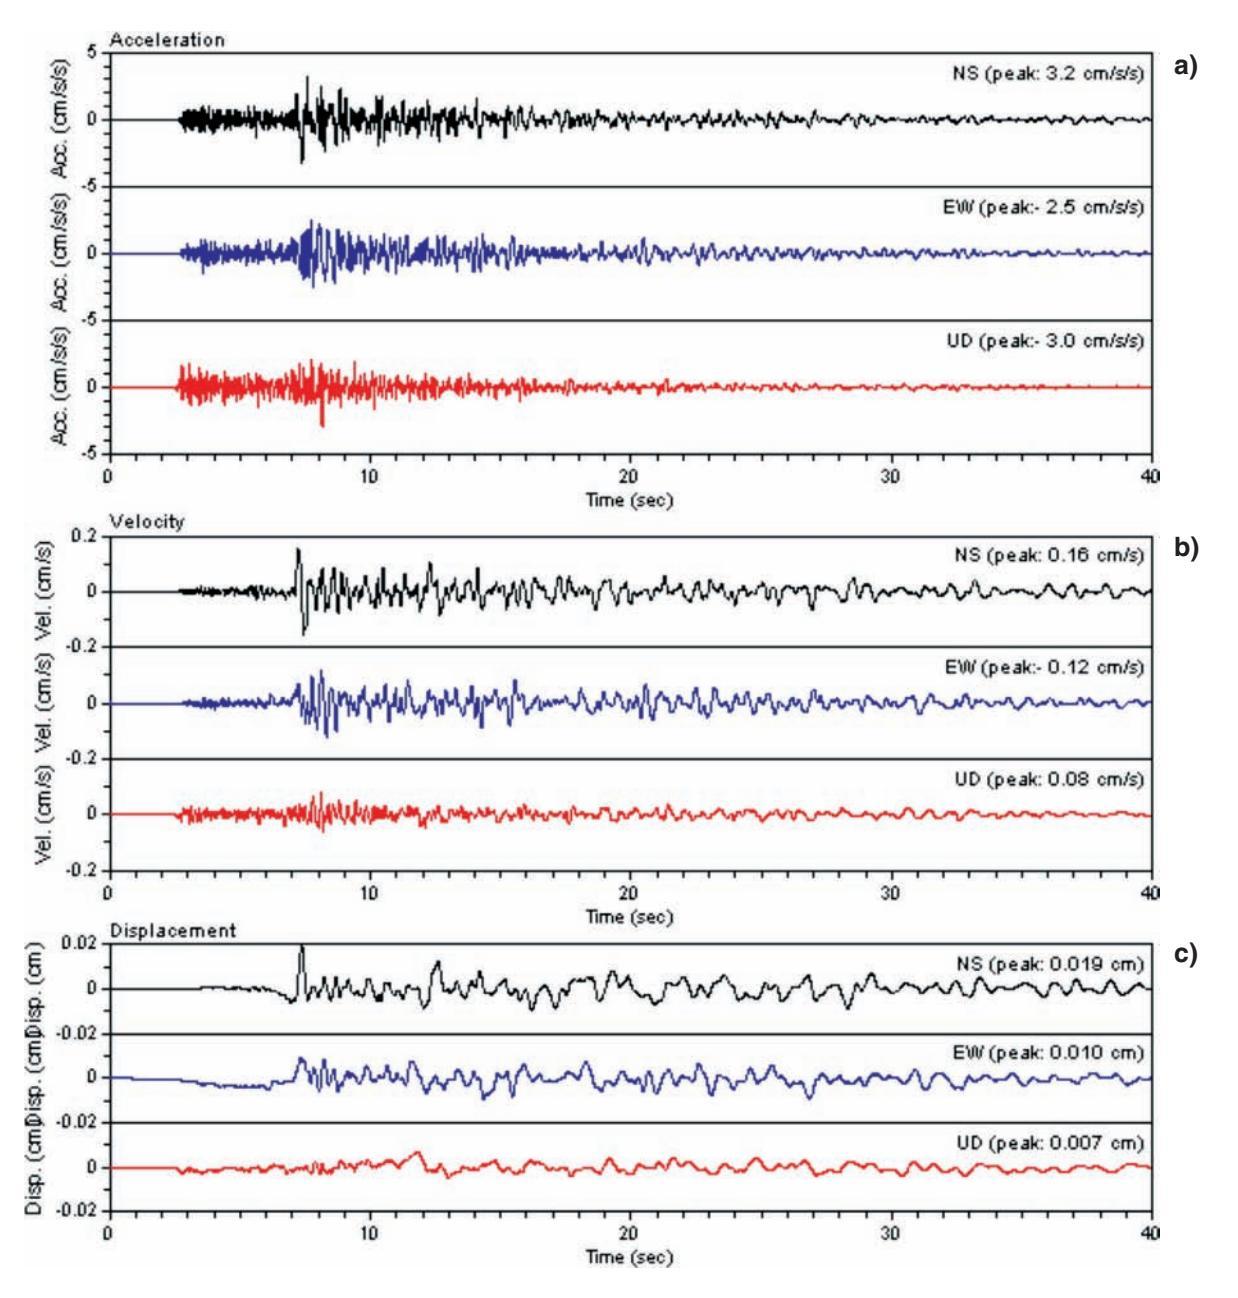
Fig.12. Corrected acceleration (a), velocity (b) and displacement (c), time histories for the $M_L = 4.6$, 21 November 2011 aftershock, recorded in Van. The epicenter is shown in Fig. 5. The epicentral distance is about 25 km.

distance of about 25 km, while Van is located on the foot wall. However the proximity to the fault (distance about 25 km) is a factor for interpretation. And this becomes more interesting since in /35/ it is concluded that the rupture was propagated to the southwest which contributes to the proximity of Van to the fault.
