PRELIMINARY REPORT

VAN EARTHQUAKE - TURKEY (Mw 7.2 - 23 OCT 2011)

The October 23 ($M_W = 7.2$) and November 9 ($M_W = 5.7$), 2011 Van, Turkey earthquakes. A geoscientific and engineering report

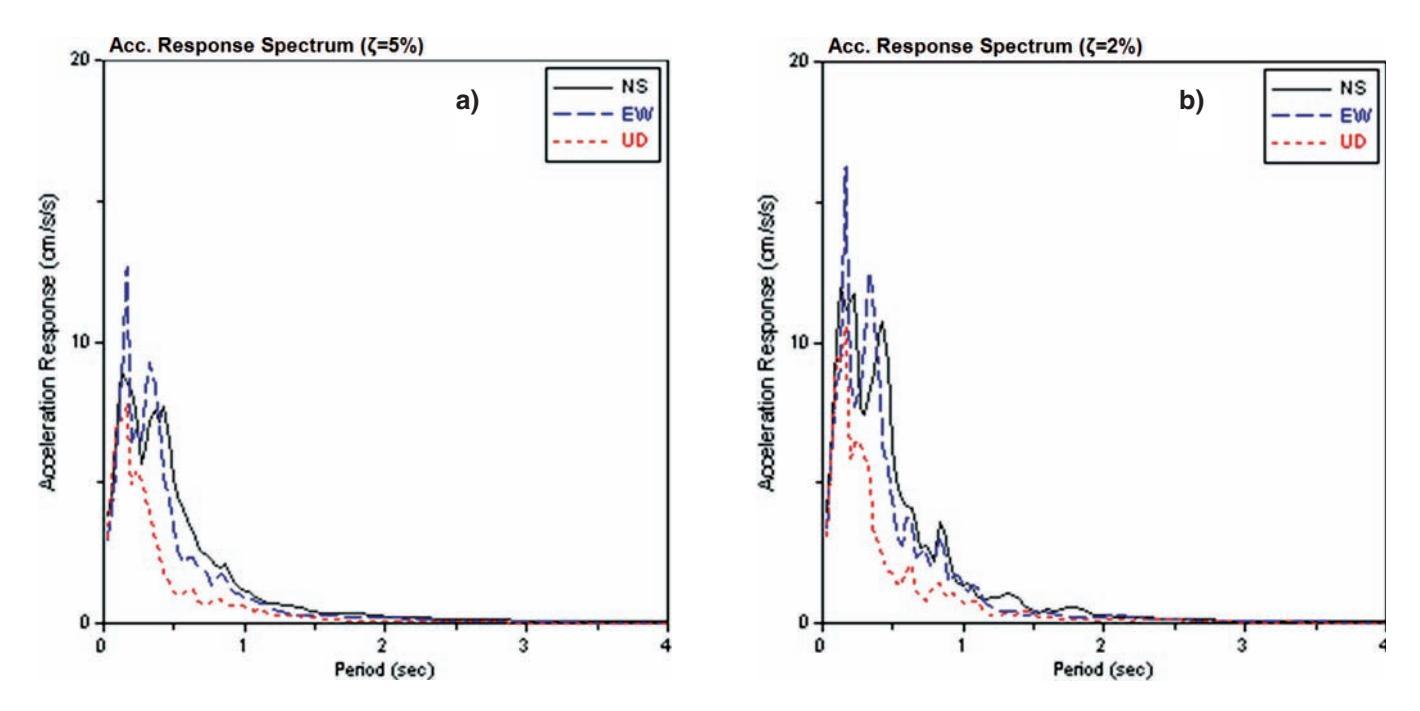
Fig. 13. Acceleration response spectra for the M_L = 4.6, 21 November 2011 aftershock, recorded in Van, for ζ : (a) 5% and (b) 2%.

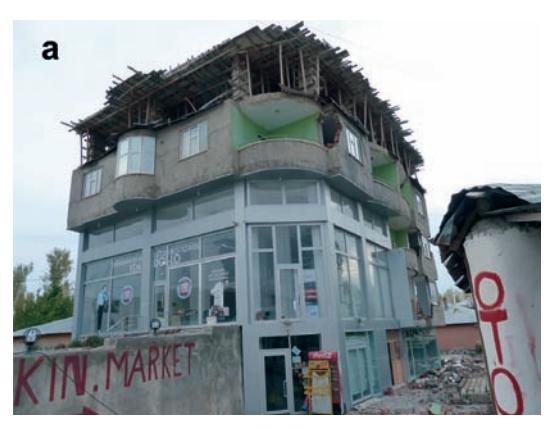
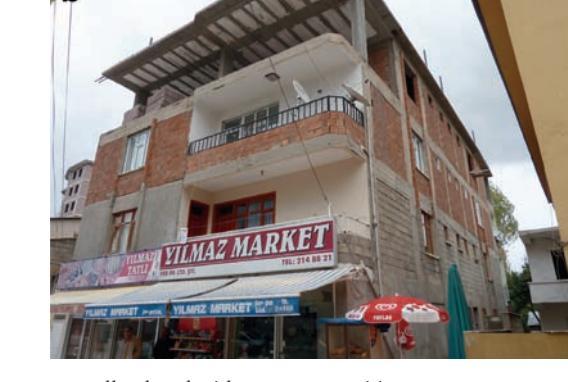
Fig. 20a, b. Usually, one or two storeys are added at the top and the balconies are externally closed with masonry partitions.

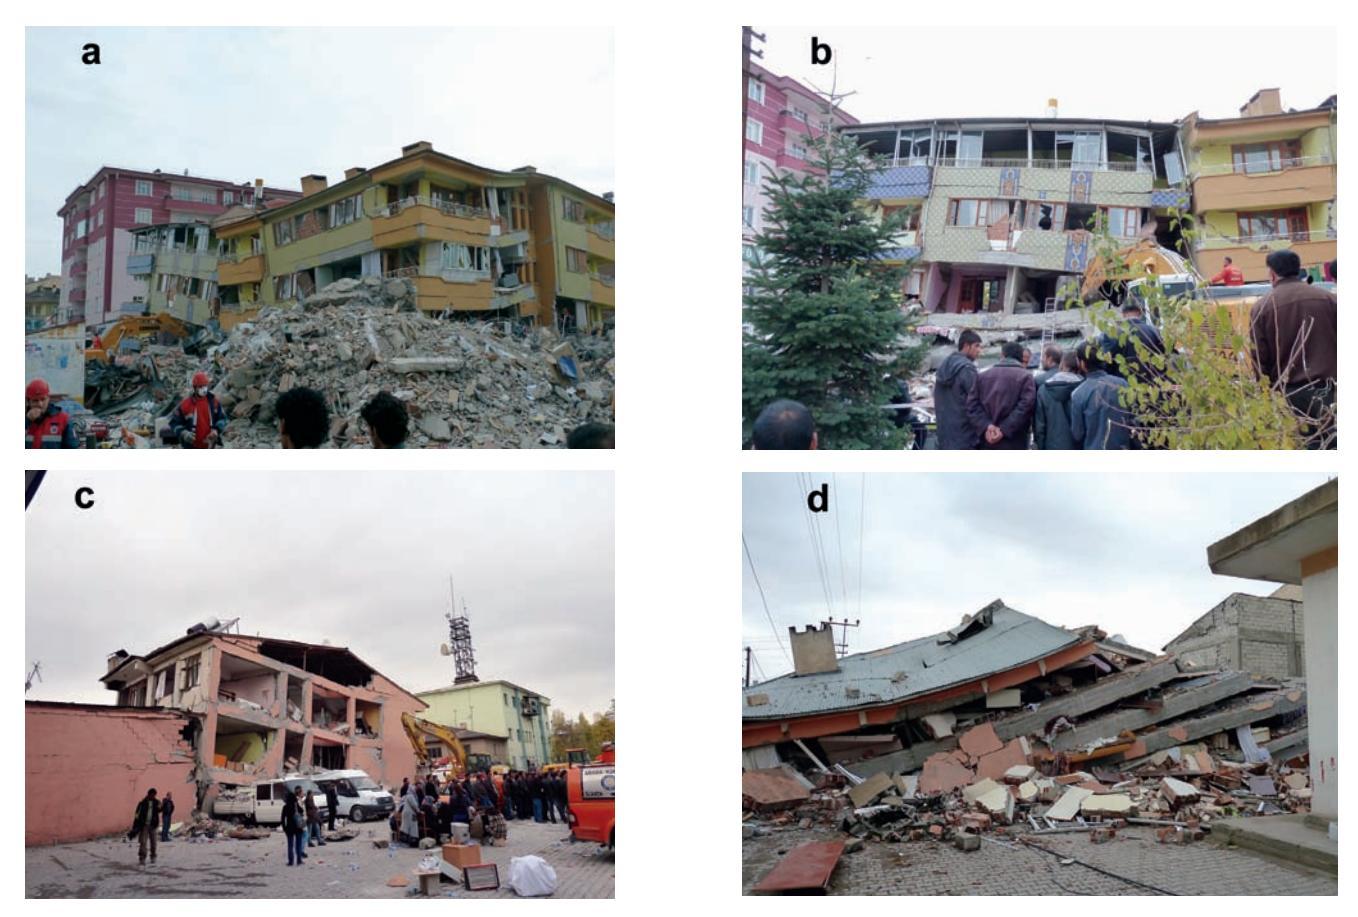
Fig. 24a-d. An agglomerate of collapsed buildings in the city center of Ercis. Note, that some chimneys are standing upwards.

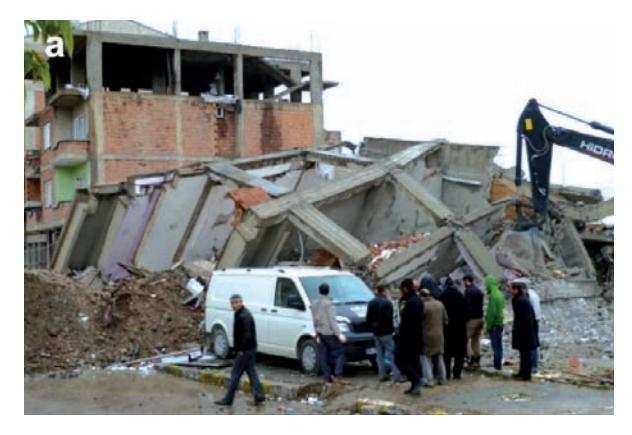
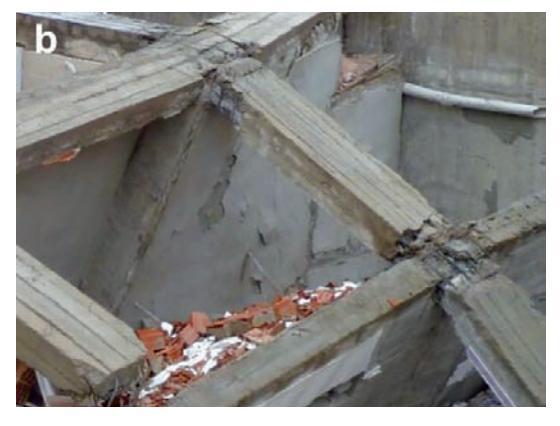
Fig. 25a, b. A technically interesting collapse. The reinforcement detailing is acceptable. Perhaps the concrete quality might have a problem or the concreting.

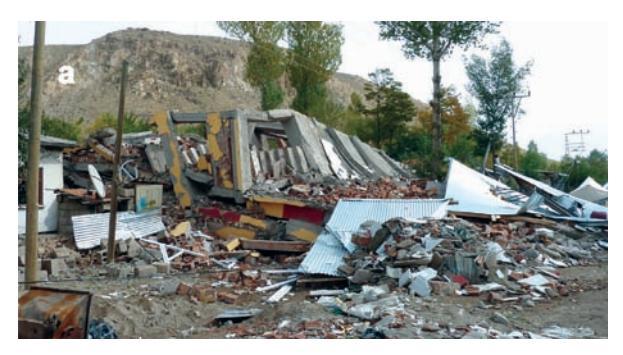
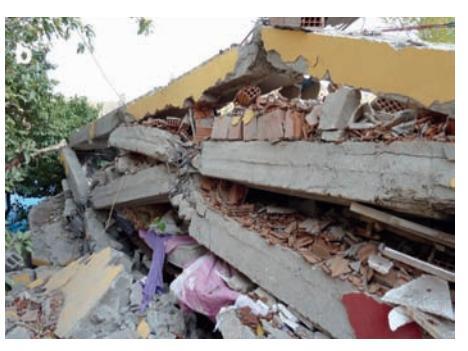
Fig. 26a, b. An other technically interesting collapse: a) In the fore-ground is the roof and the roofing corrugated iron-sheet; b) The top is the back column. The other columns are shaken off. Note that a flat-slab construction system does not allow any space for protection during collapse. The owner was describing that during the main shock he was staying on the ground. He felt two extremely violent upwards jolts, the one followed by the second making him to jump-up. At that time the building was jumping-up too. It was balancing, at the first cycle it stood on the front columns in parallel to the street. Next, the building stood on the back columns and then in the front ones with a stronger stroke when it toppled over.
