Date: 20th May, 2011

GEOLOGICAL PRELIMINARY FIELD REPORT OF THE LORCA EARTHQUAKE (5.1 M_w , 11TH MAY 2011)

Translation from the original report in Spanish

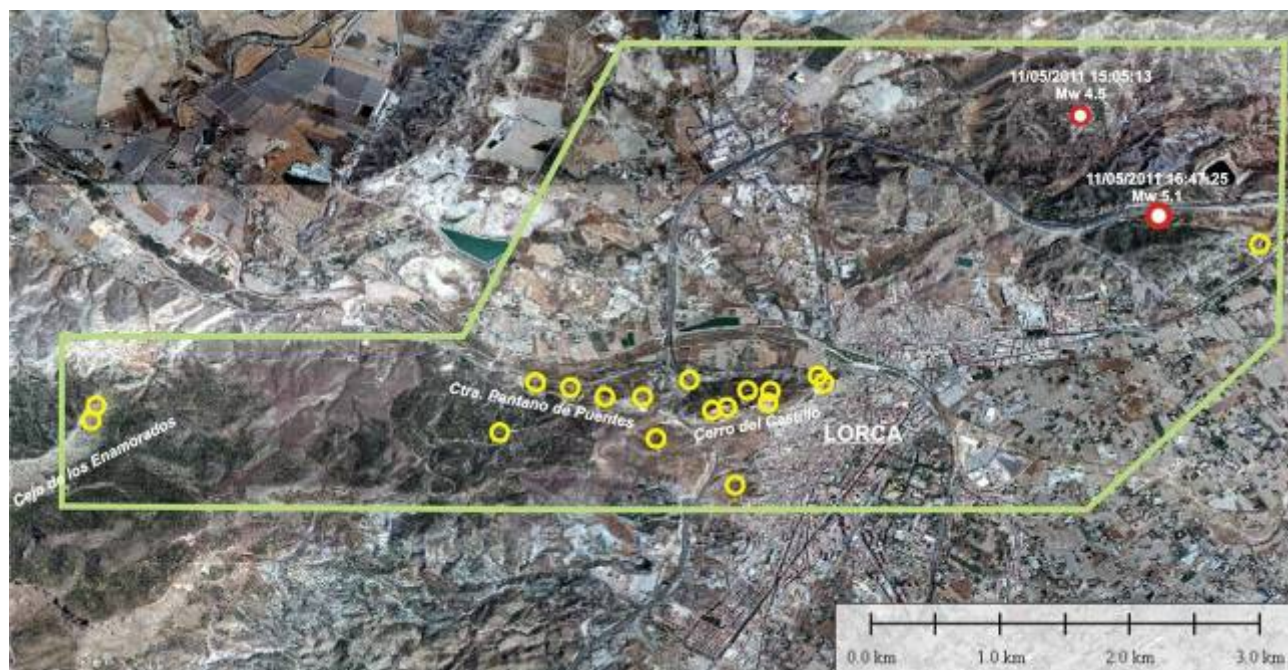
Figure 4.1: Situation of the main slope instabilities identified in the field survey.

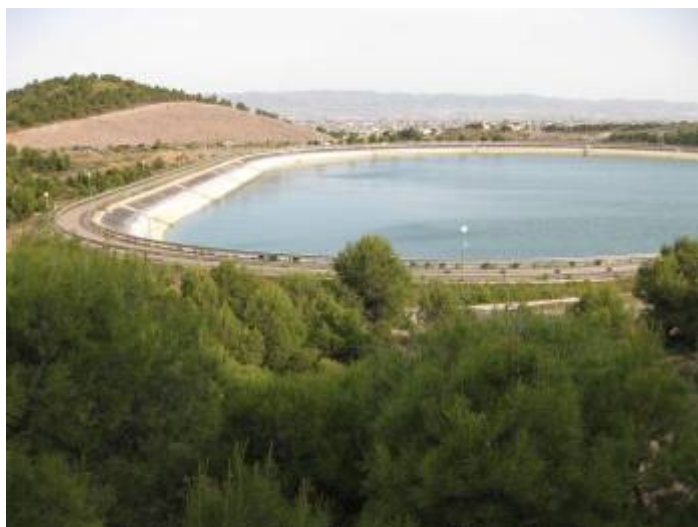
Figure 4.7: Irrigation pool situated nearby the epicentres of the 11 May earthquakes. Neither damage was observed in this area, nor instabilities on the talus on the background.

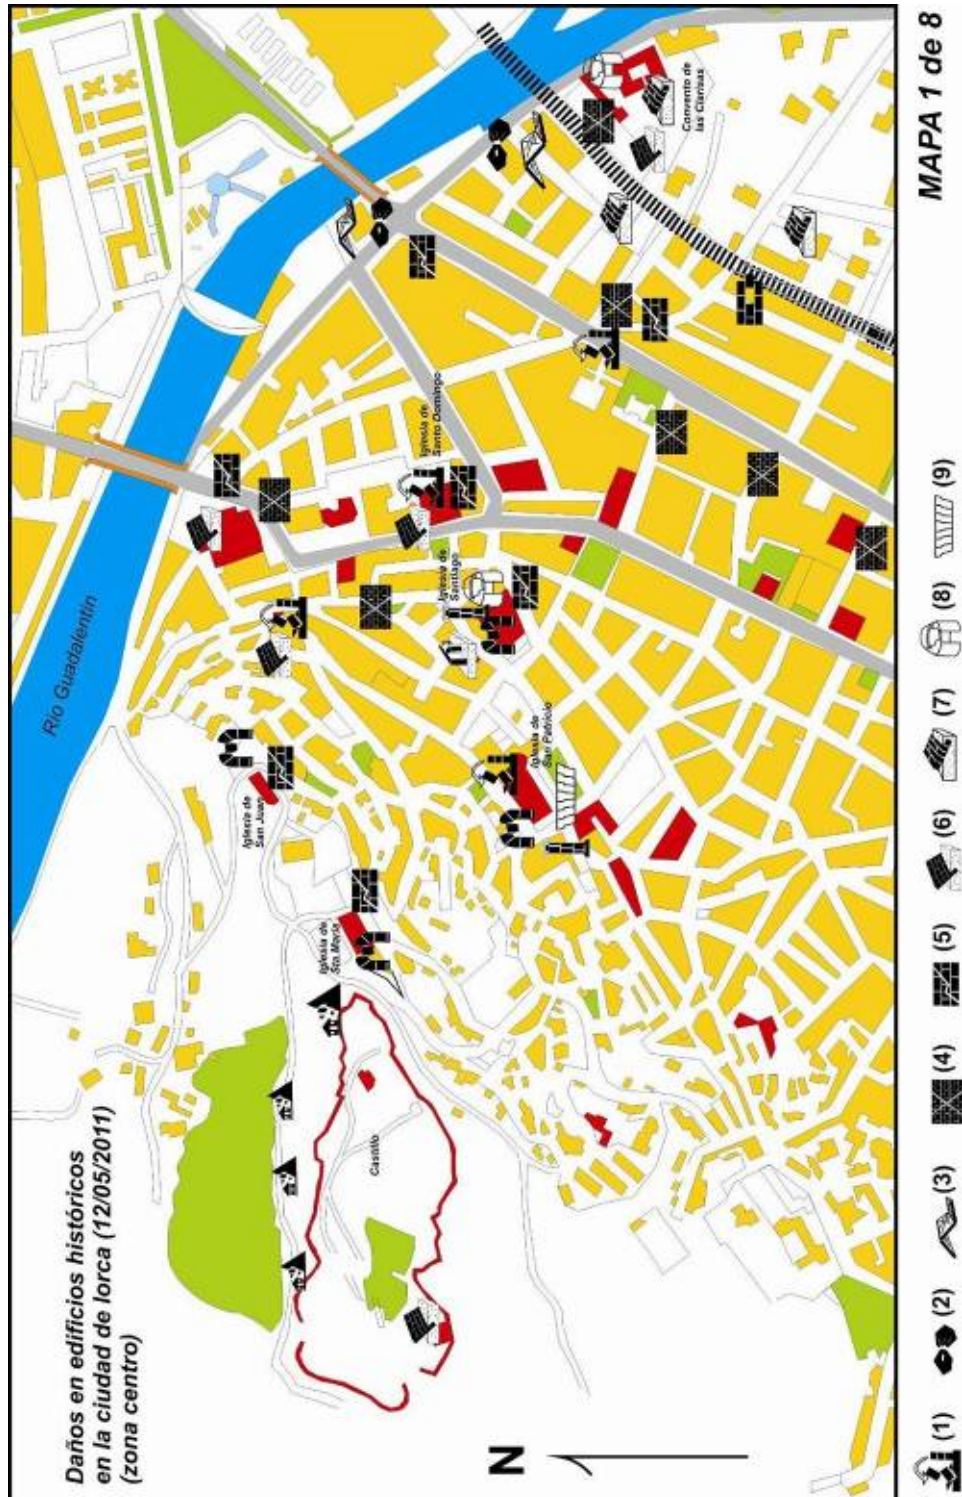
Figure 5.2 shows the map of the downtown area of Lorca, identifying the main EAEs recognized in this study. The symbols of the EAE are shown in Figure 5.1. The figures describe the main EAEs recognized and they have been created using the methodology of Giner-Robles et al., 2009.

Figure 5.2: Map of downtown of Lorca, with the spatial distribution of the main EAEs classified during the field work after the earthquake. See figure 5.1 for further explanation of the symbols.

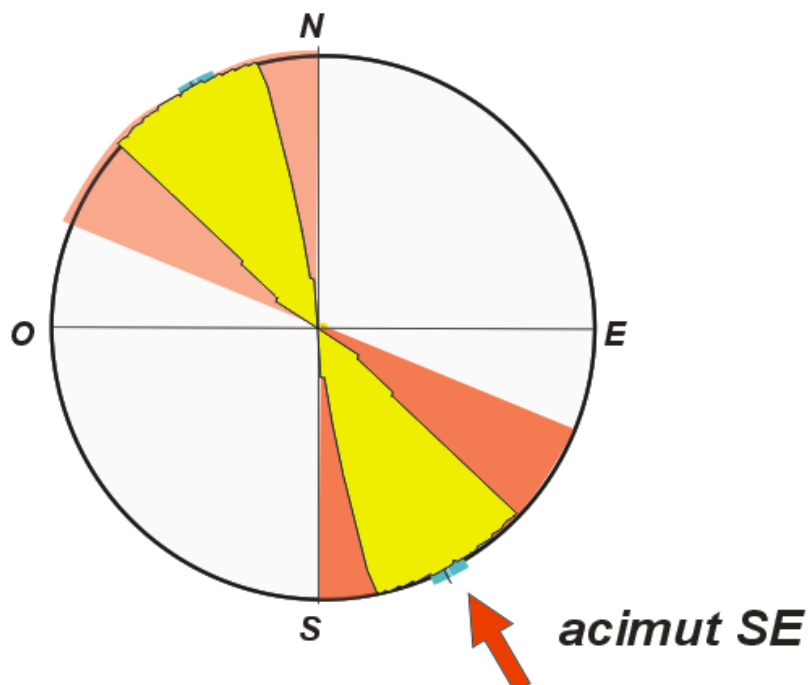
All this preliminary information has been represented in a rose diagram (Figure 5.10), showing the main orientation in a NW-SE trend, $N150^\circ$ - 160° E. We interpret these direction NW-SE with azimuth from the SE. This suggests a direction of σ_1 $N150^\circ$ - 160° , which is coherent with the regional stress field, the focal mechanism of the earthquake (left lateral with reverse component) and the epicentral location in the *Sierra de la Tercia*.

Figure 5.11: Rose diagram of the calculated main horizontal strain directions, using the EAEs. Preliminary results.
