The 15/Oct/2013 M7.1 Bohol Earthquake (Philippines)

Stéphane Baize (<u>stephane.baize@irsn.fr</u>), Marc Cushing, Sébastien Hok Institut de Radioprotection et Sûreté Nucléaire, France *Updated 24.10.2013*

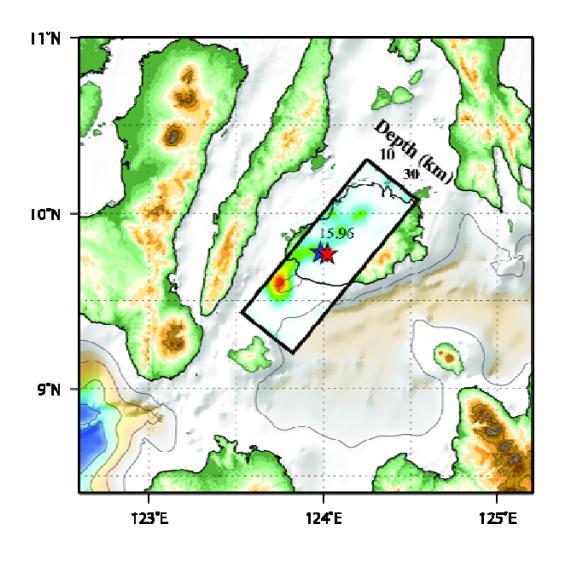
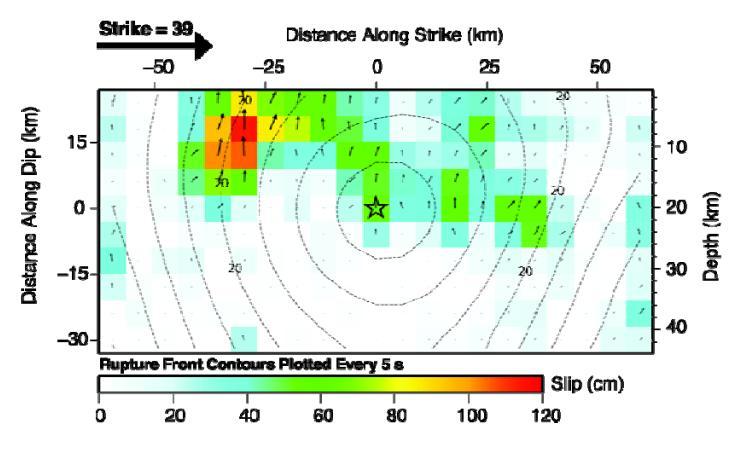
Figure 11: Slip distribution for the solution with a southeast dipping fault plane (the one consistent with geological observation of surface faulting; see hereafter) (update, 22/10/13) (source USGS)

A preliminary estimation of the slip distribution is provided by the USGS (Figure 11). By comparing with the few geological data that are available, the following is mentioned:

- 1. The maximum slip patch is located to the southwestern portion of the fault.
- 2. The maximum slip estimated at depth from seismological data (1.2 m) is much lower than the slip observed at the surface (3 m) close to a fault tip (see below).

The fault plane defined by the slip distribution (length: 75 km; depth: 20 km) is rather consistent with the aftershock map. The "seismological" fault plane at depth (75x20 km², dip 45°) would lead to a magnitude of Mw=7.3 according to the scaling relation for reverse faults of Leonard (2010). According to the same author, this would give a 60 km long fault at the surface, a maximum displacement of 5.5-6 m and an average displacement of 1.8 m.

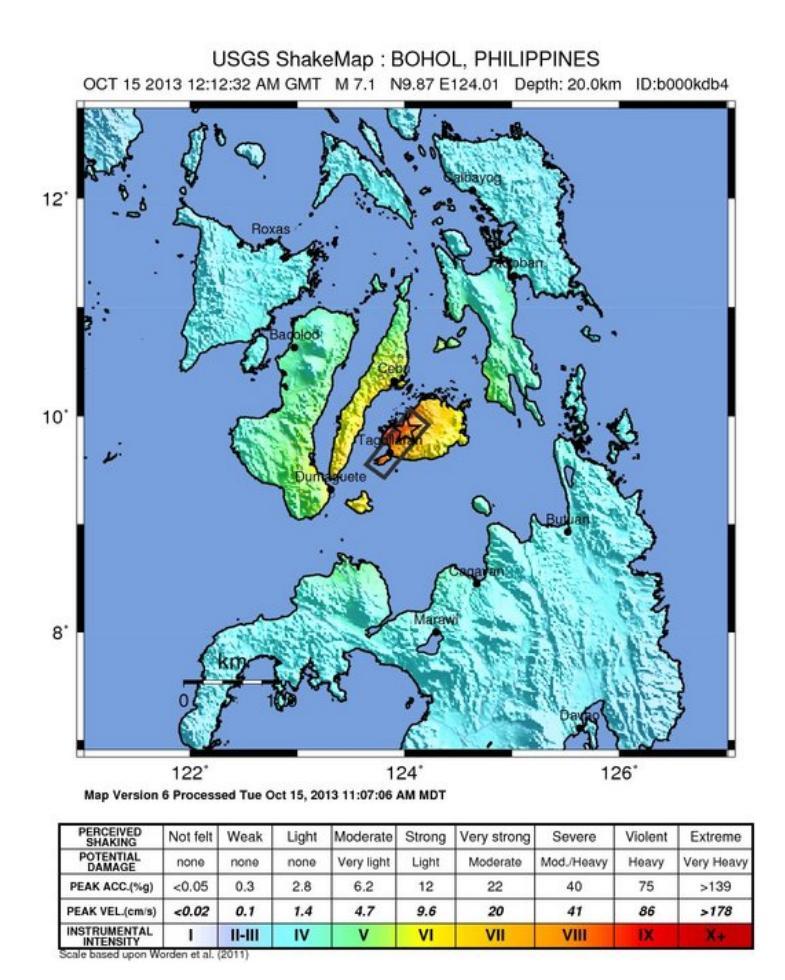
Figure 12: Estimation of the peak ground acceleration and intensities (source: USGS)

Up to now (October, 22nd), instrumental records of shaking are not available for the epicentral area. Estimation of acceleration and intensities are provided by the USGS. Acceleration and intensity may have reached respectively 0.4 g and VIII in the epicentral area (Figure 12). This calculated intensity is quite consistent with the reported damages.

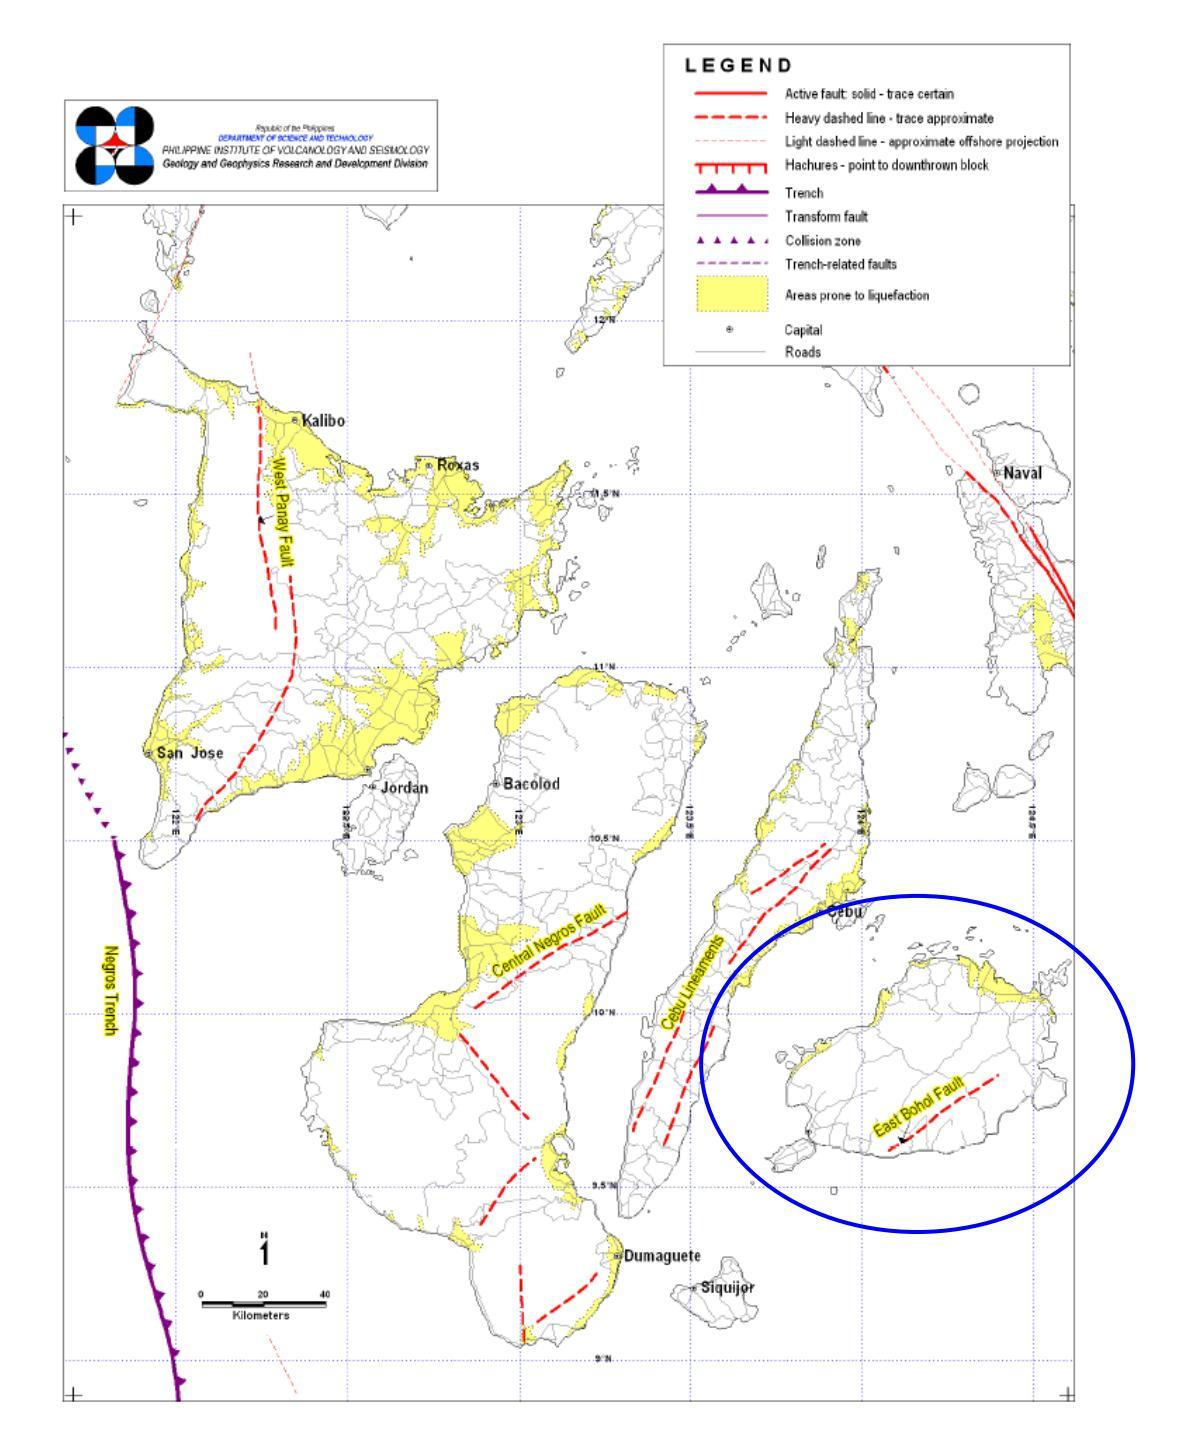
Figure 18: Active faults of the VII-VIII region of the Philippines, according to PHIVOLCS.

The PHIVOLCS describes an active fault along the southeastern coastline of the Bohol Island, the East Bohol Fault (Figure 18). Detailed data on this fault are unfortunately not available.

In the first days after the earthquake, this fault was thought to be a reliable candidate as a source because

- 1. The focal mechanism is consistent with the trend and kinematics of this fault.
- 2. The fault trace is located at almost 25 km south of the epicentre (Figure 19). Considering the depth of the focus between 12 to 20 km (depending of the institute) and the dip of the nodal plane solution (45°), this hypothesis was reasonable and was initially supported by the PHIVOLCS.
- 3. The map of the aftershock sequence shows an outstanding NE-SW plane as long as 75-80 km and 15 km wide (projected on the horizontal plane).

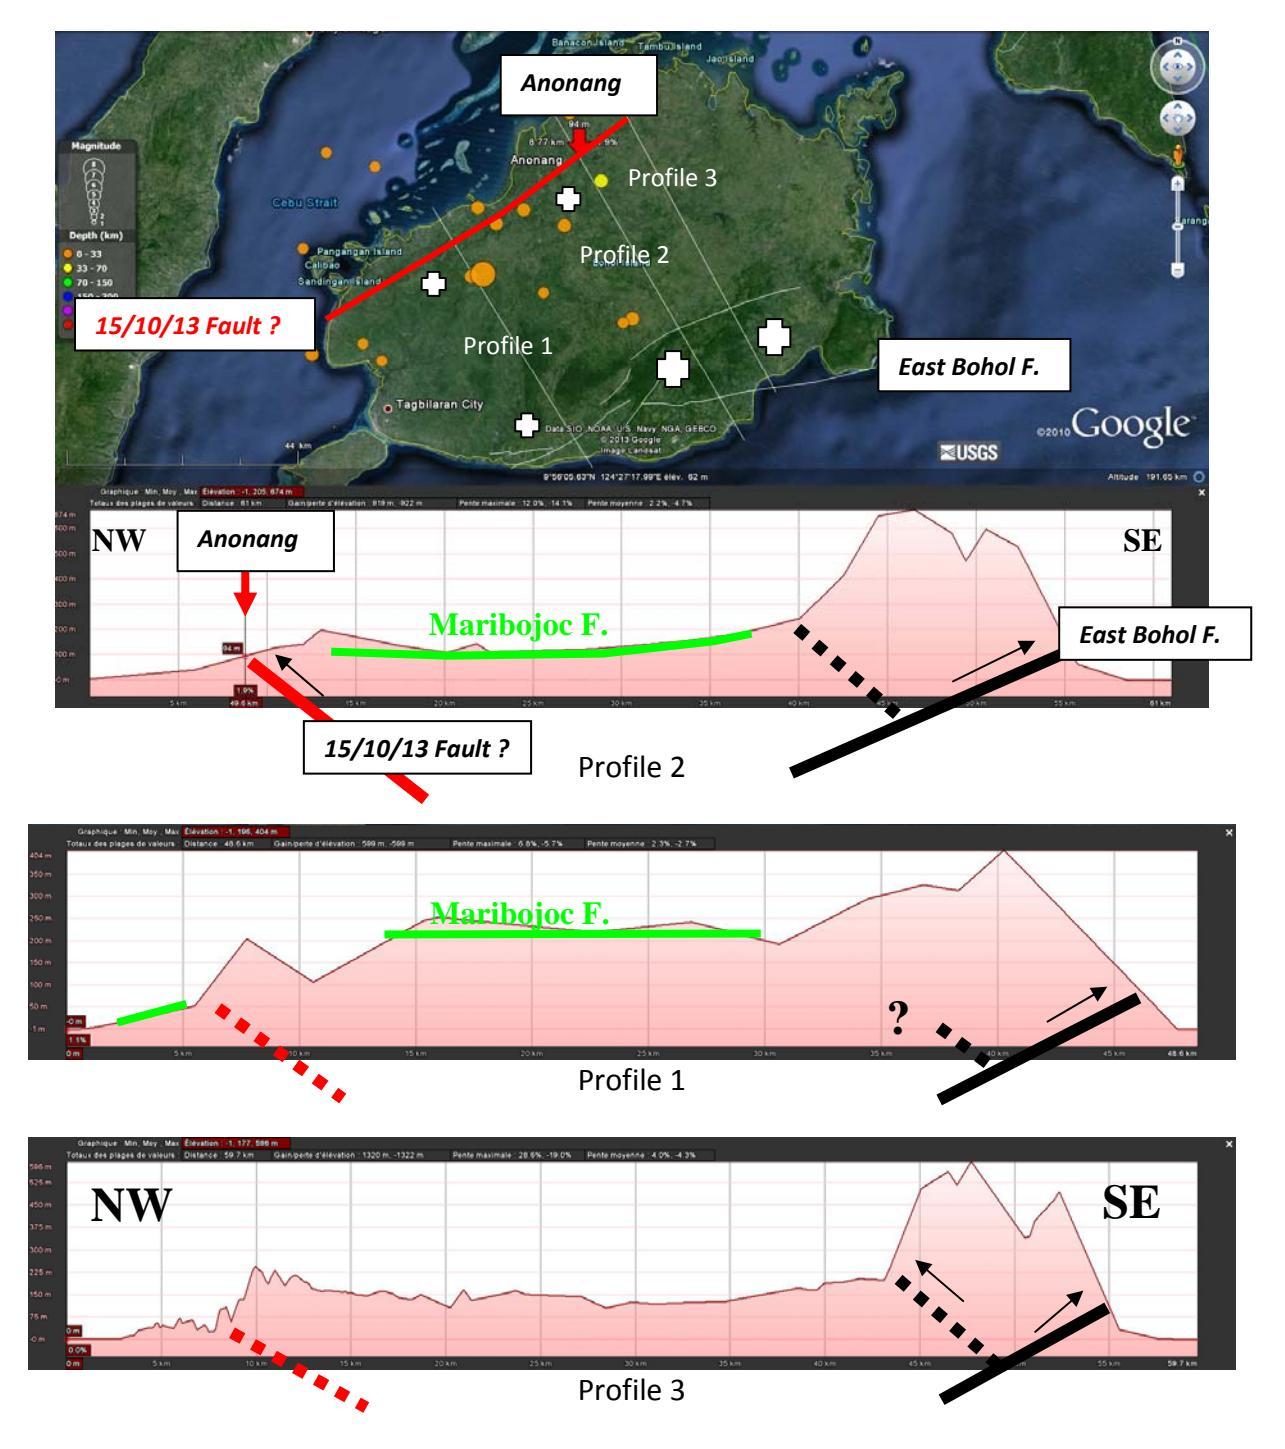
Figure 19: Morphological sections of the Bohol Island (source of topographic data: Google Earth Pro) and provisional interpretation of the potential active and morphogenic faults (source: this paper).

The island morphology suggests that the East Bohol Fault is an active and morphogenic structure. In its western portion (profile 1; Figure 19), one can distinguish a cumulative scarp of about 400 m that could be associated with the uplift of the hanging wall of the fault. To the east, this cumulative scarp increases up to 600 m (profiles 2 and 3).

- 1. A smaller (cumulative) scarp also appears to the north of the 3 profiles. Its separation is around 200 m.
- 2. In between the coastal scarps, the young (lower Pleistocene) Maribojoc Formation is uplifted of about 100 to 200 m.

This suggests that, besides the southeast-verging Eastern Bohol fault, a northwest-verging "northern" structure may cause vertical displacement and uplift of the Quaternary Maribojoc sediments. This morphogenic structure might be the continuation to the SW of the surface rupture observed in Anonang. It could be considered as a back-thrust related to the major East Bohol fault.

Assuming that the Maribojoc formation is 2 Ma old, the general uplift rate of the central part of the island, that could be associated with the thrust system activity, would be of 0.05-0.1 mm/a.
