M7.2 Kumamoto Earthquake

14 and 15 april 2016

A compilation of data and results with focus
on surface rupture

By Stéphane Baize (IRSN) for the INQUA Project
SURFACE

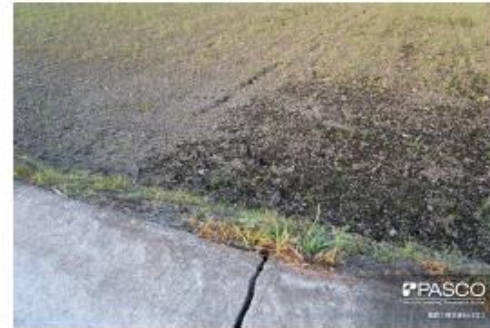
loc056

熊本県上益城郡
 益城町棚島(嘉島 JCT 北西)

アスファルト舗装および圃場に現れたクラック
 高度差はほとんどない

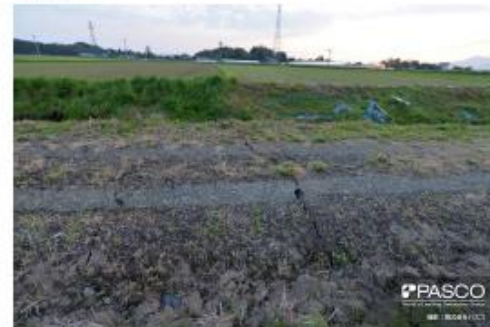
loc057

熊本県上益城郡
 嘉島町井寺(嘉島 JCT 西)

農道に現れたクラック
 高度差はほとんどない

写真は 16 日未明の地震前である 15 日に撮影

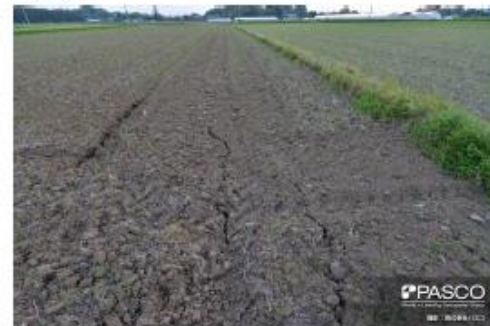
loc057

熊本県上益城郡
 嘉島町井寺(嘉島 JCT 西)

水田に現れたクラック
 高度差はほとんどない

写真は 16 日未明の地震前である 15 日に撮影

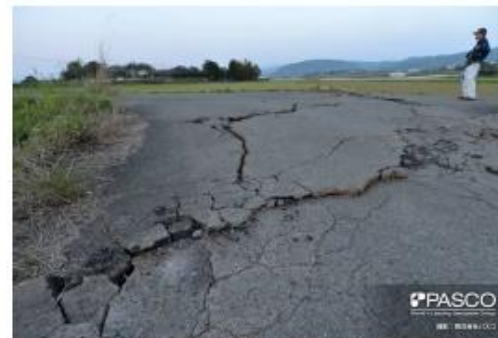
loc058

熊本県上益城郡
 嘉島町井寺(嘉島JCT西)

アスファルト舗装、水田に現れたクラック
 右横ずれを示す

写真は 16 日未明の地震前
 である 15 日に撮影

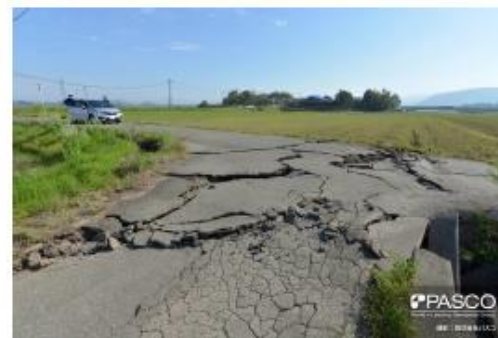
loc058

熊本県上益城郡
 嘉島町井寺(嘉島JCT西)

写真は 16 日未明の地震後
 である 16 日撮影

クラックやずれが拡大してい
 る

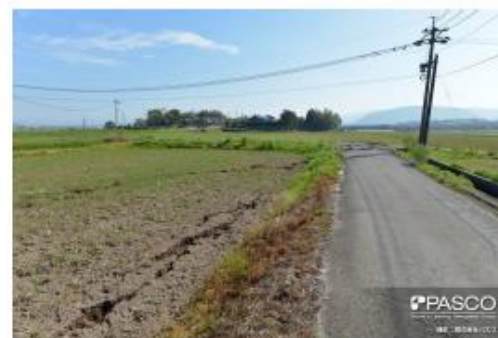
loc058

熊本県上益城郡
 嘉島町井寺(嘉島JCT西)

写真は 16 日未明の地震後
 である 16 日撮影
 電柱が上写真位置
 クラックやずれが拡大してい
 る

“Right lateral dislocations cross the road way. The gap was approximately 30cm. The dislocation may be a part of surface faulting. This is because no landslides are expected in the area, the crack azimuth agrees with the fault strike, and its location is almost on the fault surface. **According to the neighbor, the dislocation slightly appeared after the 1st event, and it grows to the current size after the 2nd event.**”

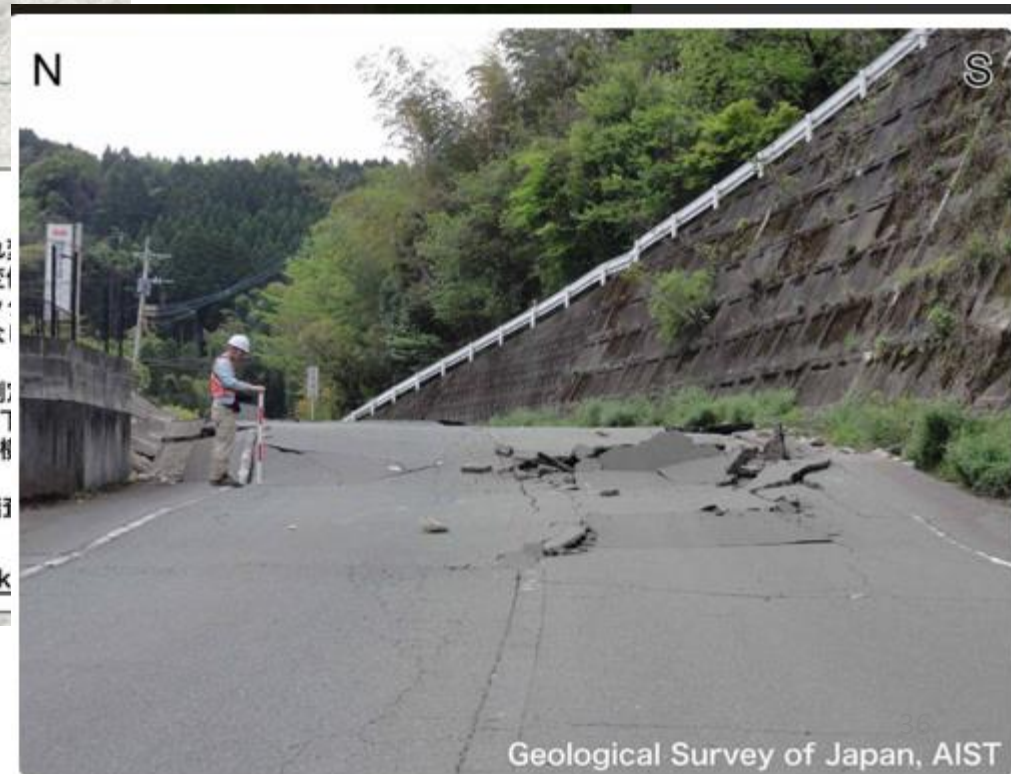
Right-lateral displacement and mall track seen in photo 4 Shimojin village west. Picture taken toward the northeast direction. Right-lateral displacement weight of about 100 cm, vertical displacement weight of about 20 cm. (2016 April 16 shooting)

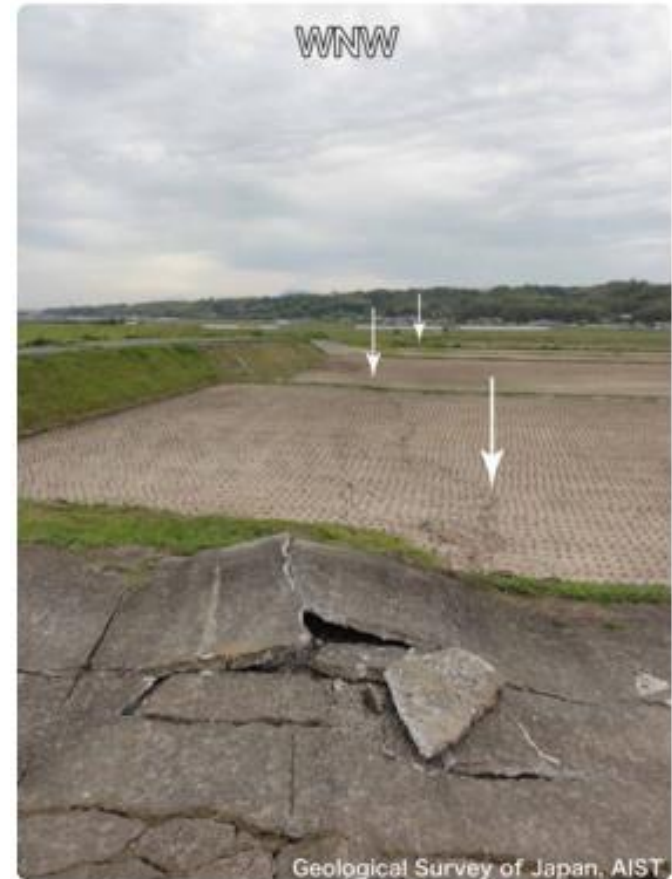
6- Flexure deformation of the paddy field with a left-lateral strike-slip component of N70W strike seen in Shimojin village west. Picture taken toward the west-northwest direction. Vertical displacement weight of about 15 ~ 20 cm, left-lateral strike-slip displacement amount is about 20 cm. (2016 April 16 shooting)

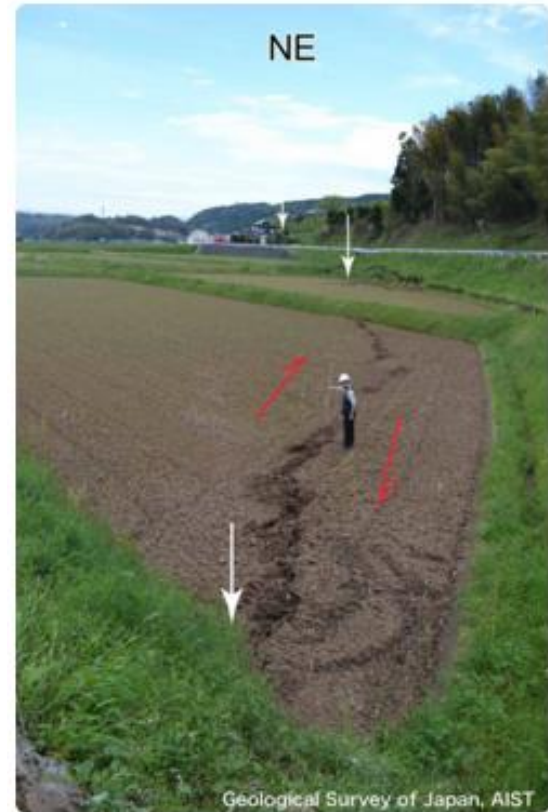
7- Right-lateral displacement seen in photo 7 Mitake village southwest of paddy. Picture taken toward the northeast direction. Fault passes through the road from the distortion part of the guardrail, through the right of the back of the house, continuing to photograph 5. (2016 April 16 shooting)

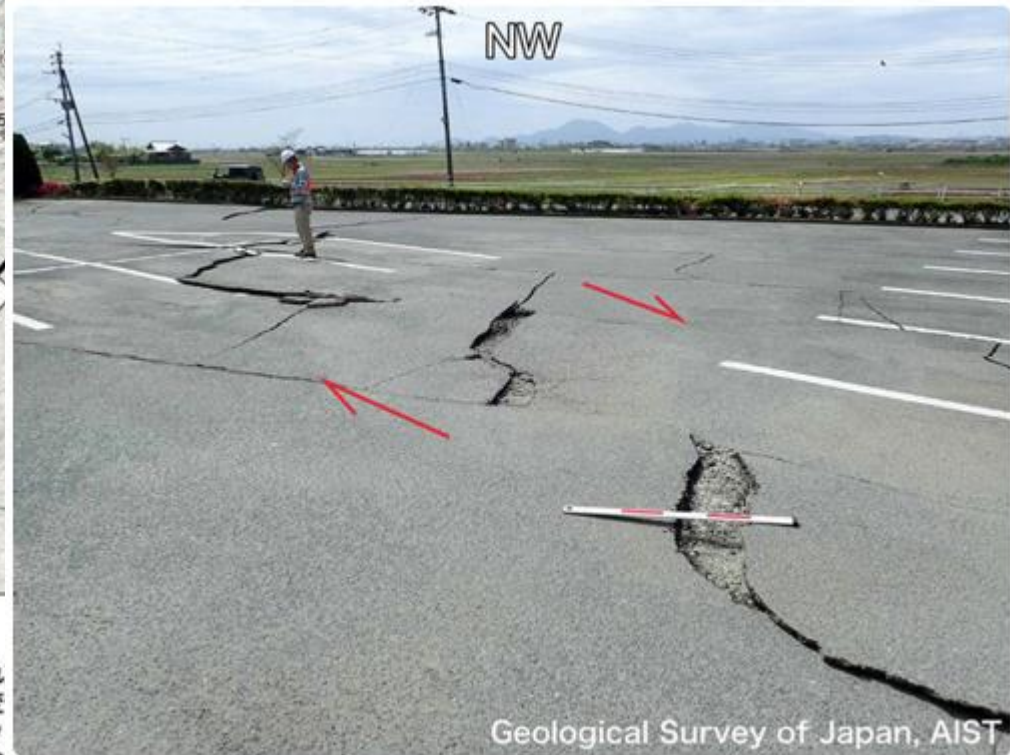
8-Akai village "mashiki townspeople rest of the house," parking lot to see is right-lateral displacement. Picture taken toward the northwest direction. Right-lateral displacement amount is about 40 ~ 50 cm. (2016 April 16 shooting)

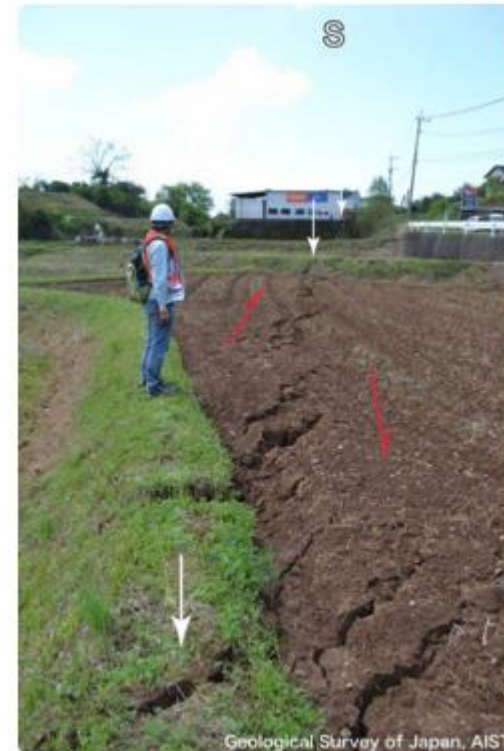
13-Right-lateral displacement seen in the rice paddies of the photo 13 Takagi village. Picture taken toward the south direction. Right-lateral displacement amount is about 50 cm. (2016 April 17 shooting)

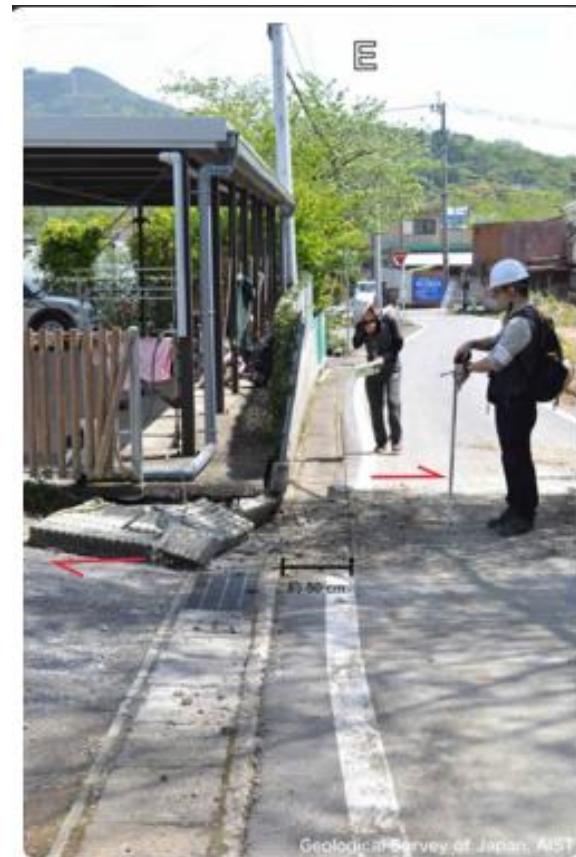
14- Right-lateral displacement seen in the pavement of Kamikoya village. Picture taken toward the east direction. Right-lateral displacement amount of time on the basis of the gutter is about 50 cm. (2016 April 17 shooting)

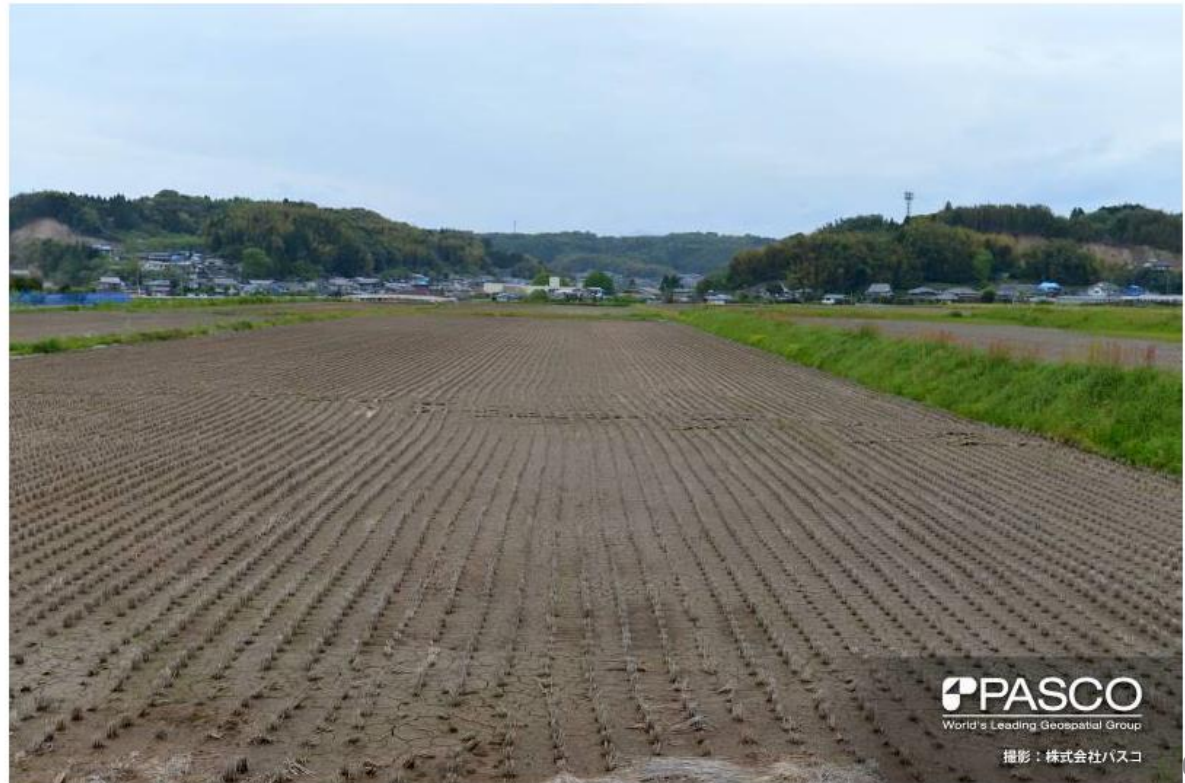
loc007

Left Lateral on WNW-ESE

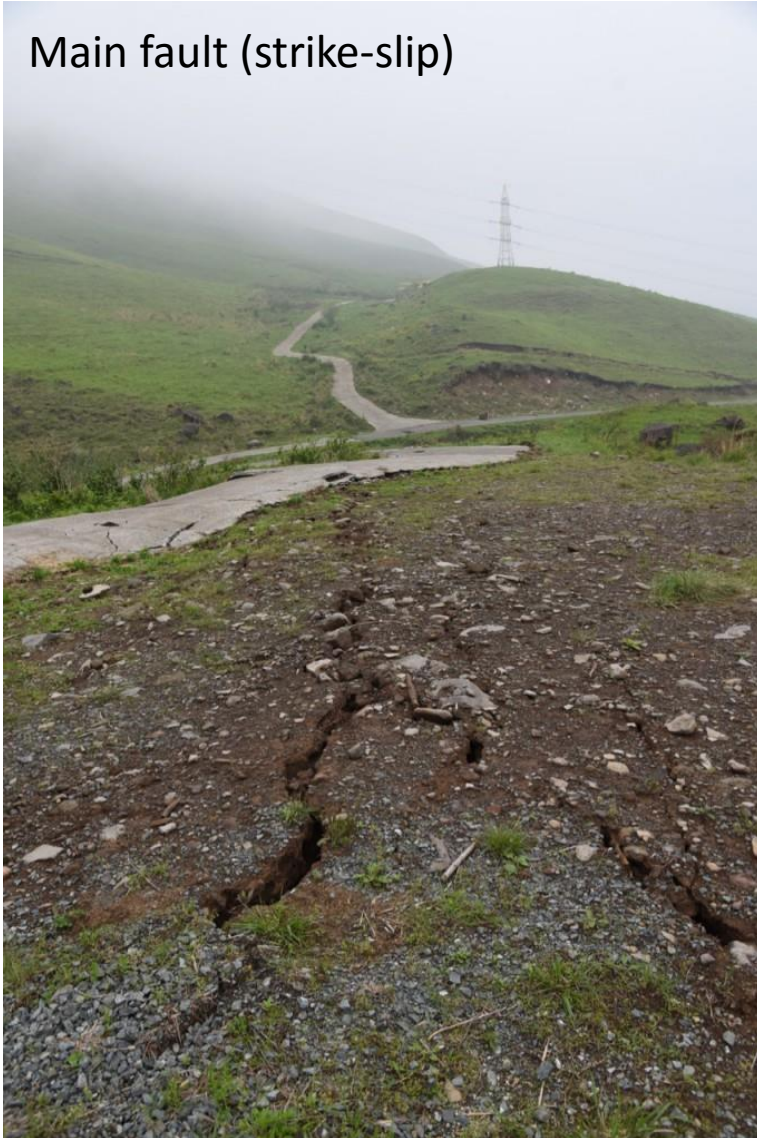
Main fault (strike-slip)

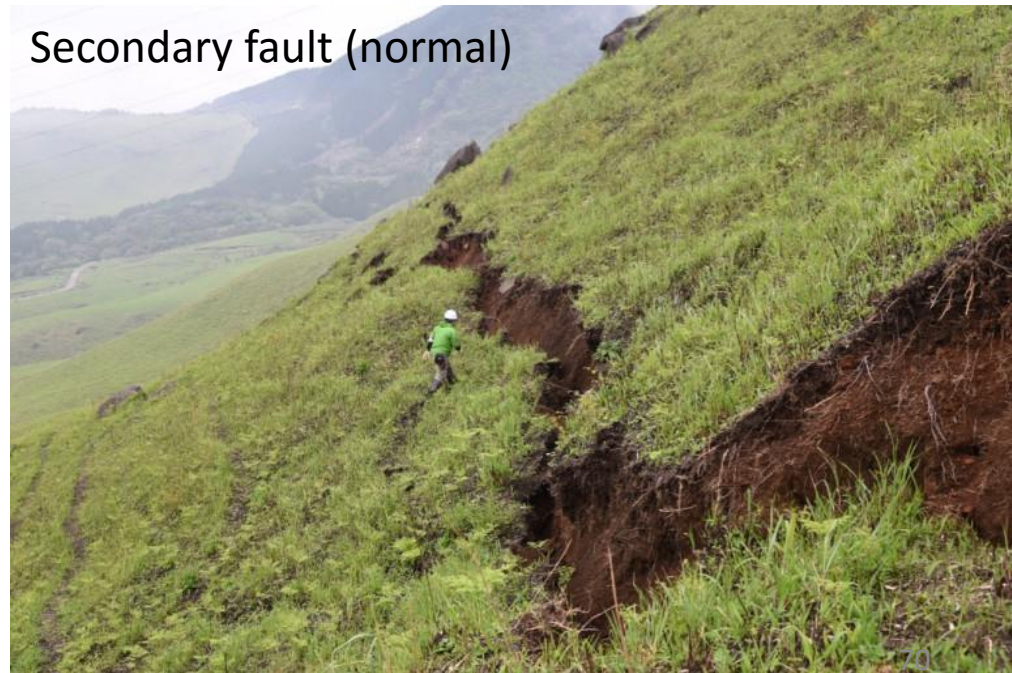
Secondary fault (normal)

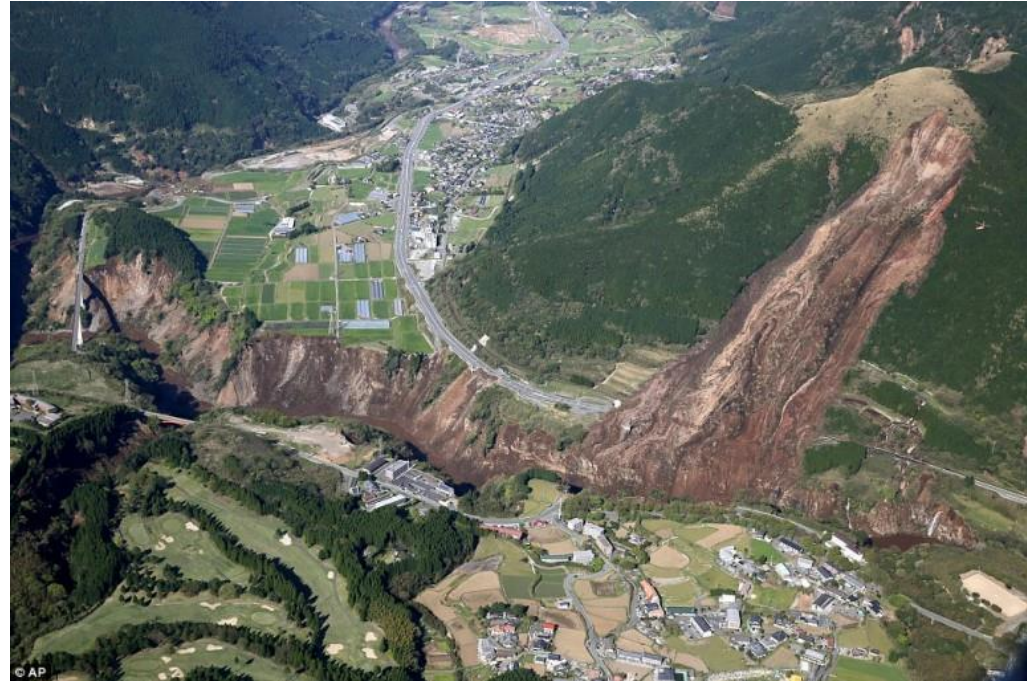
Mimami-Aso

A landslide triggered by the Kumamoto earthquake, via Asia One, that destroyed an important bridge
